Route 70 (Marlton Pike) Cuthbert Boulevard to Penn Avenue

Pedestrian Road Safety Audit/Assessment

Cherry Hill, New Jersey

September 15-16, 2008

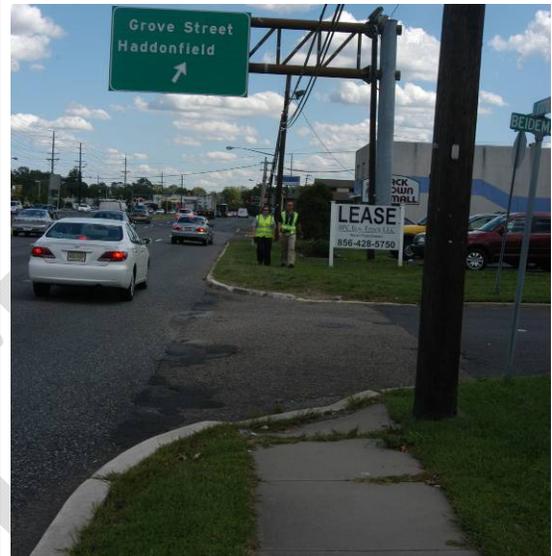
View of sidewalk along Route 70 eastbound near Grove St. Note the gaps in the sidewalk that limit access for pedestrians with mobility restrictions.

Long-term- All sidewalk upgrades within the study area should consider the urban nature of this section of road and should coordinate with redevelopment such as the Market Place at Garden State Park. Upgrades could include streetscaping projects that would create an urban roadway cross section with sidewalk and curb and no shoulder. An urban cross section may help increase driver expectancy of the presence of pedestrians and control vehicle speeds.

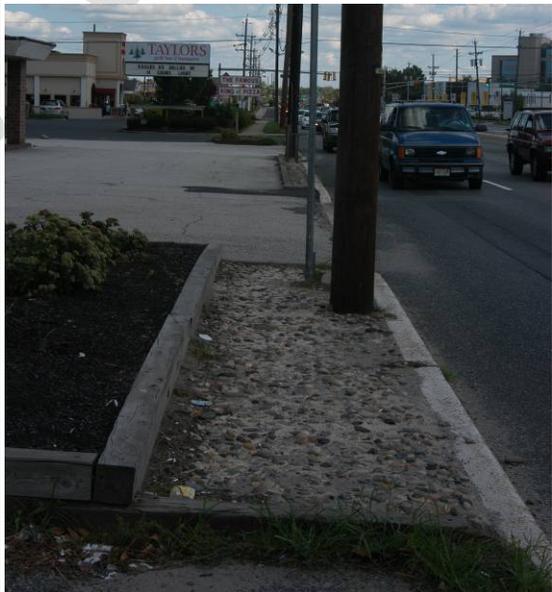
View of sidewalk along Route 70 westbound near Cornell Ave. Gaps in the sidewalk limit accessibility for pedestrians.

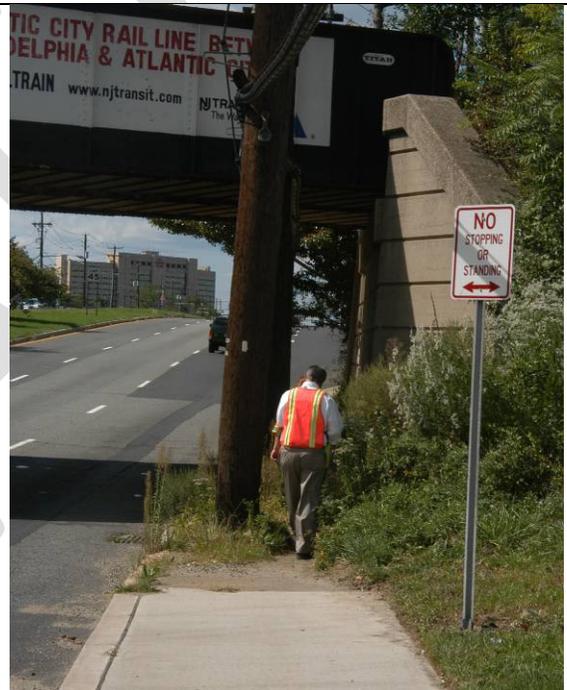
Obstructions on sidewalks: Both permanent and temporary obstructions were found on sidewalks in the study area. Obstructions affect all pedestrians, but are particularly hazardous to pedestrians with mobility restrictions who may require additional space to navigate the sidewalk, or to pedestrians with limited vision who may fail to see the obstructions. Sidewalk obstructions may cause people to use the roadway to maneuver around the obstacles, increasing the potential for a conflict with traffic. Obstructions identified by the RSA team include:

View of sidewalk on the north side of Route 70 traveling westbound. The photo shows the obstructions (i.e., utility poles and vegetation) on the sidewalk near the railroad crossing. The obstructions make it difficult to pass, particularly for those with mobility restrictions or in a wheelchair.

Intermediate to long-term- Consider removing or relocating obstructions, or building an accessible sidewalk around obstructions. The ability to widen the sidewalk will depend on the available right-of-way and existing bridge structure at the railroad crossing.

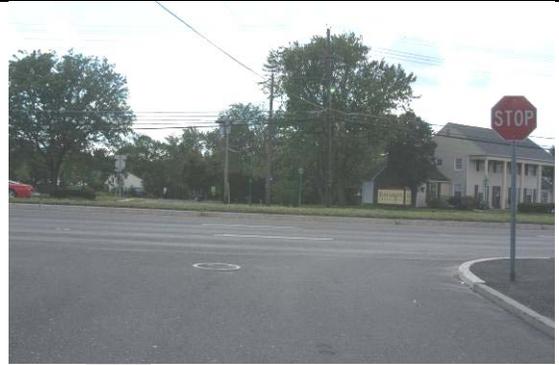
View of crossing on north side of intersection at Union Ave. Note that there is no crosswalk or curb ramp. This is an example of discontinuity and could pose a challenge to those with mobility restrictions. Furthermore, there are no indications to drivers that pedestrians may be crossing.

<p><i>Intermediate-</i></p> <ul style="list-style-type: none"> • Ensure curb ramps and cut-throughs are provided along pedestrian paths. • Ensure curb ramps align with crosswalks and sidewalks and follow direct paths. 	
<p>Lack of buffer: <i>Limited or no buffer along sections of existing sidewalk provides little separation between pedestrians and fast moving traffic.</i></p> <p>Suggestions: Consider increasing the buffer where existing right-of-way permits. It is desirable to maintain a minimum of 2-feet between the sidewalk and edge of roadway; given the traffic speeds and volumes on route 70, a 5-6 foot buffer should be considered similar to the buffer between Garden Park Boulevard and Haddonfield Road. For future pedestrian facility upgrades, consider streetscaping as described previously and coordinate improvements with future development.</p>

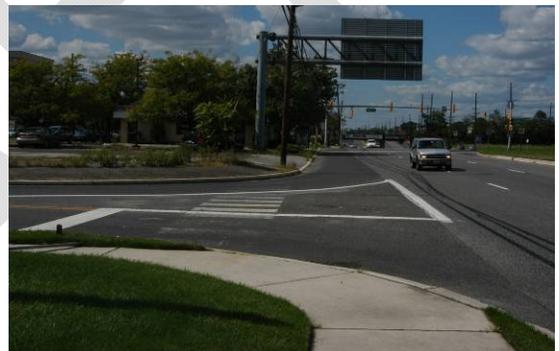
View of crossing on south side of Route 70 at the intersection with Penn Ave. Note that the crosswalk is almost completely faded across the travel lanes and there is no curb ramp on the opposite side of the intersection. Furthermore, the overhead street sign diverts driver attention away from the crossing and the large corner radius allows vehicles to turn at high speeds.

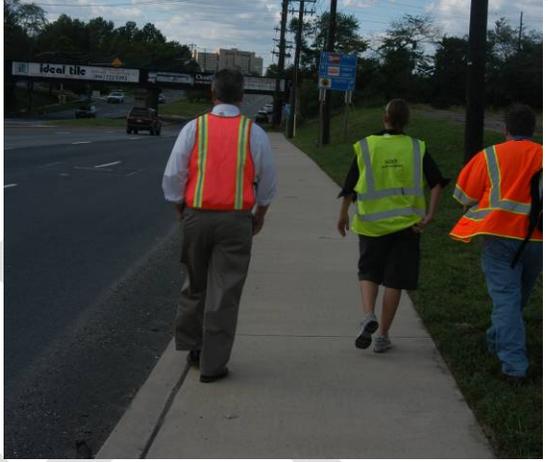
<p>View of sidewalk along north side of Route 70 just east of the railroad crossing. The limited buffer between the edge of sidewalk and the travel way may present a hazard to pedestrians walking close to the roadway.</p>

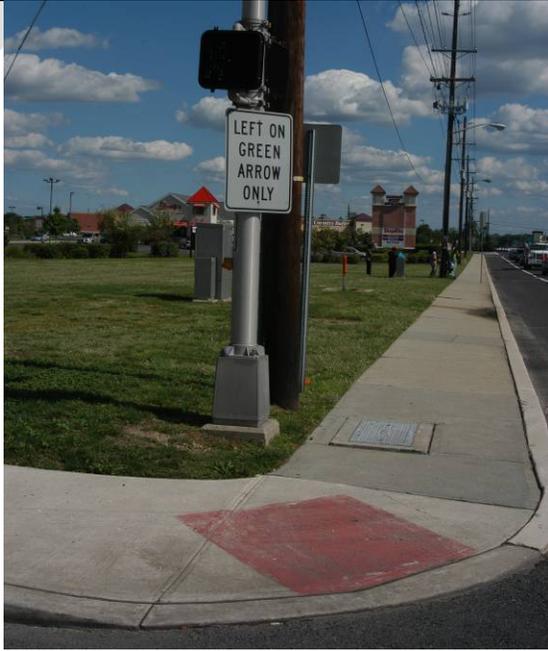
<p>Inaccessible push-buttons: <i>Inaccessible push-buttons were noted in the study area including a push-button located on the back side of a signal pole. Throughout the study area, push-buttons are inconsistent; some are activated by palm (current ADA approved) while others must be depressed by finger (not currently ADA compliant).</i> Push-button locations that are inconspicuous or inaccessible may cause pedestrians to cross against the signal, increasing the chance of pedestrian-vehicle conflicts.</p> <p>Suggestions:</p> <ul style="list-style-type: none"> • Consider upgrading push-buttons with palm-activated buttons and relocating inaccessible push-buttons to more accessible and conspicuous locations. Also consider installing pushbuttons that confirm the press. • Consider installing signs to explain the use of the push-button (e.g., MUTCD R10-3b or R10-4a). Also consider installation of a sign to indicate that the side street will automatically receive a crossing phase.

<p>View of signal pole and pedestrian push-button on northeast quadrant at Cornell Avenue. The pedestrian push-button is located on the backside of the signal pole making it difficult to identify and access.</p>

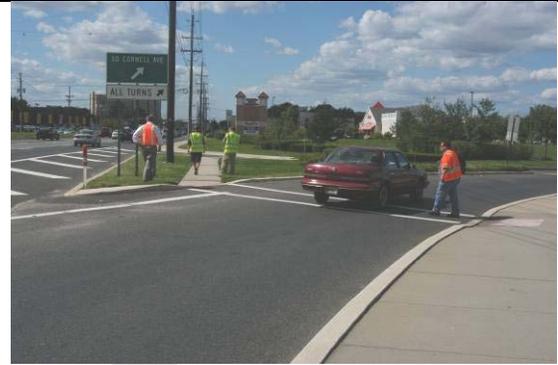
Lack of driver yielding: Drivers were observed failing to yield the right-of-way to pedestrians in several situations, including pedestrians already in a marked crosswalk. Route 70 serves as a relatively high-speed thoroughfare for commuters. Drivers in the AM and PM peak periods experience traffic delays along this section, which may lead to frustration and lack of courtesy toward pedestrians and other motorists. Also, drivers may not expect pedestrians along a major arterial, which may increase the likelihood of a collision.

View of Executive Campus Access #1. This photo shows a driver failing to yield the right-of-way to a pedestrian that had entered the crosswalk.

Suggestion: *Short-term-* Consider enhancing conspicuity of pedestrian crossings through the use of signs and pavement markings. Consider pedestrian warning signs, advance yield line signs and pavement markings, and high visibility pavement markings at crossings (see also Appendix D for details).

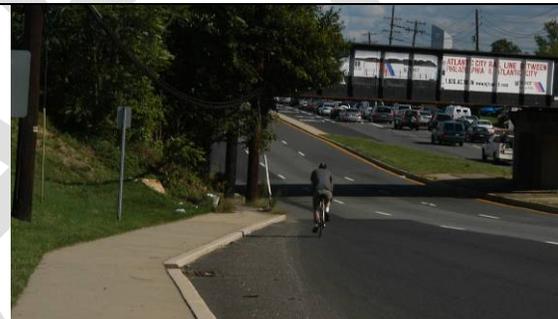
Conflicts with bicycle traffic: The RSA team observed bicyclists riding the wrong way in the road along Route 70 and on sidewalks. This is due in part to the lack of bicycle facilities on Route 70. Without dedicated facilities, bicyclists have to ride in the vehicle travel lanes, on sidewalks, or through parking areas. When bicyclists have no dedicated facilities they travel in unpredictable paths which may lead to frequent and unexpected conflicts with vehicles and pedestrians.

View of Route 70 just east of railroad bridge. The bicyclist is traveling the wrong way on a 6-lane divided roadway with no shoulder.

Consider creating bicycle facilities parallel to Route 70. Given traffic volumes and speeds on Route 70, look for opportunities to create paths separated from the roadway. Consider also creating more

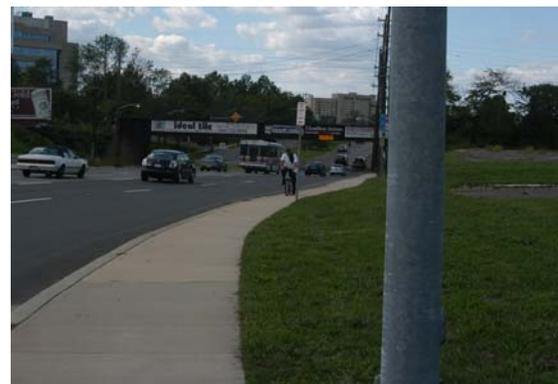
View of Route 70 just west of the railroad bridge. The bicyclist is biking on the sidewalk because of lack of a bikeable shoulder. The sidewalk is not wide enough to accommodate bicyclist and pedestrian traffic.

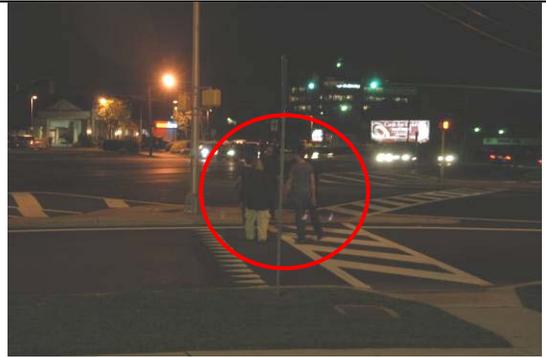
Gaps and inconsistency in lighting: *A lack of lighting makes it difficult for motorists to see pedestrians, particularly at crossings.* Lighting not only increases driver awareness of pedestrians in the area, it improves security and encourages walking in lighted areas. Lighting from Penn Avenue to Garden Park Boulevard appeared to be continuous; however, lighting was less consistent toward the western end of the study area. This issue is partly due to the fact that some lighting was not in proper working condition. Furthermore, the lighting was poor along the corridor in the roadway median due to the lack of lighting in the median and roadway width (over 100 feet wide in some areas), which decreases the effectiveness of roadside lighting. The importance of lighting is evidenced by the fact that four of the five pedestrian crashes occurred at night.

Photo shows a nighttime view of the intersection at Garden Park Blvd. and Route 70. Despite the presence of intersection lighting, it is difficult to see the pedestrians. Other intersections along the corridor are not lit as well as this intersection, which poses a safety issue for pedestrians walking at night.

Long-term- Consider installing consistent lighting along the corridor and along major pedestrian paths outside the corridor. Consider adding lighting to median for improved consistency.

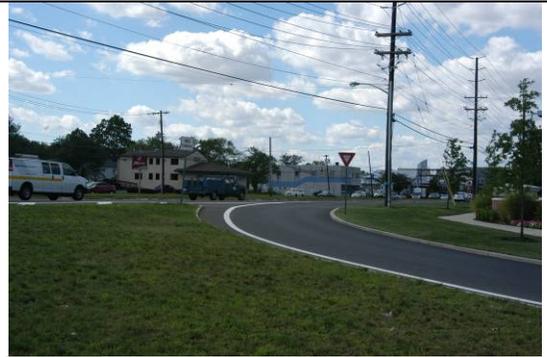
View of channelized right-turn lane on southbound approach at Haddonfield Road. The separator island creates a gap in the connection between sidewalks along either side of the intersection.

Long-term- Consider alternatives to channelized right turns. Where channelized right turns are to be installed, consider a design with a steeper angle to reduce vehicle speeds and focus driver attention toward the crosswalk.

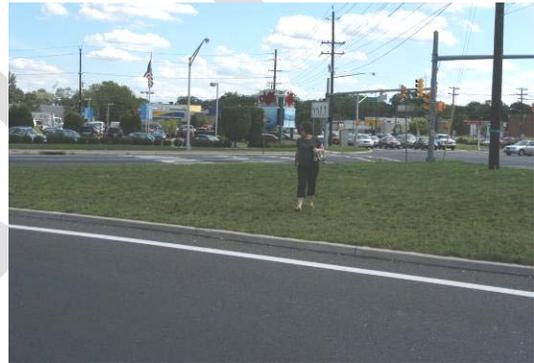
View of channelized right-turn lane and separator island on southbound approach at Haddonfield Road. The RSA team observed pedestrian activity in the area; however, there is no sidewalk or other crossing features in the separator island, resulting in pedestrians crossing at multiple locations.

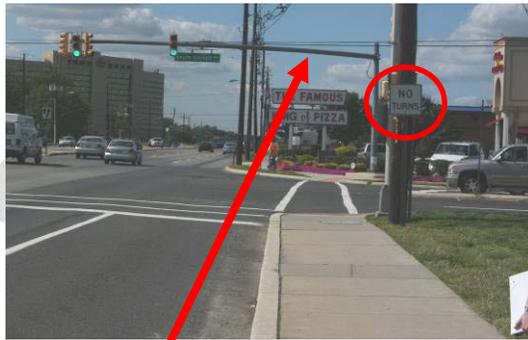
The photo above shows a ‘no turn’ sign at the intersection of Cornell Avenue. This sign may be insufficient by itself as it is sometimes disregarded. Consider diagrammatic sign (R3-1) placed on mast arm.

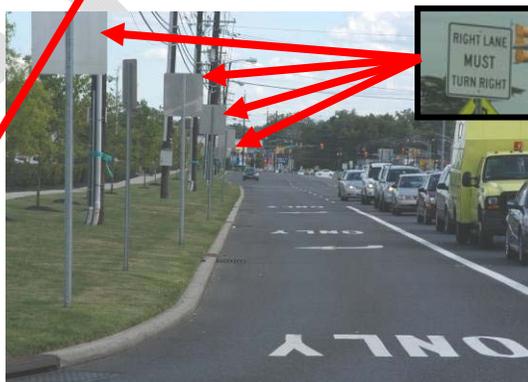
The photo above shows an example of a redundant sign. The sign is not only redundant with the pavement markings, but is also installed in four locations along the intersection approach. The same signs also obstruct the visibility of other signs (e.g., pedestrian crossing sign) as shown in the photo to the right.

- Replace faded signs (e.g., ‘USE CROSSWALK’ sign on northwest quadrant at Cornell Avenue).
- Remove redundant and outdated signs (e.g., ‘RIGHT LANE MUST TURN RIGHT’ signs on northeast quadrant at Garden Park Boulevard).
- Install signage where currently insufficient (e.g., prior to jug handle at Cornell Avenue and install one way sign (R6-1) in median facing Union Avenue).

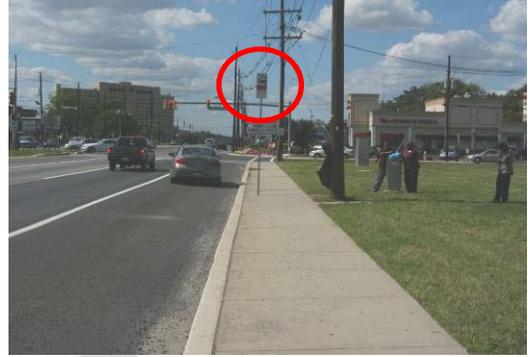
Motorists using shoulder to make right turns: *At the intersection with Cornell Avenue westbound motorists were observed using the wide shoulder as a right-turn lane.* This presents a particular issue because there is a bus stop located just east of the intersection and buses use the shoulder to stop out of the travel way.

Photo shows the wide shoulder on the westbound approach at Cornell Avenue. As can be seen in the photo, a motorist is using the shoulder as a travel lane. This is a concern because there is a bus stop on this approach (as shown by the red circle).

Short-term- Consider installing pavement markings to differentiate the shoulder from the travel lane. This may include striping out the shoulder, marking shoulder as a ‘bus only’ lane, or a combination of the two, such as marking out the lane and marking a bus loading zone at the bus stop.

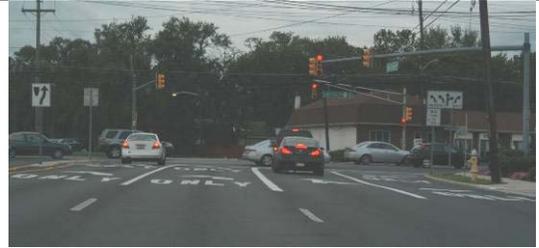
View of southbound approach at Cornell Avenue showing the dual right-turn configuration.

- Converting southbound dual right turn to single right turn lane. Right turning traffic could receive a green arrow as an overlap phase with the eastbound left turn phase.
- Converting southbound dual right turn to single right turn lane Encouraging use of alternate paths to head westbound on Route 70.

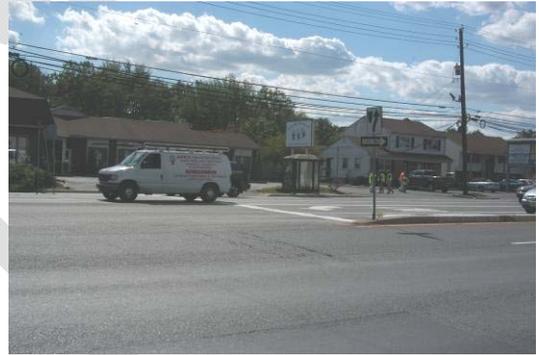
Photo of the intersection at Cornell Avenue, showing the current location of the eastbound bus stop on the southwest quadrant. The photo shows the absence of a crosswalk at this location, but also illustrates the potential impediments to installing a crosswalk (i.e., wide cross-section and limited median).

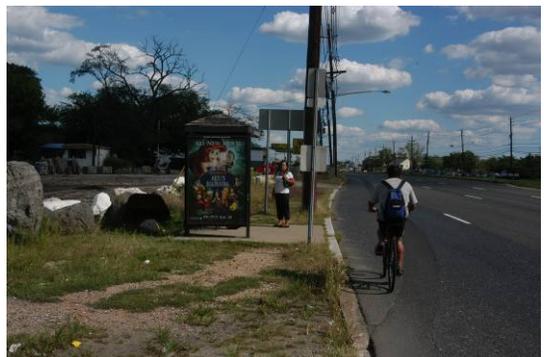
Photo shows the bus shelter along westbound Route 70. The closest crossing of Route 70 is located on the east leg of Cornell Avenue over 2500 feet away. Note also the lack of connectivity between existing sidewalks and the shelter.

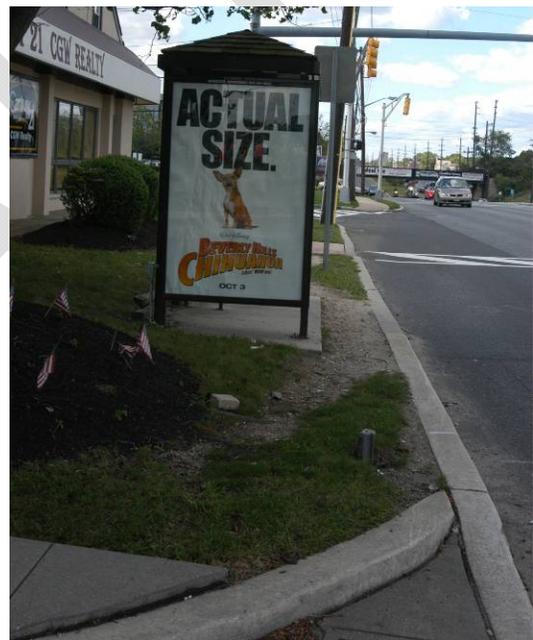
Connectivity to bus stops: *Some of the bus stops identified along the corridor may be inaccessible to pedestrians with mobility restrictions.* These stops are not connected by sidewalks or surfaces that are easily traversable. These conditions may lead to the following issues:

View of bus shelter along Route 70 just east of Garden Park Blvd. Note the lack of connectivity between the existing sidewalks and the shelter.

Long-term- Future pedestrian facility upgrades within the study area may be coordinated with redevelopment activities to provide better connectivity and continuity throughout the area.

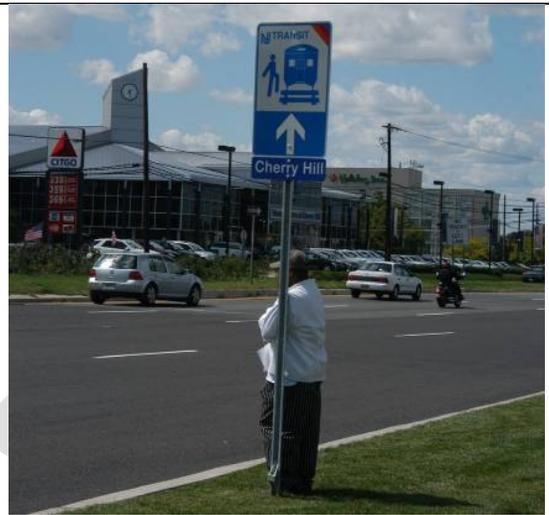
Unofficial bus stops: *Unofficial bus stops were identified along the corridor. At these locations, pedestrians were observed waiting for the bus and were eventually picked-up.* Unofficial stops can lead to safety issues for motorists if they are not expecting the bus to stop. This can also lead to increased midblock crossings if there is not a crossing near the location where pedestrians are picked-up or dropped-off.

Photo shows a sign for the train station. Pedestrian is waiting at this location for the bus, but this is not an official bus stop.

- Enhance the conspicuity of bus stops by providing consistent signage and lighting.
- Improve amenities at existing bus stop locations including landing pads, schedule and fare information, benches, and potentially shelters.

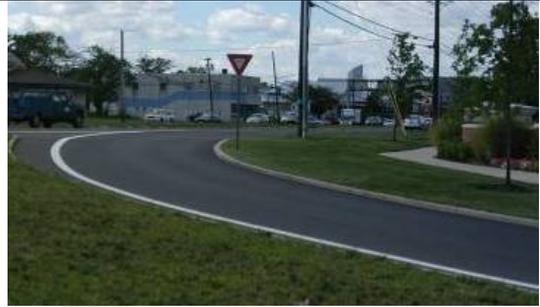
View of channelized right-turn lane on southbound approach at Haddonfield Road. The wide radius allows vehicles to make high-speed turns, which creates a potential safety issue for pedestrians turning to cross the street.

Long-term: Consider alternatives to channelized right-turn lanes. Where channelized right-turn lanes are to be installed, consider a design with a steeper angle to reduce vehicle speeds and focus driver attention toward the crosswalk.

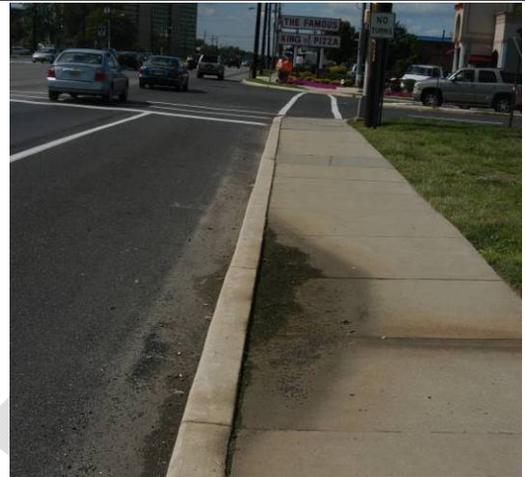
Drainage: The RSA team noted evidence of drainage issues in the right-most eastbound travel lane near Cornell Avenue. Additionally, the drainage inlets in the study area are not bicycle-friendly. Improper drainage can lead to hydroplaning or icy roadway conditions. The drainage inlets have openings that are parallel to the travel way, which creates a hazard for bicyclists (i.e., front tire dropping into drainage inlet).

The photo above shows the sidewalk on the north side of Route 70 just prior to Cornell Avenue. The photo shows evidence of drainage issues where sediment has been deposited.

Long-term- Evaluate the extent of drainage issues during wet weather conditions. If drainage issues are evident, consider improving the cross-slope to provide better drainage during subsequent roadway projects.
