# **Cerrillos Road/Alta Vista Street/Luisa Street/Cordova Road**

**Pedestrian Road Safety Assessment**

**Santa Fe, New Mexico**

**May 11 – 12, 2009**

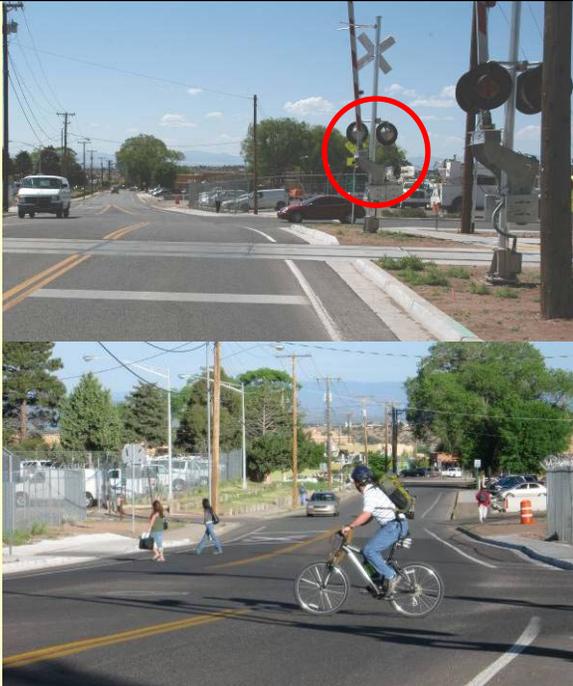
<p>Photos above show where the bicycle trail crosses Alta Vista Street to the west of the train station. There are no pavement markings to designate the crossing and a warning sign is obstructed by railroad crossing devices.</p>

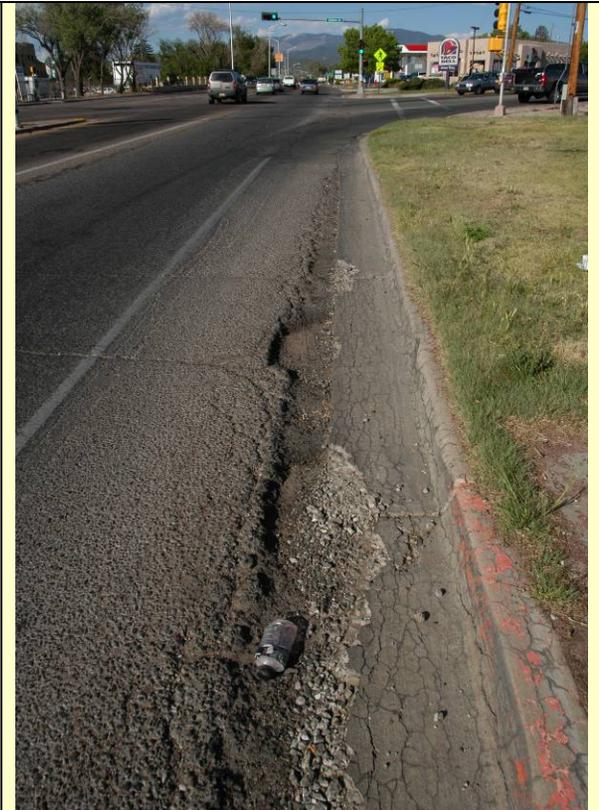
**Hazards along roadway**—there are bicycle hazards along the roadway, including longitudinal joints, drainage grates, diagonal track crossings (outside study area), and speed humps.

When hazards are present along the edge of the road, bicyclists may choose to ride further out in the travel lane, increasing the risk of conflict with vehicles.

Photo shows where pavement deterioration presents a hazard to bicyclists due to the uneven surface.

*Intermediate* – For all designated bike routes, extend pavement to the edge of the curb during resurfacing projects to eliminate longitudinal edges. Where there is sufficient width, provide a designated bike lane. Where width is insufficient for a designated bike lane, consider installing “sharrows” as described in the previous issue.

Install bicycle-friendly grates and ensure the grates are level with the pavement surface.

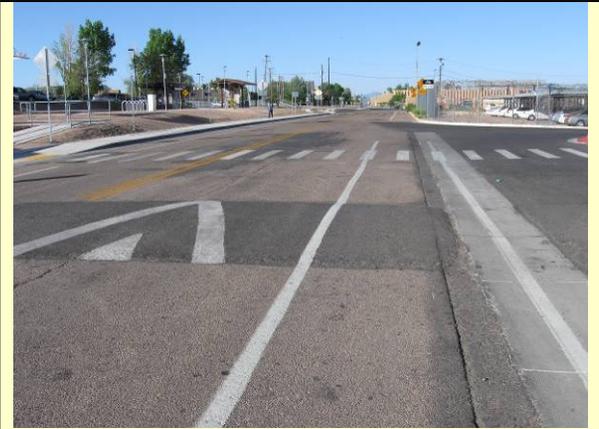
View along access road to train station. Photo shows where a speed hump extends into the bicycle lane. This presents a hazard to bicyclists.

Modify existing speed humps along the access to the train station so that humps do not cross the bicycle lane.

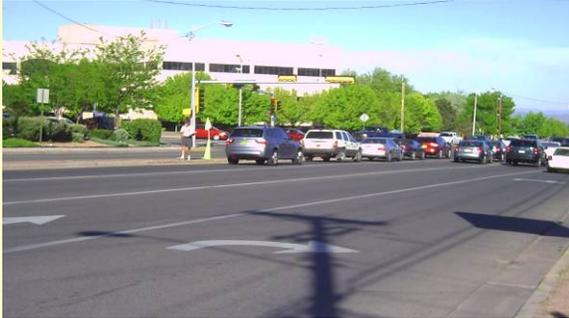
2. Geometric Issues		
Safety Issue	Suggested Improvements	Examples of Issues
<p><b>Trap lane</b>—the RSA team identified one location along Cordova where there is a “trap lane”. There are two eastbound through lanes along the segment to the west of St. Francis, but the right-most lane turns into a right-turn lane at the intersection and the left-most thru lane becomes the right thru lane at the intersection. Unfamiliar drivers may expect to continue straight from the right-most lane, but become trapped at the intersection as the lane changes to a right-turn only lane.</p>	<p><i>Short-term</i> – Install “Right lane must turn right” signage for eastbound traffic on Cordova Road at St. Francis Drive to warn motorists of the “trap lane”.</p>

<p>View of Cordova Road looking eastbound toward the intersection of St. Francis. Photo shows where the eastbound thru lane becomes a right-turn lane near the intersection.</p>

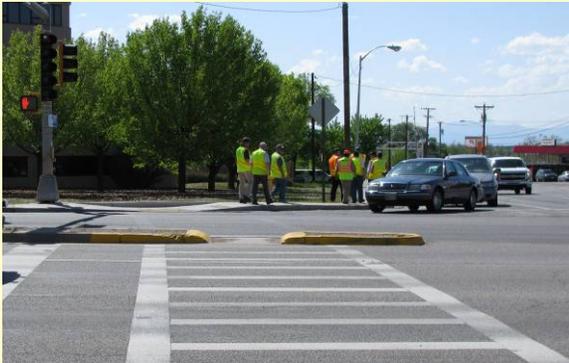
<p><b>Wide turning radius</b>—the team identified relatively wide turning radii at many intersections within the study area. The safety concern is two-fold because wide radii allow vehicles to make higher-speed turning movements and also increase the crossing distance for pedestrians.</p>	<p><i>Intermediate</i> – Consider reducing turning radii at following intersections:</p> <ul style="list-style-type: none"> <li>• Cordova and St. Francis (there was one pedestrian crash and one bicycle crash at this location during the study period)</li> <li>• Cerrillos and Cordova (there was one pedestrian crash and one bicycle crash at this location during the study period)</li> <li>• Cordova and Luisa</li> <li>• Alta Vista and St. Francis (there were three pedestrian crashes and one bicycle crash at this location during the study period)</li> </ul>

<p>View of intersection at St Francis and Cordova. Photo shows the relatively wide turning radius on the southwest corner.</p>

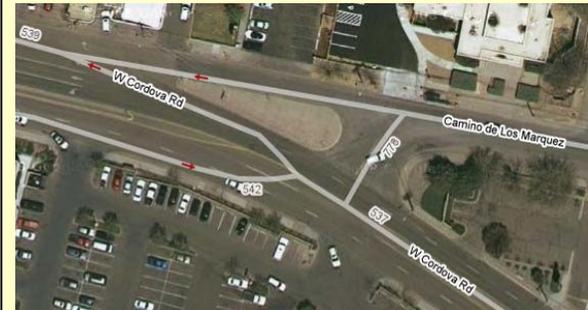
**Skewed offset intersection**—the intersection of Cordova Road and Marquez is skewed and offset from access points on the south side of Cordova Road. The intersection skew creates sight distance issues. This also creates additional conflict points because drivers can access Cordova Road at two locations in close proximity along Marquez. The current configuration of the west access point provides direct access from Marquez to the westbound left-turn lane on Cordova Road. It is also relatively close to the intersection at St. Francis Drive, which creates issues with weaving maneuvers to access the through and left-turn lanes.

There was one bicycle crash at this location during the study period.

Aerial from Google Maps shows the skewed intersection of Cordova Road and Marquez where multiple access points create several conflicting movements.

*Short-term* – Consider conducting a formal traffic study to reduce conflicts at this location. The following intermediate/long-term options can be considered as part of the study.

*Intermediate/Long-term* – Consider closing one of the access points to Marquez.

- Option 1: Close west access point to create a cul-de-sac near Maria’s and channel traffic to the east access point. The cul-de-sac could be designed to provide on-street parking for Maria’s while allowing westbound bicyclists to travel through the end of the cul-de-sac onto Cordova Road.

- Option 2: Close east access point across from the shopping entrance and redesign west access point to provide better access to through and left-turn movements at St. Francis Drive. The west access point could be moved further east (within the existing channelizing island) to provide direct access to the right-most through lane on Cordova Road. This will improve access to the through and left-turn movements at St. Francis Drive for drivers coming from Marquez. Also consider eliminating left-turns from Marquez onto Cordova Road. These vehicles can access Cordova Road via Don Diego Ave (further to the east).

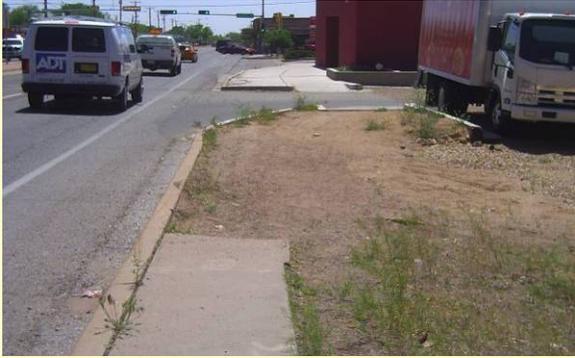
<p>Photo shows a gap in the sidewalk, creating a discontinuity for those with mobility restrictions.</p>

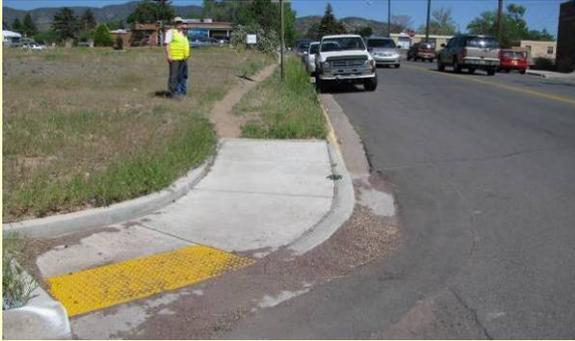
<p>Photo shows an example of a gap in the sidewalk network where curb ramps were installed, but the sidewalk was not continued along Alta Vista Street. It is apparent that there is pedestrian activity in this area, evidenced by the “goat path”.</p>

<p><i>Long-term</i> – Consider evaluating sidewalk connectivity and continuity outside of study area and fill-in identified gaps.</p>

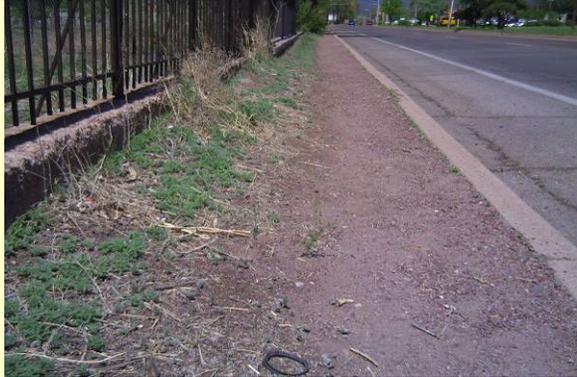
<p>Photo shows the west side of Cerrillos Road. There is obvious pedestrian activity and existing pedestrian crossings to access the west side of Cerrillos Road. However, there is not a sidewalk provided, creating a gap in the network.</p>
<p><b>Lack of buffer</b>—there is limited or no buffer provided between the sidewalk and travel way at locations within the study area.</p>	<p><i>Intermediate</i> – Determine opportunities for sidewalk setback (buffer) based on traffic volumes, existing development, and existing right-of-way. Several government buildings are located within the study area, which may present low-cost opportunities for sidewalk relocation due to availability of right-of-way.</p>

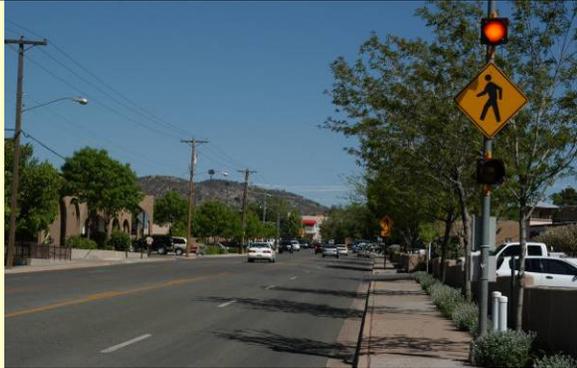
<p>Photo shows a sidewalk along Cordova Road, which is adjacent to the travel lanes with no buffer.</p>

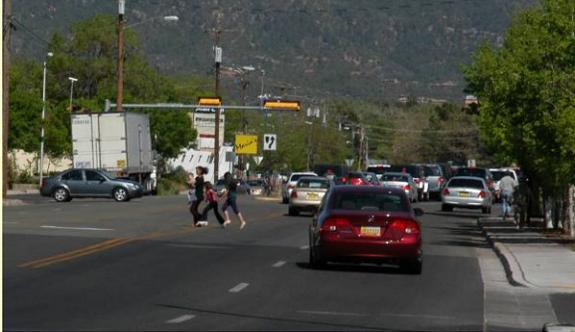
<p>Photo shows where three pedestrians are crossing midblock in between traffic, increasing the potential for conflict with vehicles.</p>

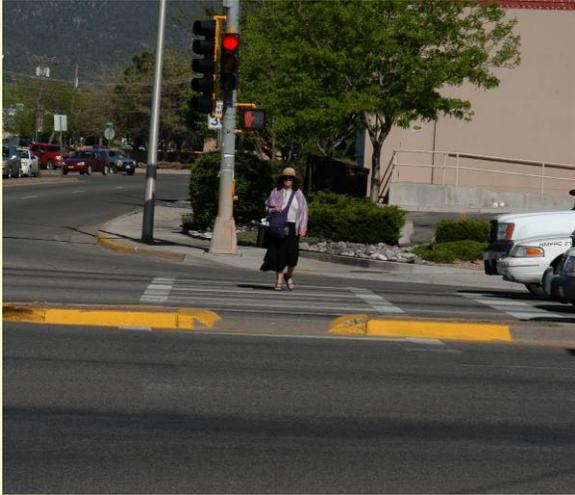
<p>Photo shows a pedestrian crossing the first half of the road (against the signal) while adjacent vehicles are turning left.</p>

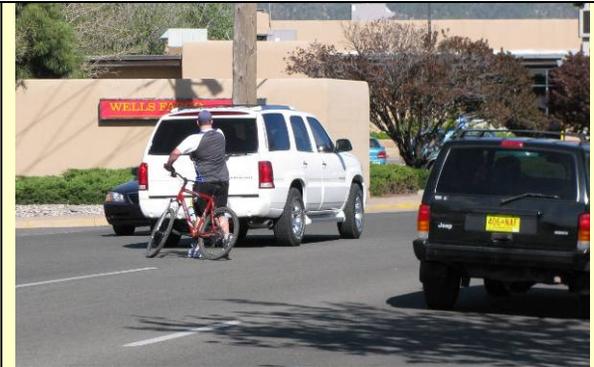
**Unsafe bicyclist behavior**—the team observed unsafe behaviors by bicyclists, including riding across several lanes of traffic, riding along the railroad tracks to cross the road, and pushing their bike across the road at midblock locations rather than merging with traffic or crossing on foot at an intersection crossing.

Photo shows example of unsafe behavior where a bicyclist dismounted and crossed midblock rather than merging with traffic and performing a left-turn maneuver.

*Intermediate* – Establish designated bike routes and post signs to clearly mark the routes. Consider aggressive education program. This may include developing and publishing bike route brochures and tourist information about safe bicycle riding behaviors. Bicycle education programs could be coordinated with other educational campaigns for pedestrians and drivers. Educational messages could be posted at kiosks at the train station and even on the trains if/when advertisements are permitted.

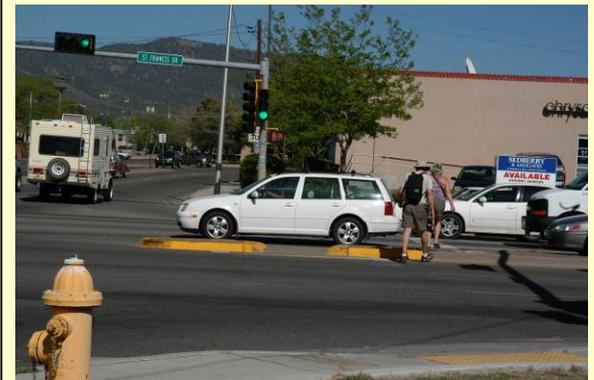
**Failure to yield to pedestrians**—the team observed drivers failing to yield the right-of-way to pedestrians when turning. For example, drivers turning left during the permissive phase did not always yield to pedestrians crossing the side street. Also, there were some drivers that waited in the crosswalk to turn left and did not make the left-turn phase, so they continued to obstruct the crosswalk during the following phase.

Failure to yield was cited as the primary contributing factor for 30 percent of the pedestrian and bicycle crashes during the study period.

Photo shows an example of a driver obstructing the crosswalk, causing the pedestrians to walk outside the crosswalk and between queuing traffic.

*Short-term* – Consider enhancing conspicuity of pedestrian crossings through use of signs and high-visibility pavement markings at signalized intersections.

*Intermediate* – Install bulb outs or reduce the turning radius to reduce the crossing distance for pedestrians.

Consider increasing the presence of law enforcement.

Consider an aggressive education program to inform both motorists and pedestrians of the rules of the road.

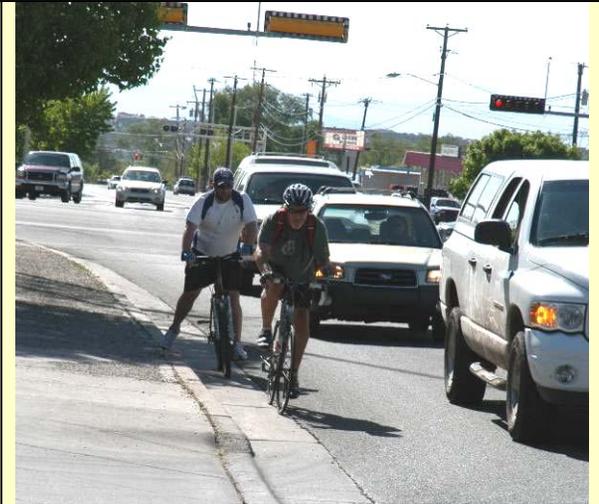
**Failure to yield to bicyclists**—the team observed drivers failing to yield the right-of-way to bicyclists when turning.

For example, the RSA team observed a driver turning right into a shopping plaza along Cordova Road. The driver passed two bicyclists and turned directly in front of them to enter the plaza. The front bicyclist had to stop short to avoid hitting the vehicle and the second bicyclist nearly rear-ended the front bike.

View of entrance to shopping plaza along Cordova Road. Photo shows an example of a driver not yielding to bicyclists. The driver of the white truck passed the bicyclists and turned in front of them to enter the plaza; both bicyclists had to stop to avoid a collision.

*Short-term* – Consider an aggressive education program to inform both motorists and bicyclists of the rules of the road.

*Intermediate* – Enhance conspicuity of bike lanes and facilities through use of “sharrows” and bike route signs and pavement markings.

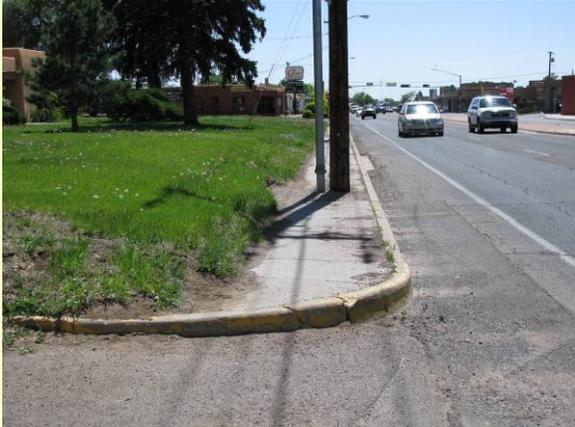
<p>Photo shows a sidewalk along Cerrillos Road where there is no curb ramp or tactile warnings provided and a utility pole is creating an obstruction.</p>

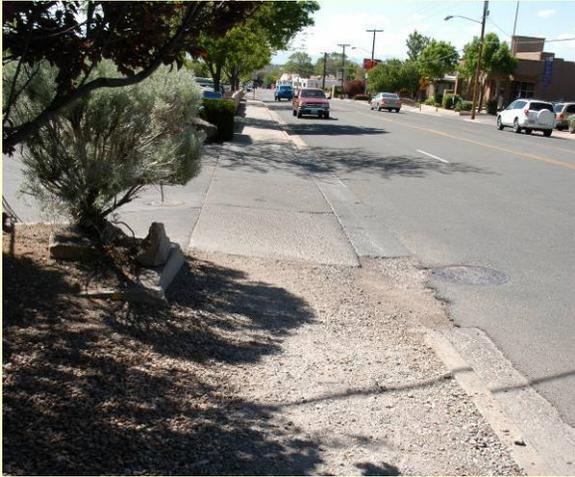
<p>View of sidewalk along Cordova Road. Photo shows where the cross-slope of the sidewalk at the driveway</p>

<p>is greater than 2 percent, which is a safety issue for those with mobility restrictions. The issue is compounded by the fact that there is no separation between the sidewalk and travel lane.</p>
<p><b>Location of push buttons</b>—push buttons are located on the opposite side of the signal pole at some locations. Pedestrians may not see the push buttons when they are located on the far side of the pole.</p> <p>The push button on the southwest corner of St Francis and Cordova is located behind signal post and difficult to access.</p>	<p><i>Short-term</i> – Relocate push-buttons toward pedestrian traffic and the sidewalk.</p> <p><i>Intermediate</i> – Review all signalized intersections within the City and ensure proper placement of push-buttons.</p>

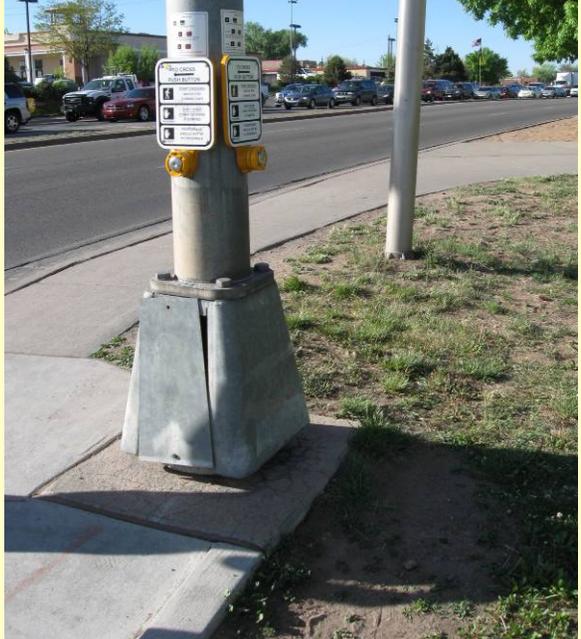
<p>Photo shows the location of the push-buttons on the southwest corner of St Francis and Cordova. The push-button on the back side of the signal pole is difficult to access, particularly for those with mobility restrictions.</p>

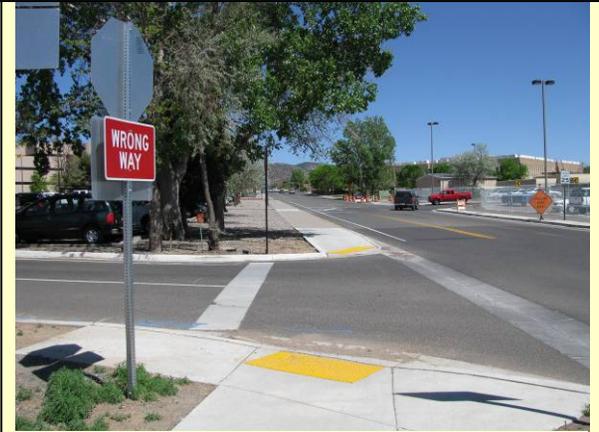
—the team identified several curb ramps and domes that were not oriented in the direction of the pedestrian crossing. Instead, the ramps were oriented diagonally across the street, potentially leading pedestrians out of the crosswalk.

Photo shows curb ramps and truncated domes that are not aligned with the crossing. The ramps and tactile warnings are actually leading people into the adjacent travel lane.

*Short-term* – Review standards for the orientation of curb ramps and truncated domes and modify as necessary to better align the ramps and tactile warnings with the crosswalks.

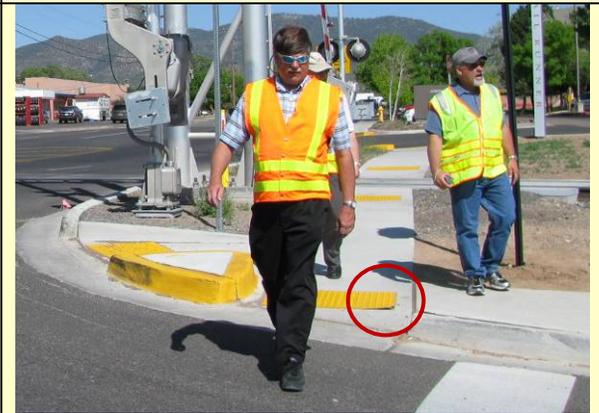
**Maintenance of truncated domes**—there is a general lack of maintenance of truncated domes. The team identified several locations where the truncated domes were separating from the sidewalk surface. This creates a tripping hazard and eventually the truncated domes will be completely removed from the surface.

Photo shows a truncated dome that is separating from the surface of the sidewalk.

*Short-term* – Replace or repair damaged truncated domes.  
*Intermediate* – Review installation practices to identify opportunities to provide a better seal between the truncated domes and the sidewalk surface.

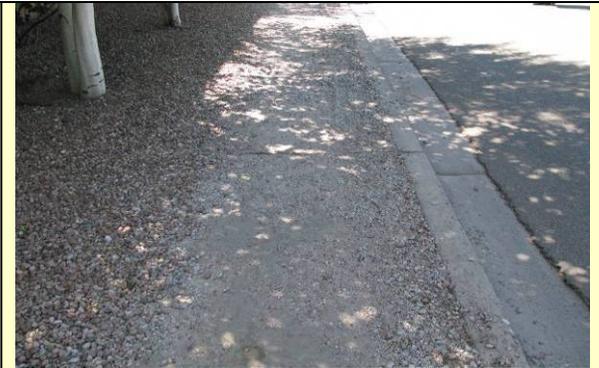
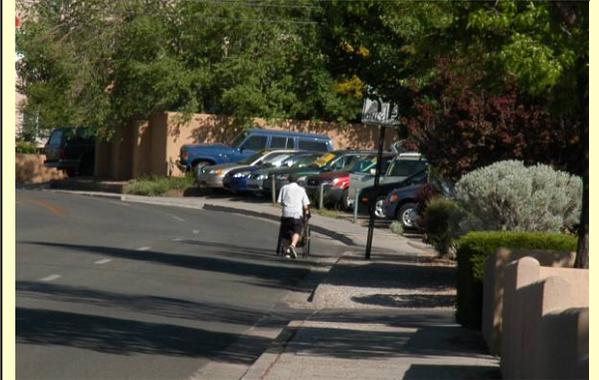
**Sidewalk maintenance**—the team identified several locations where the surface of the sidewalk made it impassable to some pedestrians. An example is the sections of sidewalk on the south side of Cordova Road, just east of Luisa Street (see photos, right).

Photo shows a sidewalk along Cordova Road where the surface has deteriorated. The RSA team observed a person pushing another person in a wheelchair along this section; however, they had to push the wheelchair in the roadway due to the condition of the sidewalk surface.

*Short-term* – Perform a system-wide maintenance inventory of all pedestrian facilities. Develop a priority list of locations with existing deficiencies based on hazard potential.

*Intermediate* – Repave sidewalks and upgrade pedestrian facilities as necessary based on the inventory.

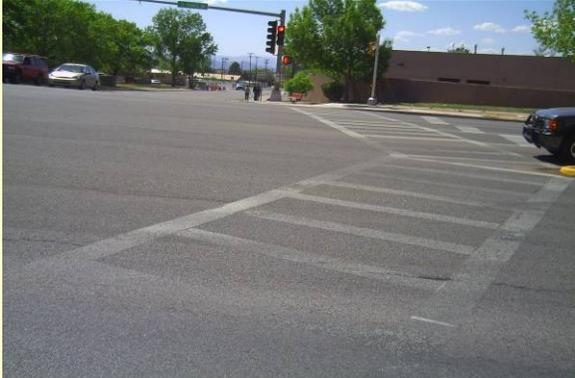
<p>Photo shows an example of a crossing at the intersection of Alta Vista and St. Francis that is faded and indirect.</p>
<p><b>Indirect crosswalks</b>—the team identified one location where the crosswalk did not follow a direct path across the intersection (see photo, right). This not only increases crosswalk length, increasing exposure of pedestrians, but it also is difficult for pedestrians with visual impairments to follow the intended crosswalk path.</p>	<p><i>Intermediate</i> – Reconfigure indirect crosswalks repainting the crosswalk straight across the intersection or placing a refuge island in the median with tactile warnings (truncated domes) to direct pedestrians with limited vision along the correct path.</p>

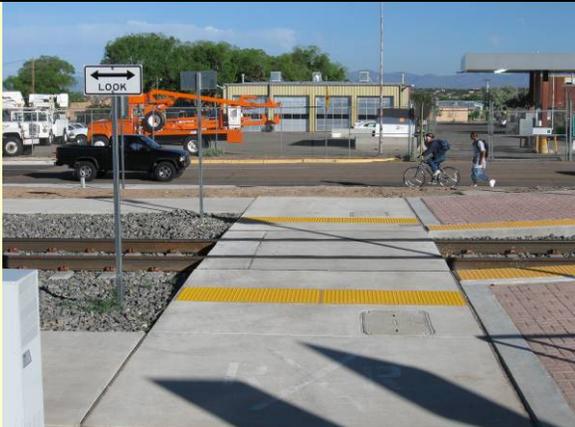
<p>Photo shows a pedestrian/bicycle crossing along the railroad tracks. There is a sign telling pedestrians and bicyclists to look both ways before crossing, but no gates to prevent pedestrians with limited vision from crossing at the tracks.</p>

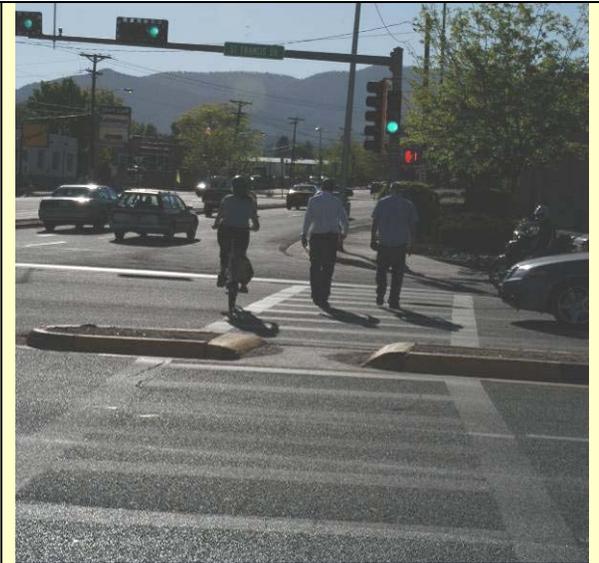
**Pedestrian intervals**—the pedestrian intervals are relatively short at the intersection of St Francis and Cordova. The team observed several instances where pedestrians began walking at the start of the walk interval and barely made it to the other side by the end of the clearance interval.

Photo shows pedestrians crossing St Francis along Cordova with just 1 second left on the countdown signal.

*Intermediate* – Review pedestrian clearance intervals, particularly at St Francis and Cordova, to ensure that pedestrians have sufficient time to cross. At locations where pedestrian volumes are greater, consider providing more than the minimum to allow larger groups of pedestrians to cross per phase.

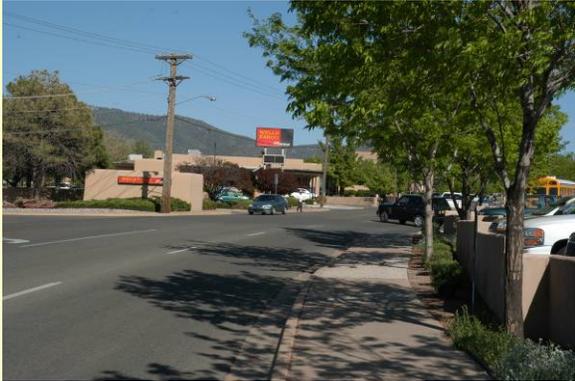
<p>View of access point along Cordova Road. Photo shows where trees and a wall are obstructing sight distance for drivers. The issue is compounded by the horizontal curve.</p>

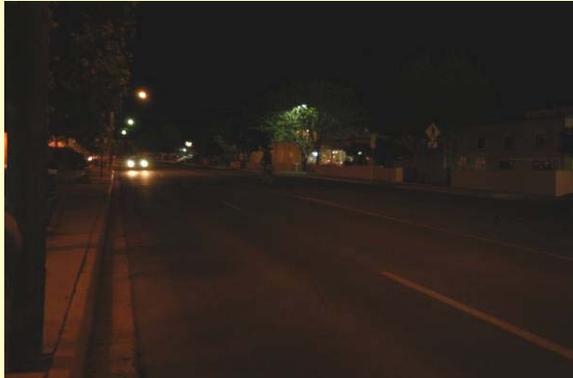
<p>The midblock crossing on Cordova Road has no lighting illuminating the crossing.</p>

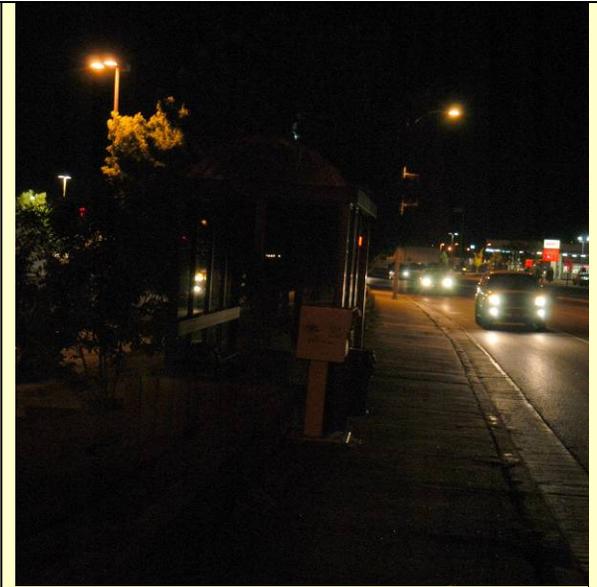
Lighting at this bus stop on St. Francis Drive is poor.

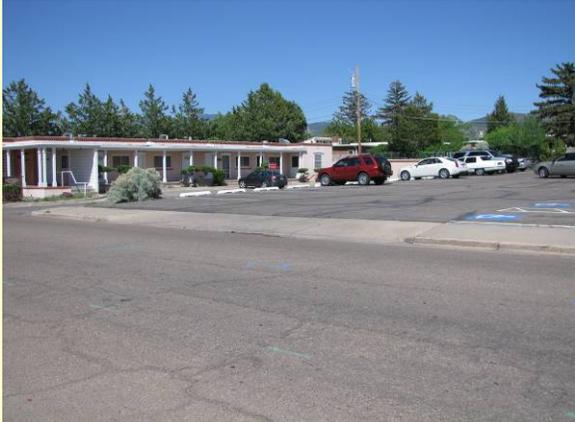
<p>Photo shows a wide access point along Luisa Road, increasing exposure and opportunities for conflict between pedestrians and vehicles.</p>

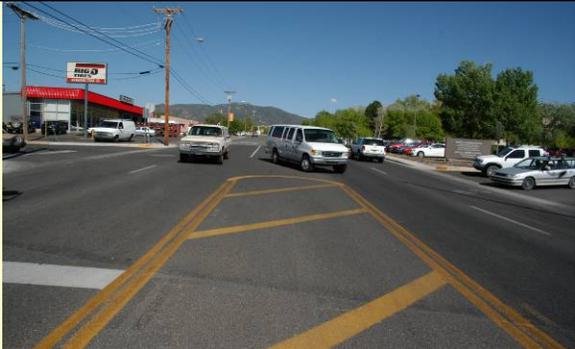
<p><b>Unrestricted left-turns from businesses</b>—drivers are allowed to turn left into and out of access points along Cordova Road. There are several access points along this road in close proximity and the team observed pedestrians crossing at several unmarked midblock locations. The unrestricted left-turns create several potential conflict points and increase risk for pedestrians crossing midblock.</p> <p>There were two pedestrian crashes and three bicycle crashes along Cordova Road during the study period.</p>	<p><i>Intermediate</i> – Consider installing a median island along Cordova Road, restricting access to right-in-right-out only. There is currently a two-way left-turn lane along this section that could be converted to a median island. A median island will also provide refuge for pedestrians crossing at midblock locations. Median islands have been shown to reduce pedestrian crashes by 40% (<i>Safety Effects of Marked Versus Unmarked Crosswalks at Uncontrolled Locations</i> (Zegeer et al, 2005)).</p>

<p>View of cross-section of Cordova Road. Photo shows the unrestricted access to properties along Cordova Road and the existing right-of-way within the turn lane, which provides an opportunity to install a median island.</p>

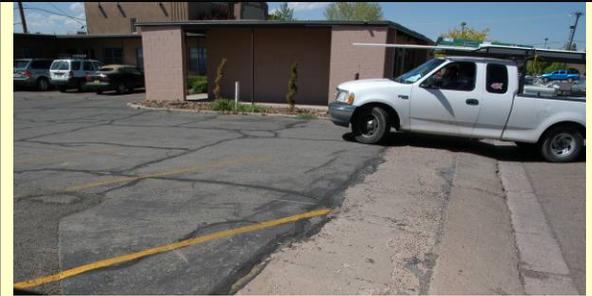
View of parking lot along Luisa Road. Photo shows where angle parking leads directly onto the sidewalk as vehicles back out of the space.

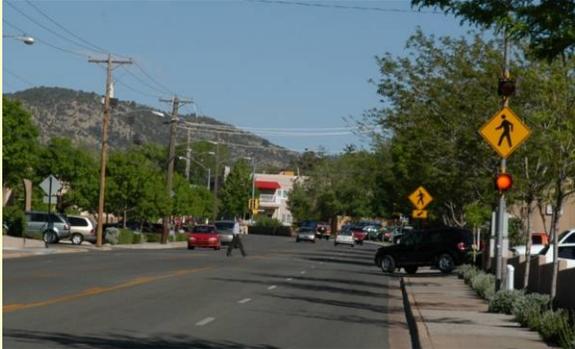
<p>View along Cordova Road toward the midblock crossing. Photo shows a pedestrian crossing within the crosswalk, but the markings are not visible even from this close distance. There is also a vehicle turning right out of an access point and the driver is looking to the left for a gap in traffic and is unaware of the crossing pedestrian.</p>
