# LOW-COST SAFETY IMPROVEMENTS CAN IMPROVE SAFETY AT STOP SIGN-CONTROLLED INTERSECTIONS

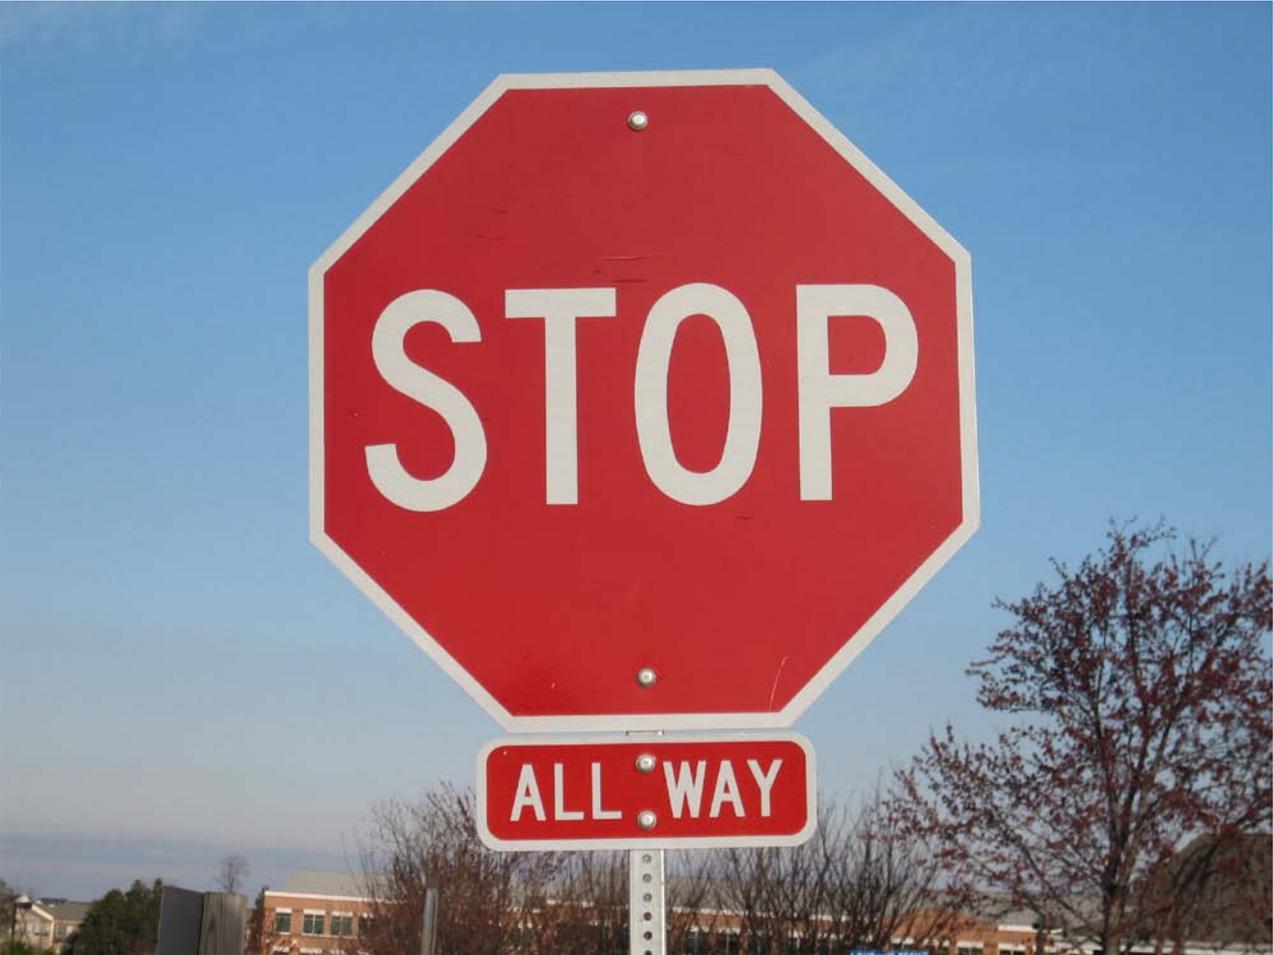
Figure 1: Larger (30-inch) Stop Sign

Winston-Salem replaced existing 24-inch stop signs with 30-inch signs (Figure 1) and placed 12-inch stop bars and a short segment of double-yellow centerlines at four intersections. Officials also installed "Stop Ahead" advance traffic control signs at two intersections. Data showed that 45 crashes occurred before the improvements were made; 20 crashes occurred after the changes. **These relatively inexpensive treatments have proven effective in reducing crashes, and Winston-Salem experienced an average crash reduction of 56.9 percent per year at these intersections.**

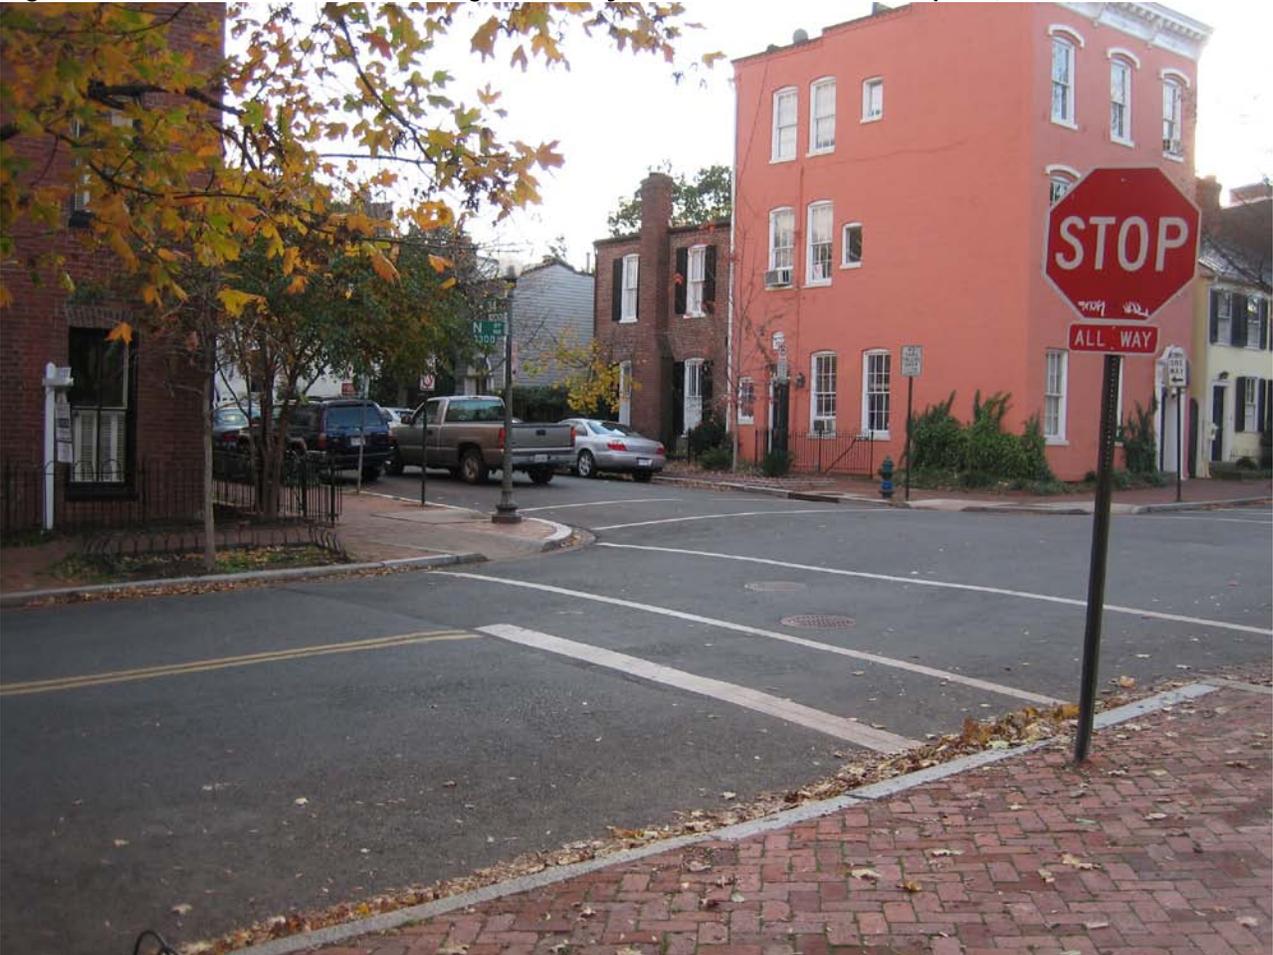
Figure 2: Enhanced Pavement markings (double-yellow centerlines and stop bar)

Winston-Salem added pavement markings at four two-way, two-lane, stop-controlled intersections to increase visibility of both the intersection and the proper stop position as well as to alert drivers to the intersection control (Figure 2). Data showed that 45 crashes occurred before the improvements were made; 21 crashes occurred after the changes. **Installing these simple, low-cost countermeasures reduced crashes by 52.7 percent and reduced injuries by approximately 70 percent per year.**

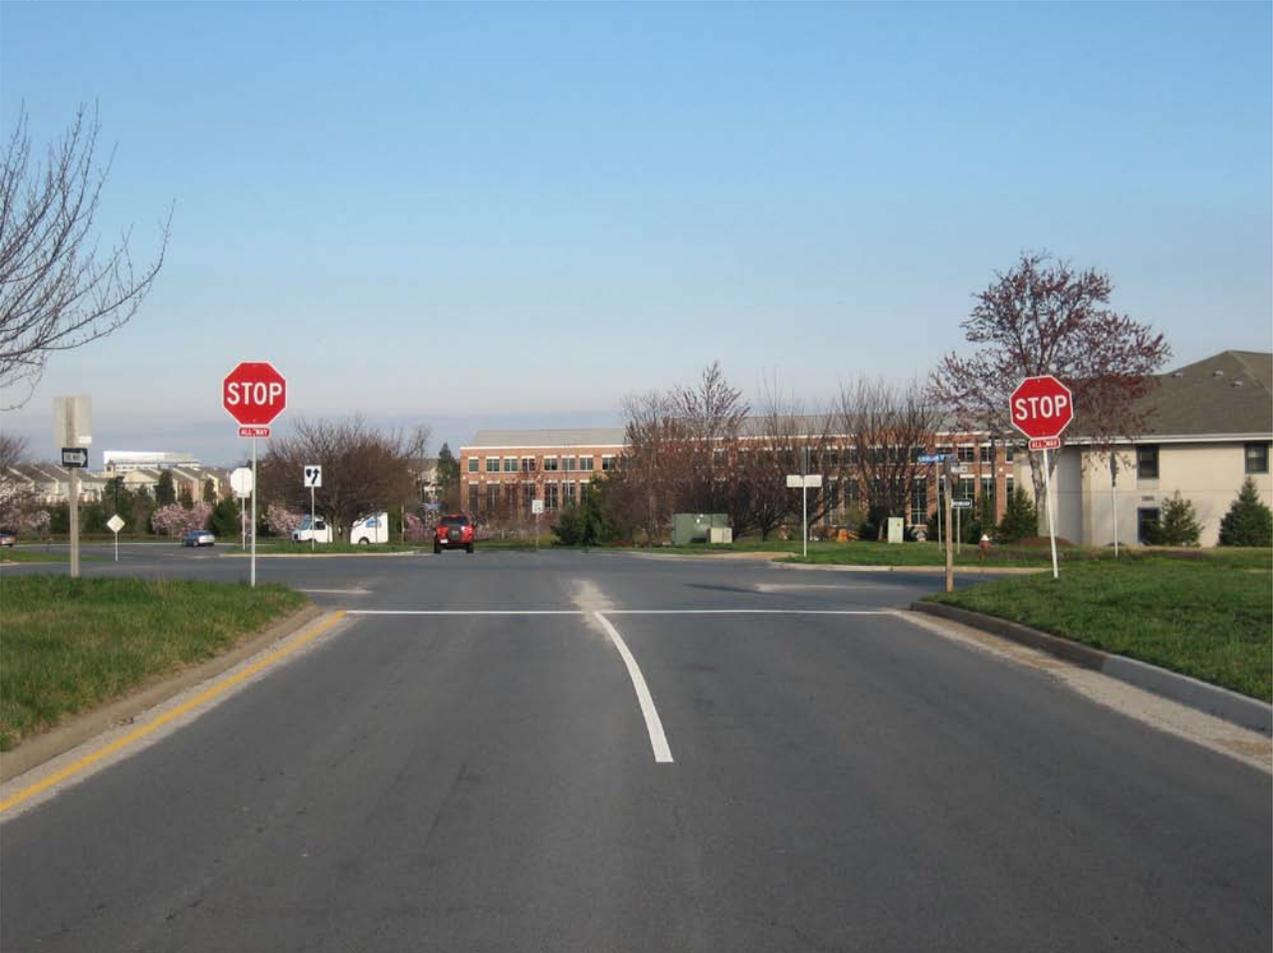
Figure 3: Additional, larger (30-inch) stop signs with stop bars

To visually emphasize the required stop at four intersections, Winston-Salem placed additional stop signs on the left side of the stop approach and used larger (30-inch) stop signs for the intersections (Figure 3). These enhancements were intended to better alert drivers to the upcoming stop sign, and enhance their ability to safely navigate the intersection. Data showed that 68 crashes occurred before the improvements were made; 35 crashes occurred after the changes. **Winston-Salem realized an average crash reduction of 48.3 percent per year at these locations.**
