**Pedestrian Safety Engineering and Intelligent Transportation  
System-Based Countermeasures Program  
For Reducing Pedestrian Fatalities, Injuries, Conflicts, and  
Other Surrogate Measures**

Phase 2 Final Technical Report

September 15, 2008

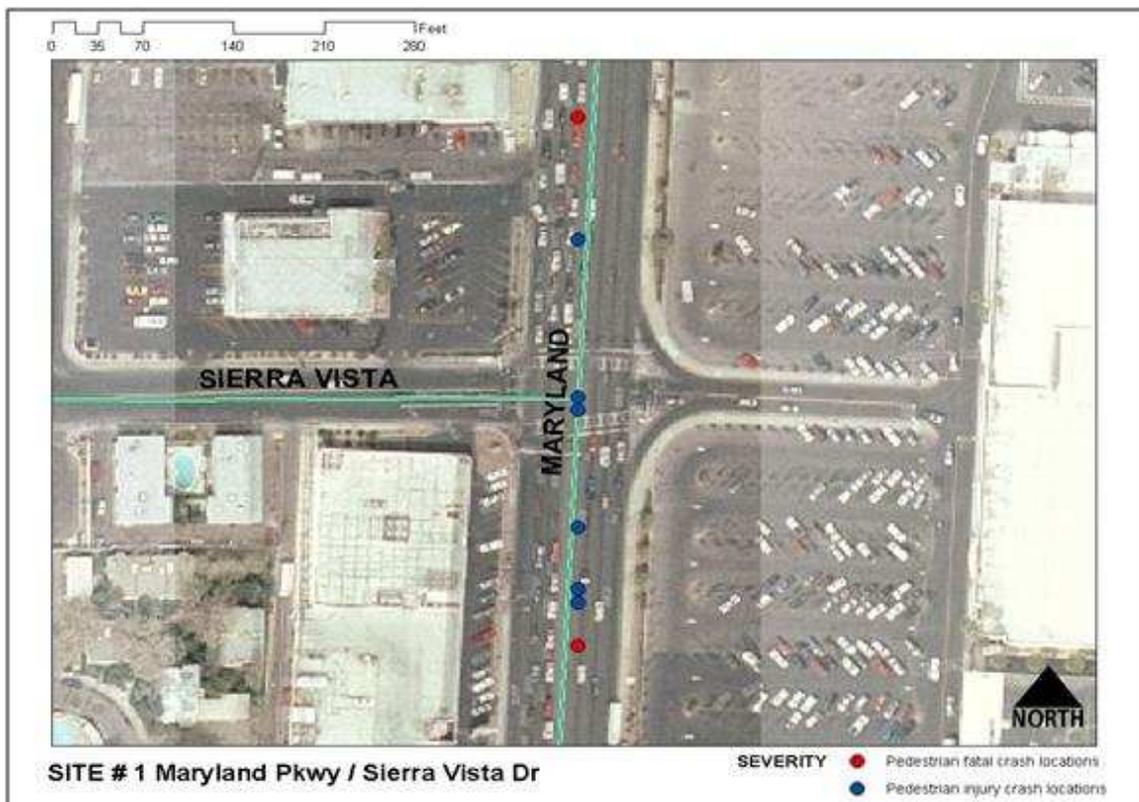
This is an intersection of a six lane minor arterial (Maryland Parkway) with a speed limit 30 mph, and a two lane local street (Sierra Vista Drive) with speed limit of 25 mph. At this location, the principle comments relate to the need to connect crosswalks to sidewalk ramps. Initially, these crosswalks are not connected to the ramps at the crossings and end up at the pork chop island. This location has a mixed land use of residential and shopping. Figure 3 presents the aerial photograph of this site. Site 1 in Appendix B presents implementation plan and the conceptual design of this location. Figure 3 shows an aerial photograph of the site with pedestrian crashes super imposed on it for site 1. This figure shows that the pedestrian crashes are distributed along Maryland Parkway.

**Figure 3: Aerial Photograph of Maryland Parkway and Sierra Vista Drive**

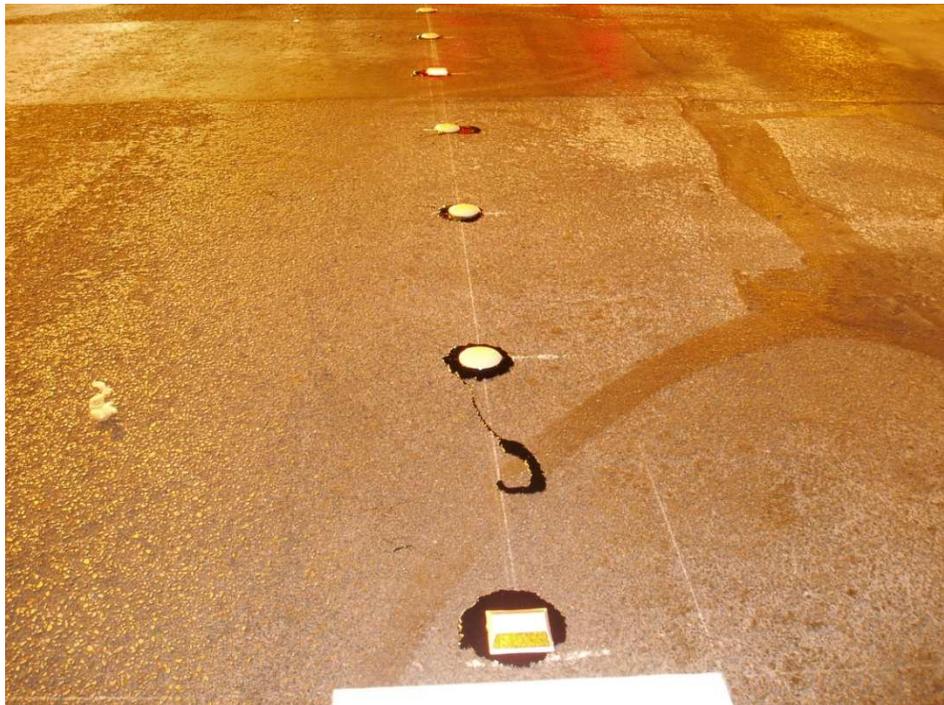
**Figure 4. Reflective Pavement Marking (RPM) standard line at Site 1**

Countermeasures deployed during this stage are “high visibility crosswalk treatment, relocating existing pedestrian sign; and install RPM standard line 100 feet long at the upstream crosswalk.” These countermeasures were installed on October 4-7, 2006. The after condition data for Stage 1 countermeasure deployment was collected on October 31, 2006. Figure 4 and Figure 5 shows the countermeasures deployed at this location.

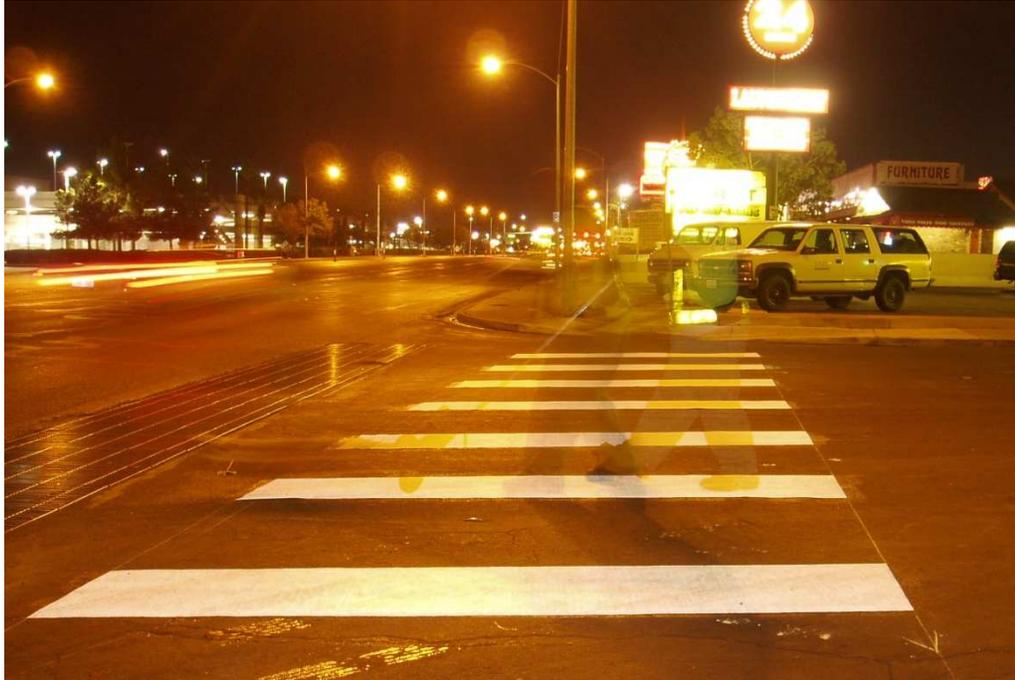
**Figure 5: High Visibility Crosswalk Treatment at Site 1**

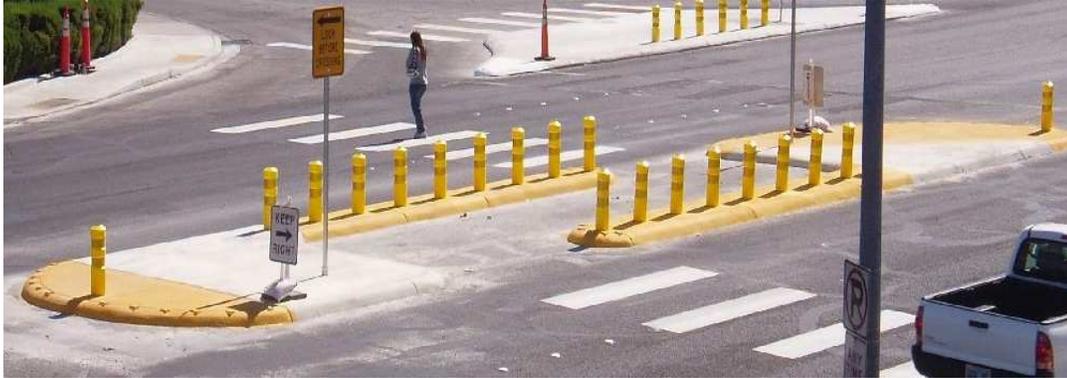
**Figure 7: High Visibility Crosswalk Treatment, Median Refuge and Danish Offset**

October 26 and November 2, 2006. Figure 7 shows the countermeasures deployed in stage 1 at this location.

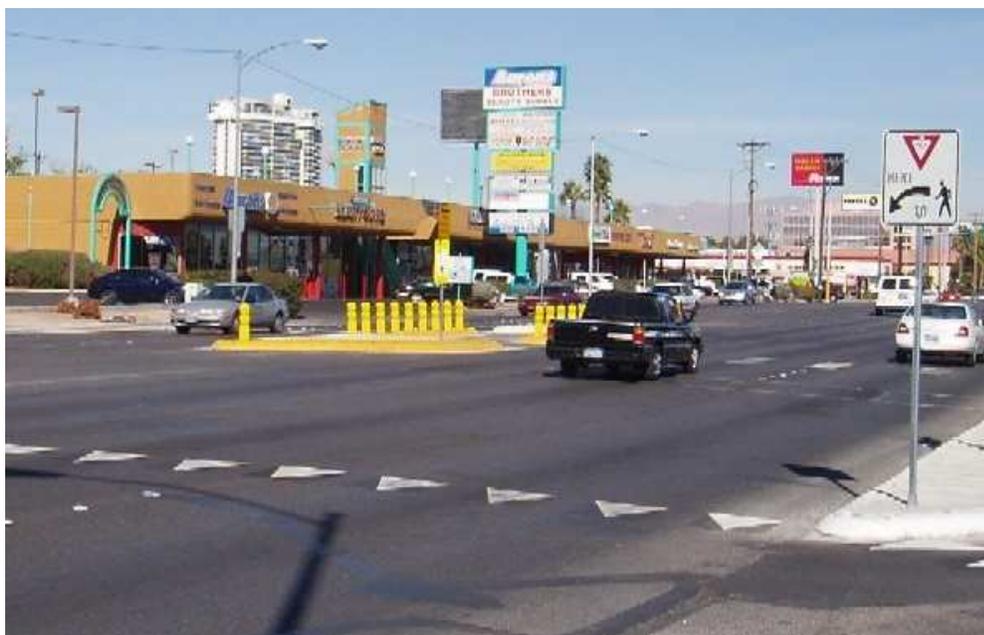
**Figure 8: Advance Yield Markings and “Yield Here to Pedestrians” Sign**

Countermeasure deployed during this stage is “Advanced Yield Markings.” This countermeasure is installed on November 06, 2006. The after condition data for stage 2 countermeasure deployment is collected between November 30 and December 1, 2006. Figure 8 shows the countermeasures deployed in stage 2.

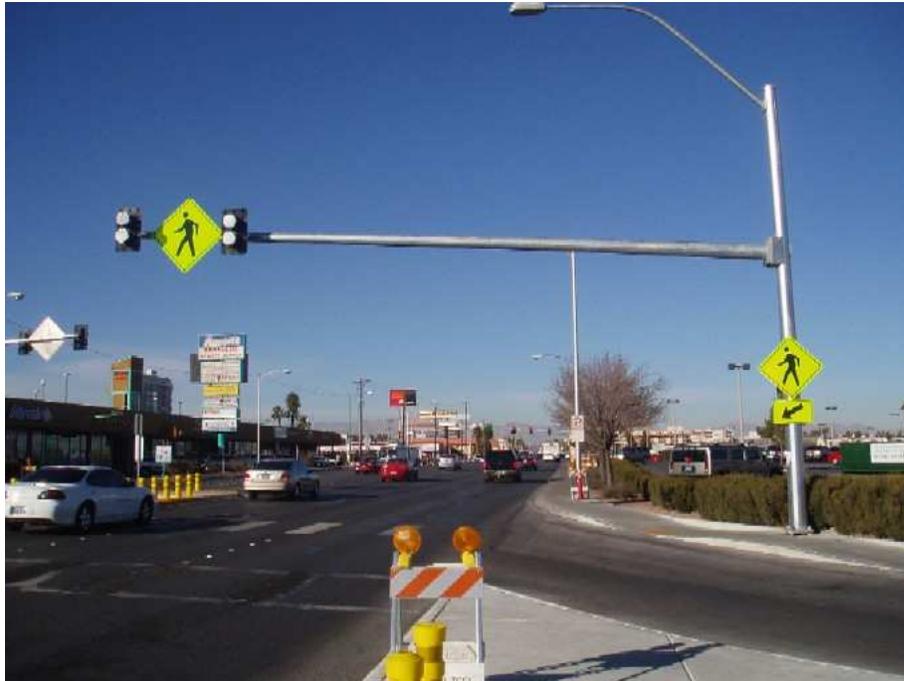
**Figure 9: Pedestrian Activated Flashing Yellow**

Countermeasures deployed during this stage are “Pedestrian Activated Flashing Yellow.” This countermeasure was installed on March 7, 2007. The after condition data for Stage 3 countermeasure deployment was collected on March 22 – April 6, 2007. Figure 9 shows the countermeasure deployed in Stage 3 at this location.

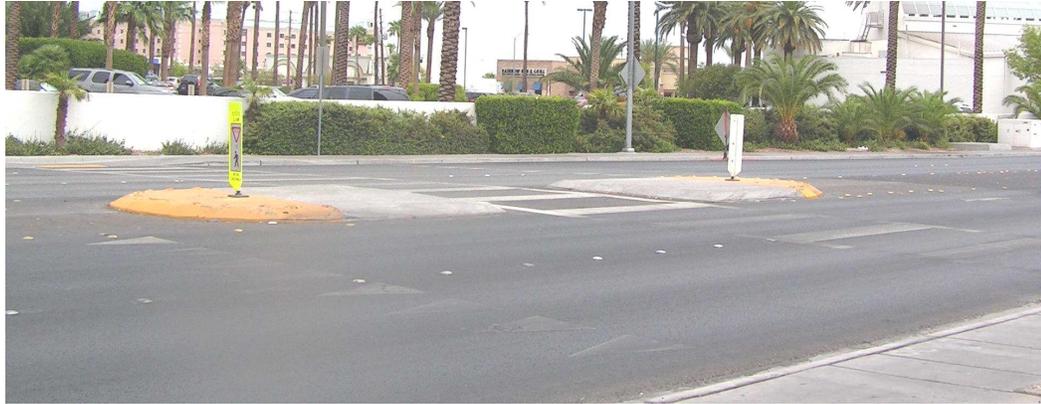
**Figure 14: High Visibility Crosswalk and Median Refuge installed at Site 5**

condition data for stage 1 countermeasure deployment are collected on March 8 and 9, 2007. Figure 14 shows the countermeasures deployed in stage 1 at this location.

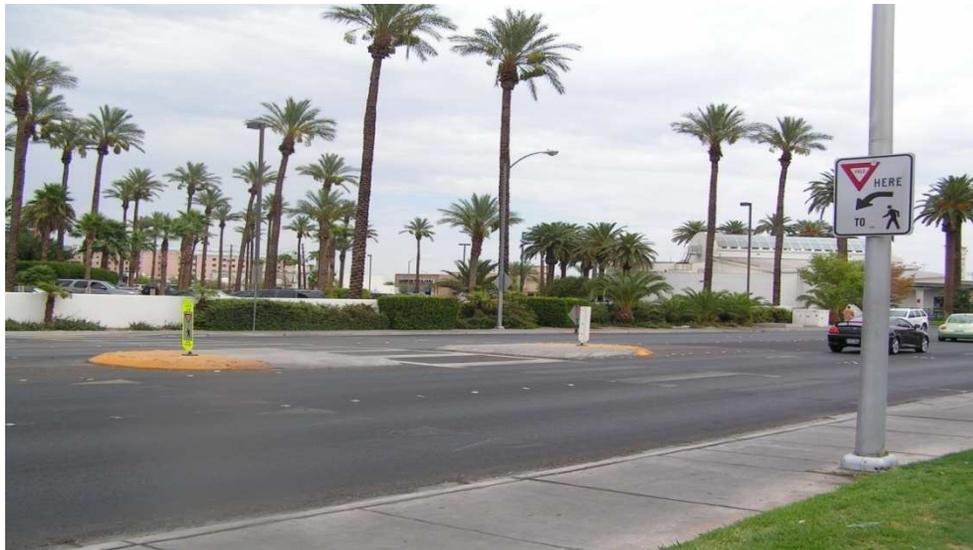
**Figure 15: Yield Here to Pedestrians Sign installed at Site 5**

Countermeasures deployed during this stage are “Advanced Yield Markings.” These countermeasures are installed on March 9 to 11, 2007. The after condition data for stage 2 countermeasure deployment were collected on March 30, 2007. Figure 15 shows the countermeasures deployed in stage 2.

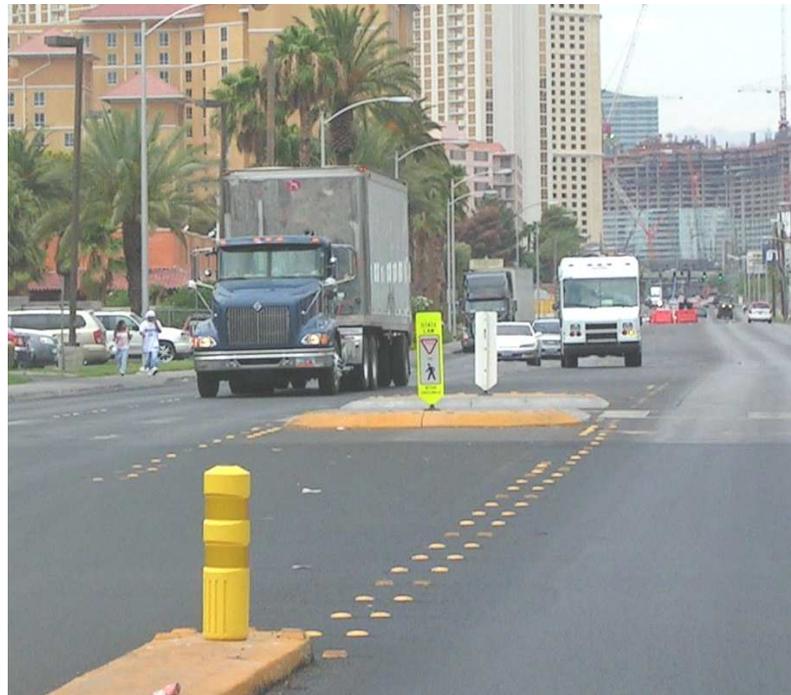
**Figure 16: In-roadway Knockdown Signs installed at Site 5**

Countermeasure deployed during this stage is “In-Roadway Knockdown Signs.” This countermeasure is installed on March 31, 2007. The after condition data for stage 3 countermeasure deployment are collected on April 13, 2007. Figure 16 shows the countermeasure deployed in stage 3 at this location.

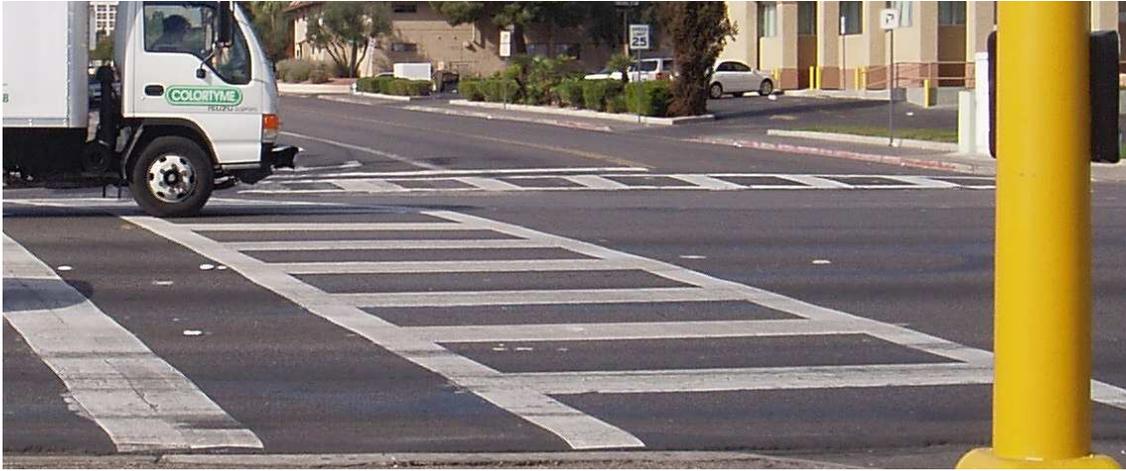
**Figure 18: High Visibility Crosswalk Treatment installed at Site 7**

Stage 1 countermeasure deployment are collected on February 14, 2006. Figure 18 shows the countermeasures deployed in stage 1 at this location.

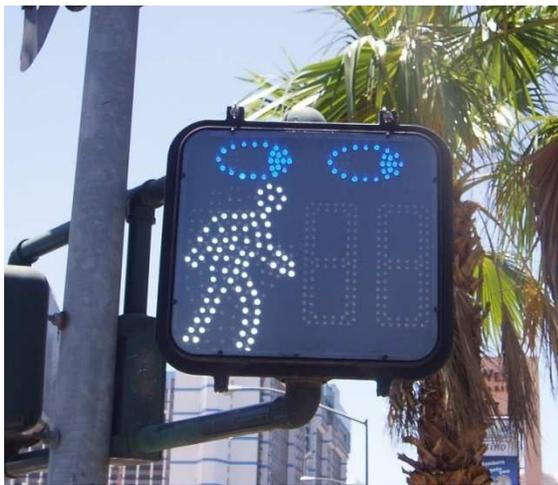
**Figure 19: Pedestrian Countdown Timers with Animated Eyes**

Countermeasure deployed during this stage is “Pedestrian countdown signs with animated eyes.” This countermeasure is installed on June 9 to 11, 2007. The after condition data for stage 2 countermeasure deployment is collected on July 12 and 13, 2007. Figure 19 shows the countermeasures deployed in stage 2.

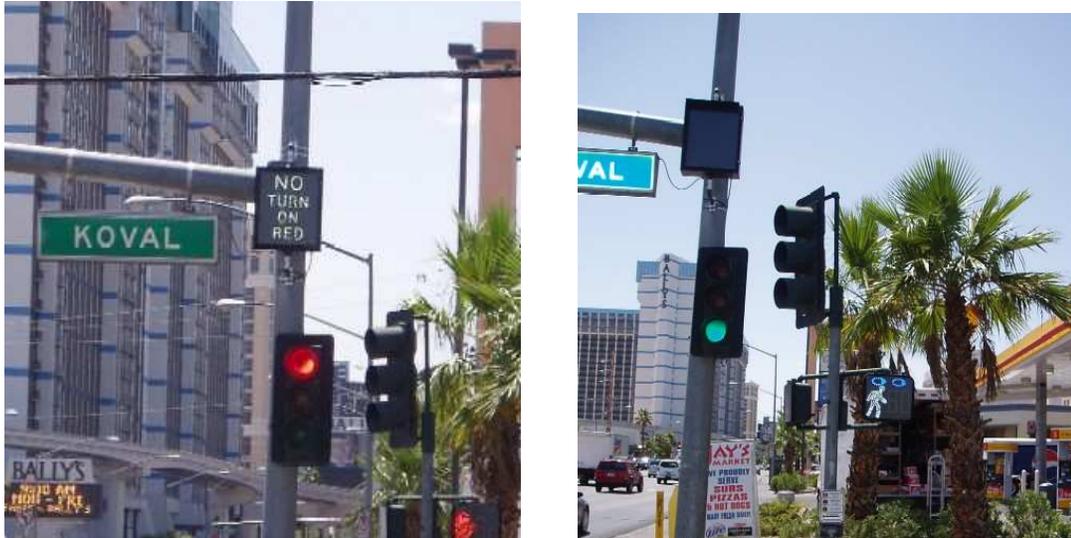
**Figure 20: ITS No-Turn On Red – Activated**

Countermeasure deployed during this stage is “ITS No-Turn on Red Signs.” This countermeasure is installed on November 26, 2007. The after condition data for stage 3 countermeasure deployment is collected on December 17 and 19, 2007. Figure 20 shows the countermeasure deployed in stage 3 at this location.

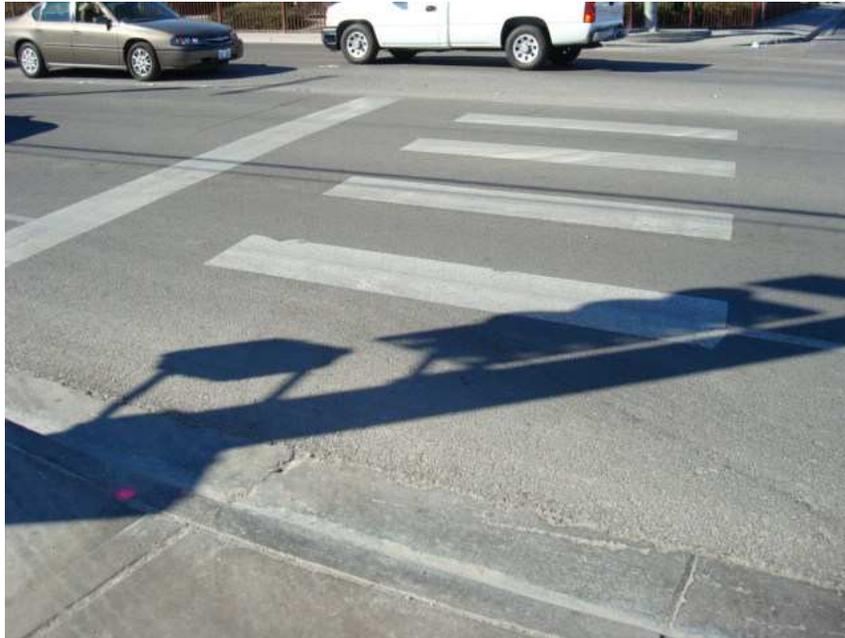
**Figure 25: High Visibility Crosswalk Treatment installed at Site 9/10**

Countermeasures deployed during this stage are “High Visibility Crosswalk Treatment” and “Warning Signs for Motorists.” These countermeasures are installed on August 4-7, 2006. The after condition data for Stage 2 countermeasure deployment are collected on August 21 to 24, 2006. Figure 25 shows the high visibility crosswalk treatment installed at Site 9/10. Warning signs for motorists installed at the site are shown in Figure 26.

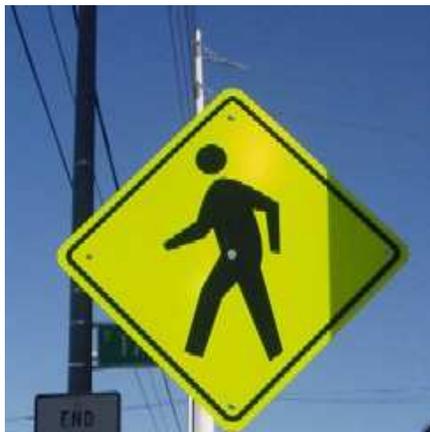
**Figure 26: Warning Signs for Motorists installed at Site 9/10**

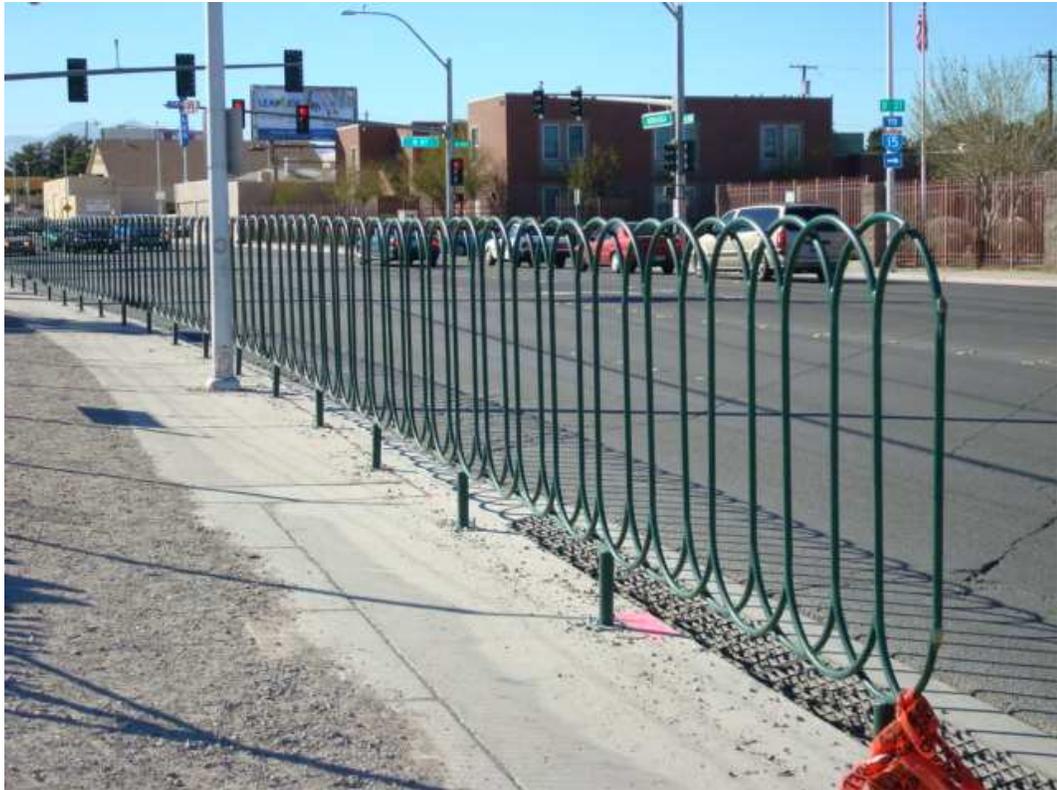
**Figure 27: Pedestrian Channelization installed at Site 9/10**

Countermeasure deployed during this stage was “Pedestrian Channelization.” This countermeasure is installed on October 29 to November 2, 2007. The after condition data for Stage 3 countermeasure deployment are collected on December 20 and 21, 2007. Figure 27 shows the countermeasure deployed in Stage 3 at this location.

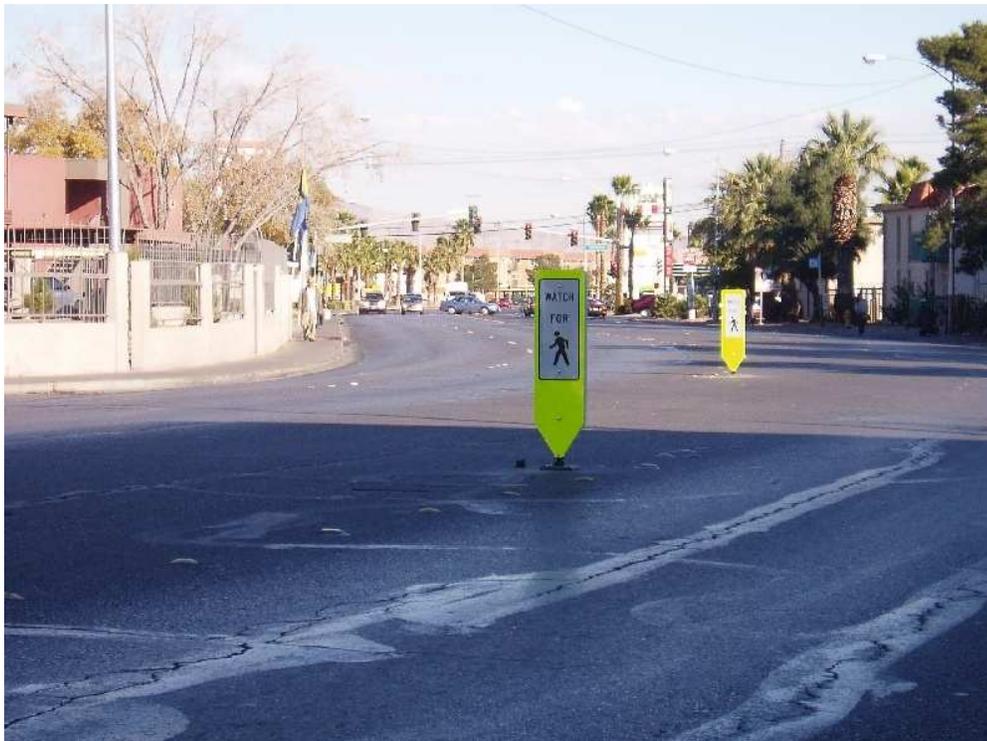
**Figure 30: In-Roadway Knockdown Signs installed at Sites 11 and 12**

The countermeasures deployed during stage 1 are “In Roadway Knockdown Signs.” These signs were installed between October 10 and 14, 2005. The after condition data for stage 1 countermeasure deployment were collected between November 1 and 4, 2005. Figure 30 and Figure 31 show the countermeasures deployed in Stage 1 at this location.

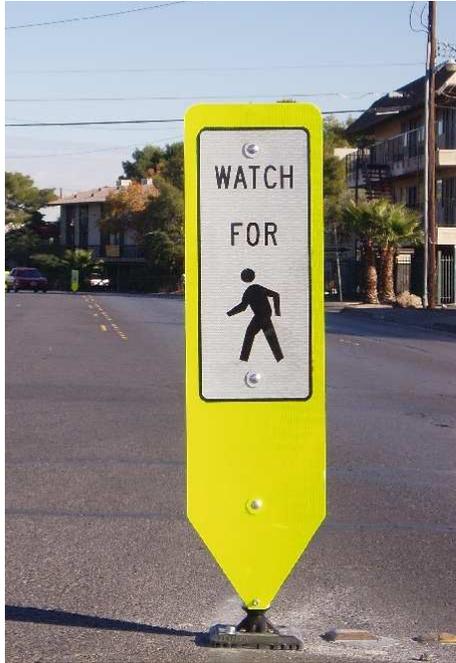
**Figure 31: Close-up view of “In-Roadway Knockdown Signs” installed at Sites 11 and 12**

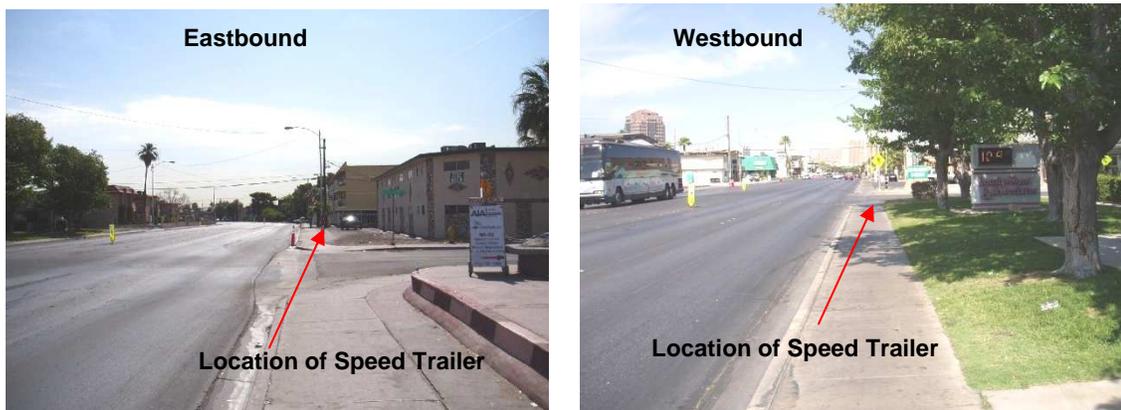
**Figure 32: Installation location of Speed-trailer on Twain Avenue**

The countermeasure deployed during stage 2 is “Portable Speed Trailer.” This countermeasure was installed between August 1 and September 30, 2006. The after condition data for Stage 2 countermeasure deployment were collected on October 18 and 19, 2006. Figure 32 shows the countermeasure deployed in Stage 2 at this location.

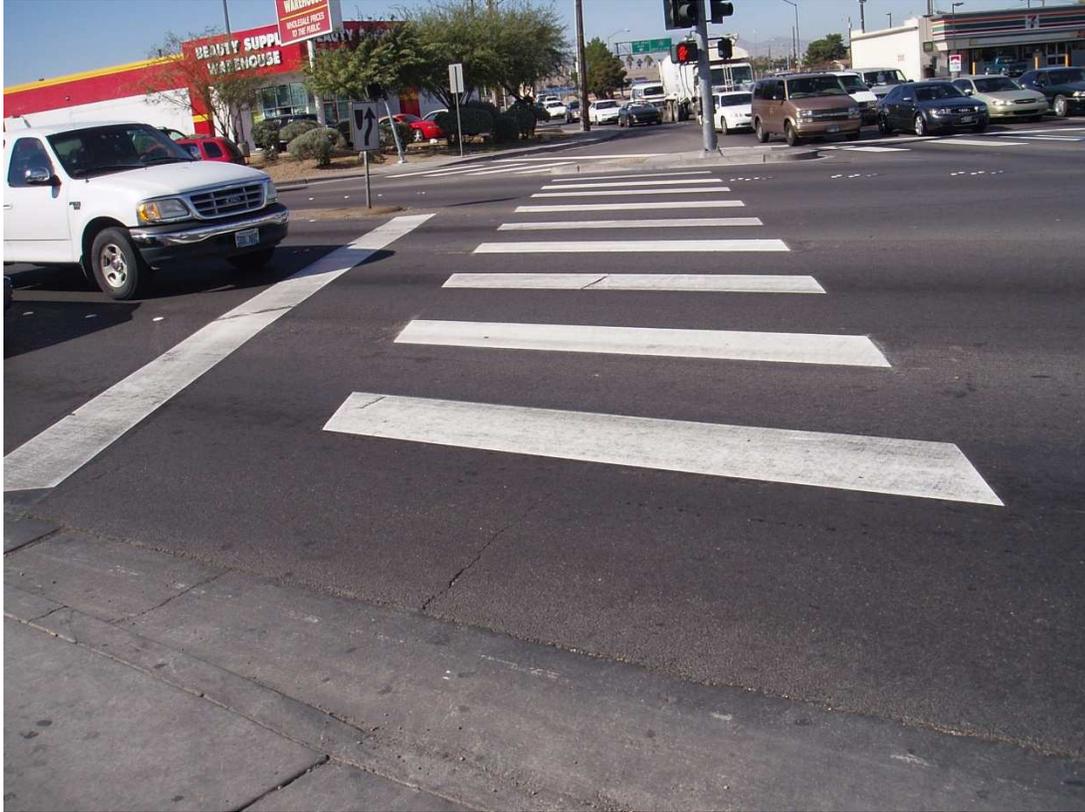
**Figure 34: High Visibility Crosswalk Treatment installed at Lake Mead Boulevard and Las Vegas Boulevard**

Countermeasure deployed during this stage is “high visibility crosswalk treatment.” This countermeasure is installed between October 3 and 7, 2005. The after condition data for stage 1 countermeasure deployment are collected on November 7, 2005. Figure 34 shows the countermeasures deployed at this location.

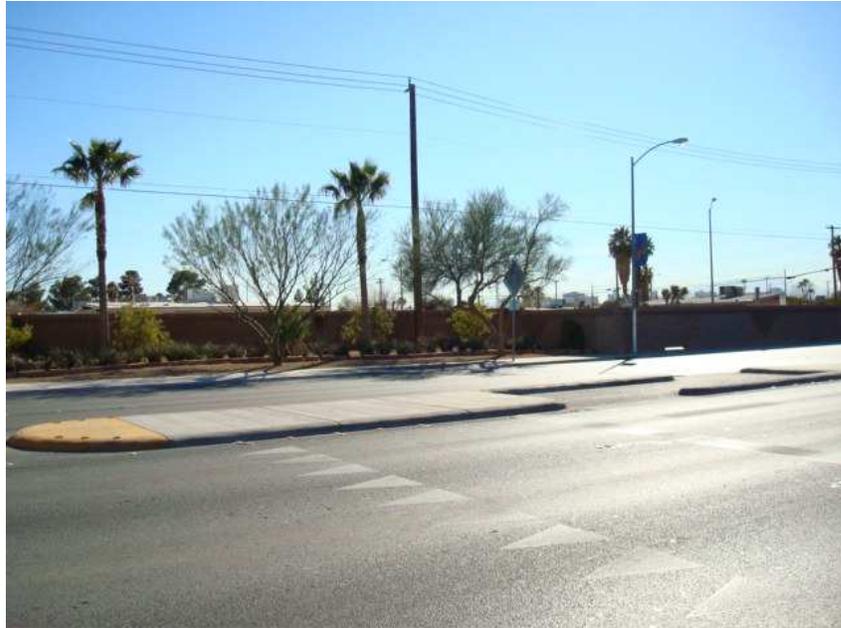
**Figure 37: High Visibility Crosswalk Treatment, Danish Offset and Median Refuge**

and March 2, 2007. Figure 37 and Figure 38 show the countermeasures deployed in stage 1 at this location.

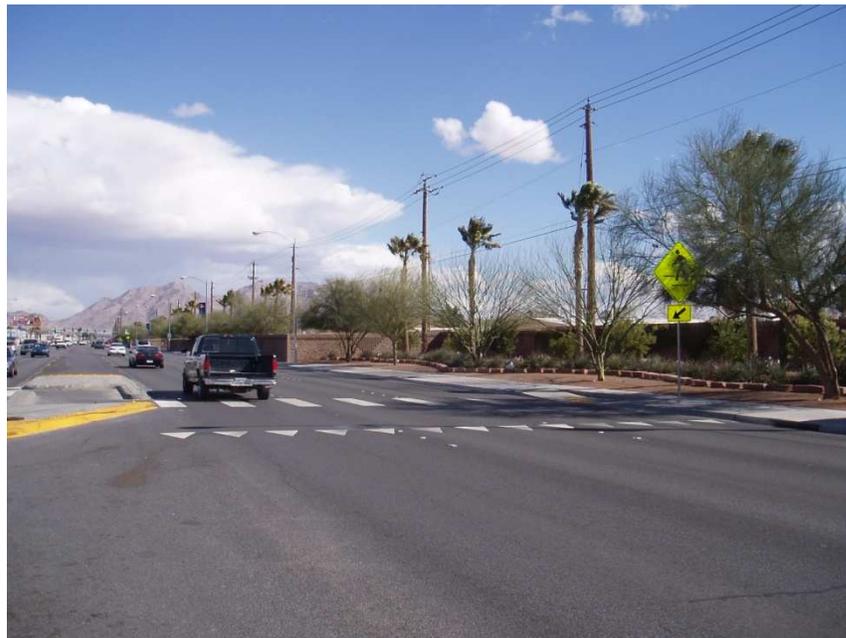
**Figure 38: Advanced Yield Markings installed at Lake Mead Boulevard: Belmont Street to McCarran Street**

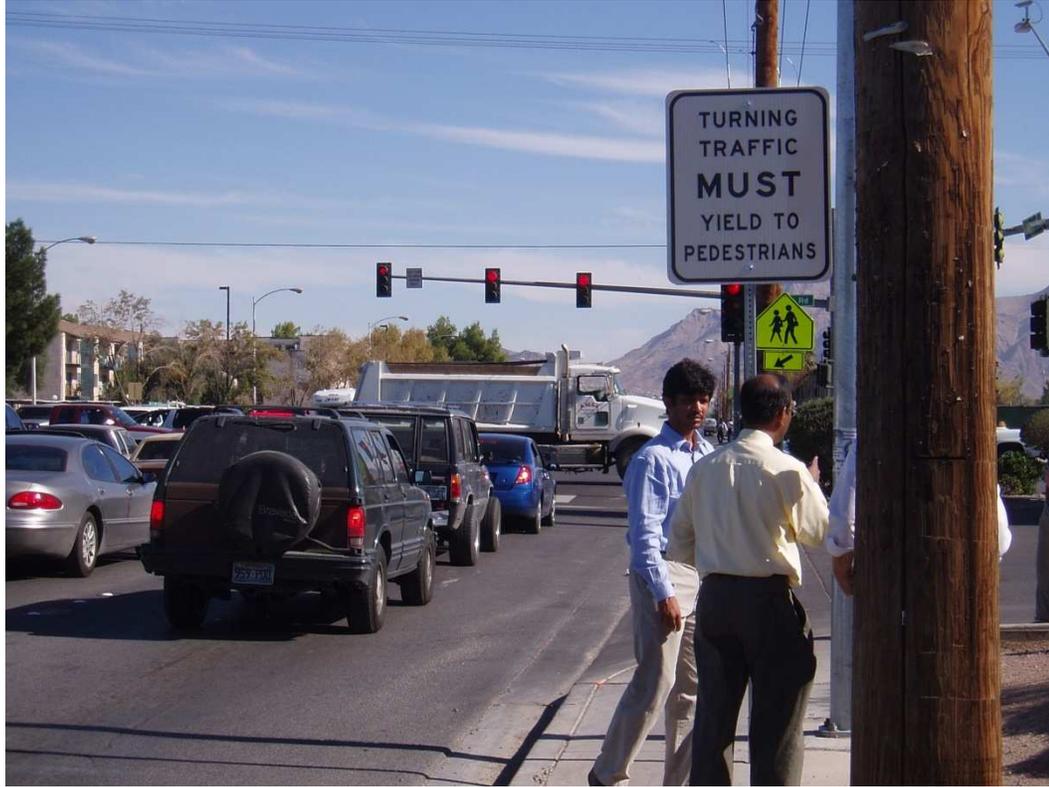
**Figure 40: “Turning Traffic Must Yield to Pedestrian” signs installed at Lake Mead Boulevard and Pecos Road**

Countermeasures deployed during this stage are “Warning Signs for Motorists” and “Turning Vehicles Yield to Pedestrians.” These countermeasures were installed between May 16 and 20, 2005. The after condition data for Stage 1 countermeasure deployment was collected from June 6 to 10, 2005. Figure 40 shows the countermeasure deployed in Stage 1 at this location.

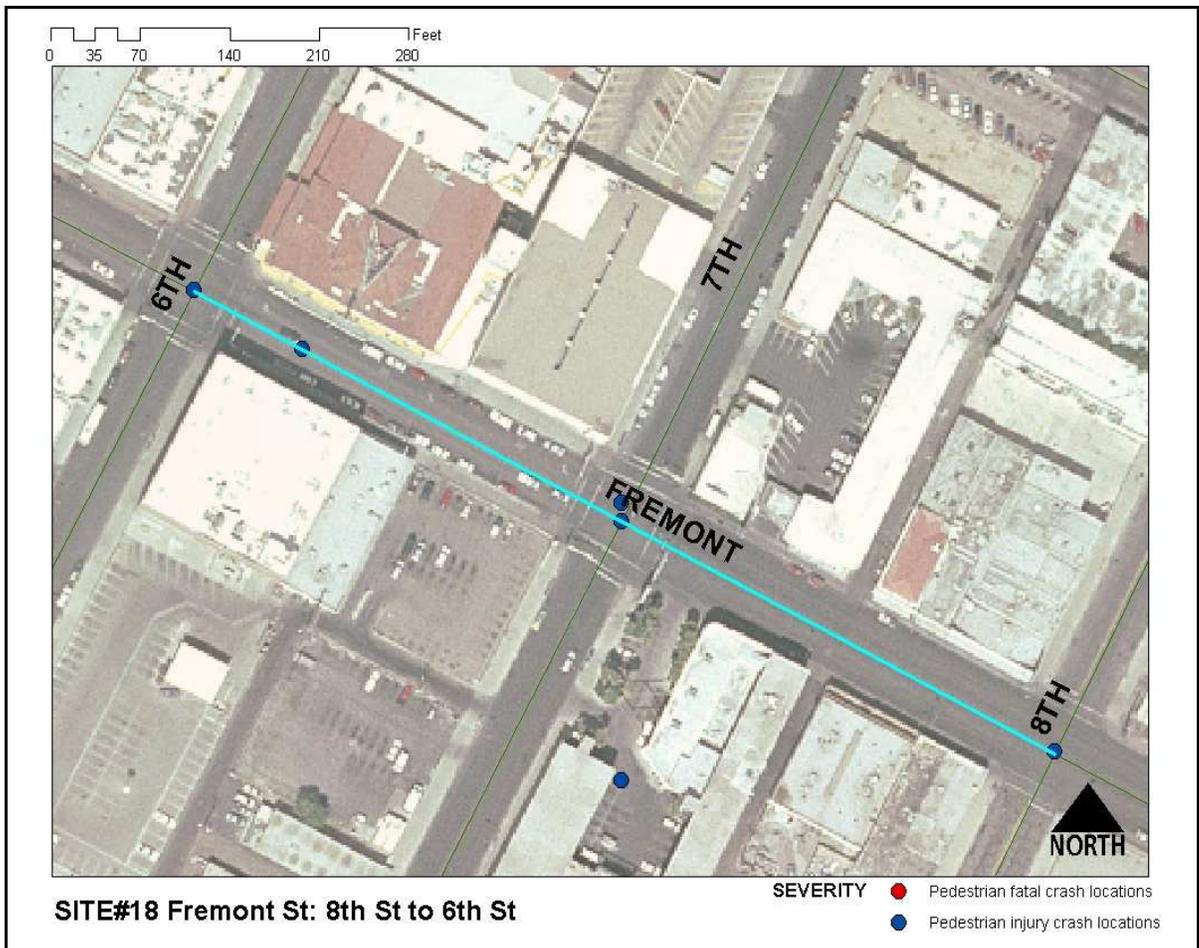
Land use adjacent to the corridor includes hotels, casinos and other commercial activities. The location is within the jurisdiction of the City of Las Vegas. Fremont Street is classified as a minor arterial and the posted speed limit is 25 mph. As per 2006 traffic count statistics, the ADT at Fremont Street is 13,800 along this corridor. Figure 42 presents the aerial photograph of the site. Implementation plan and conceptual designs of this site are presented in Site 18 in Appendix B.

Figure 42: Aerial Photograph of Fremont Street: 8<sup>th</sup> Street to 6<sup>th</sup> Street

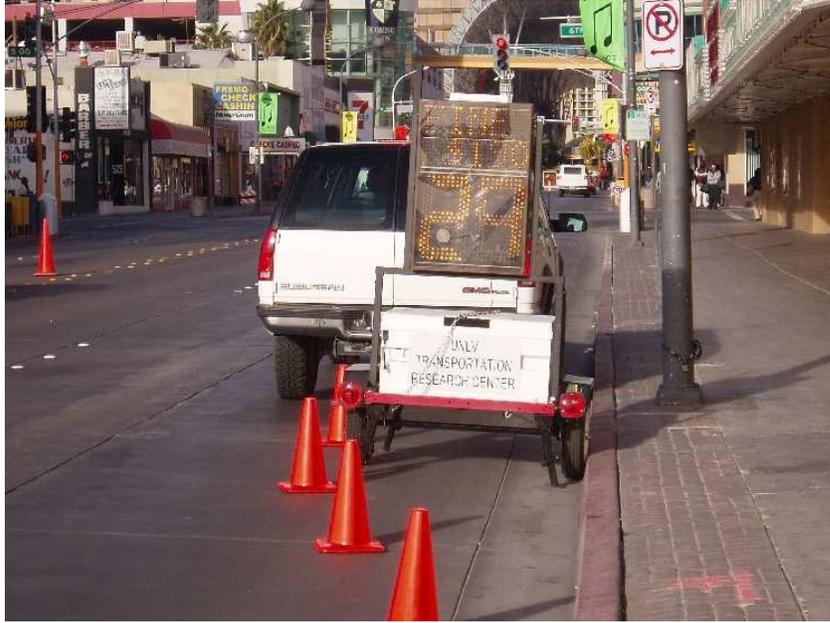
**Figure 43: Portable Speed Trailer on Fremont Street**

Countermeasure deployed during this stage is “Portable speed trailer.” This countermeasure is installed between January 1 and 28, 2006. The after condition data for stage 1 countermeasure deployment is collected on February 16, 2006. Figure 43 shows the countermeasures deployed in stage 1 at this location.

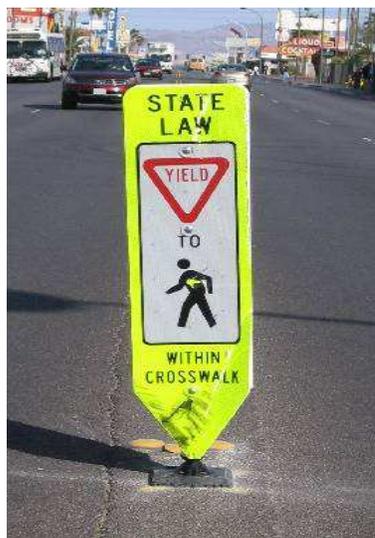
**Figure 44: In-Roadway Knockdown Signs**

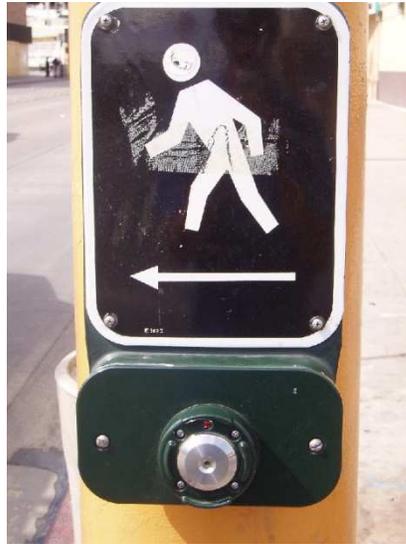
**Figure 45: Pedestrian Push Button that Confirm Press**

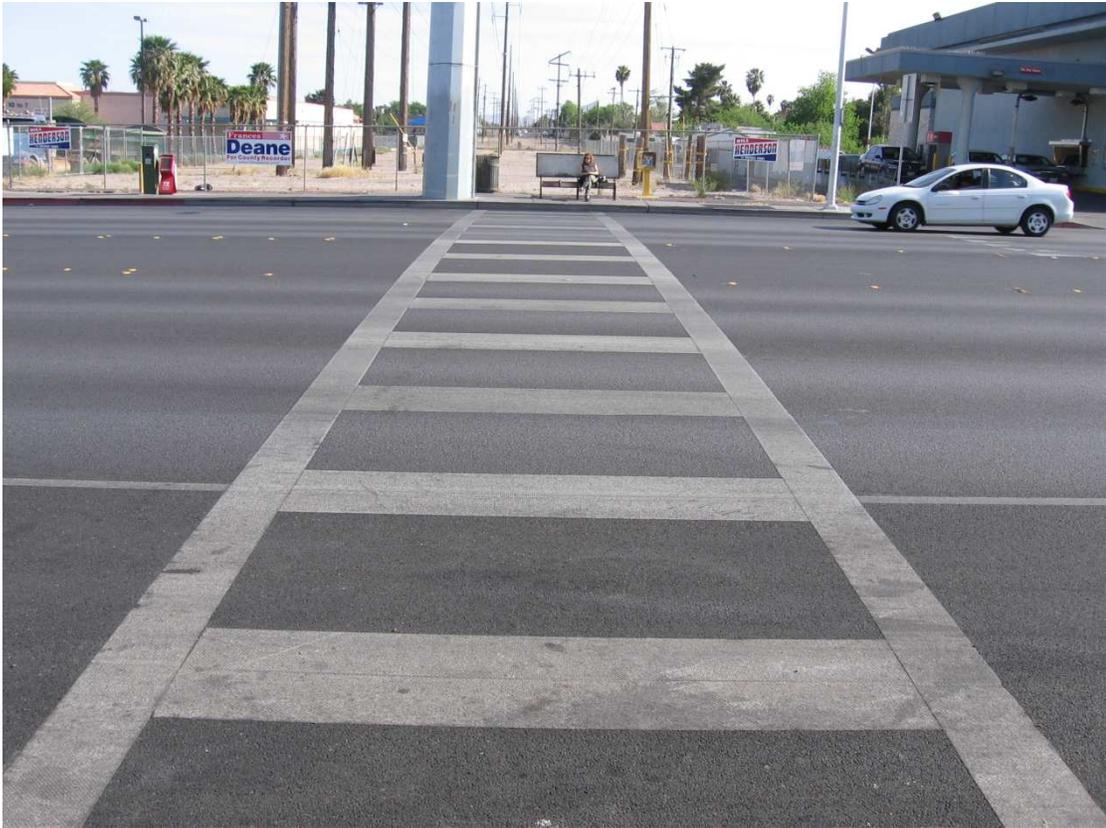
**Figure 47: High Visibility Crosswalk Treatment at Charleston Boulevard and 17<sup>th</sup> Street**

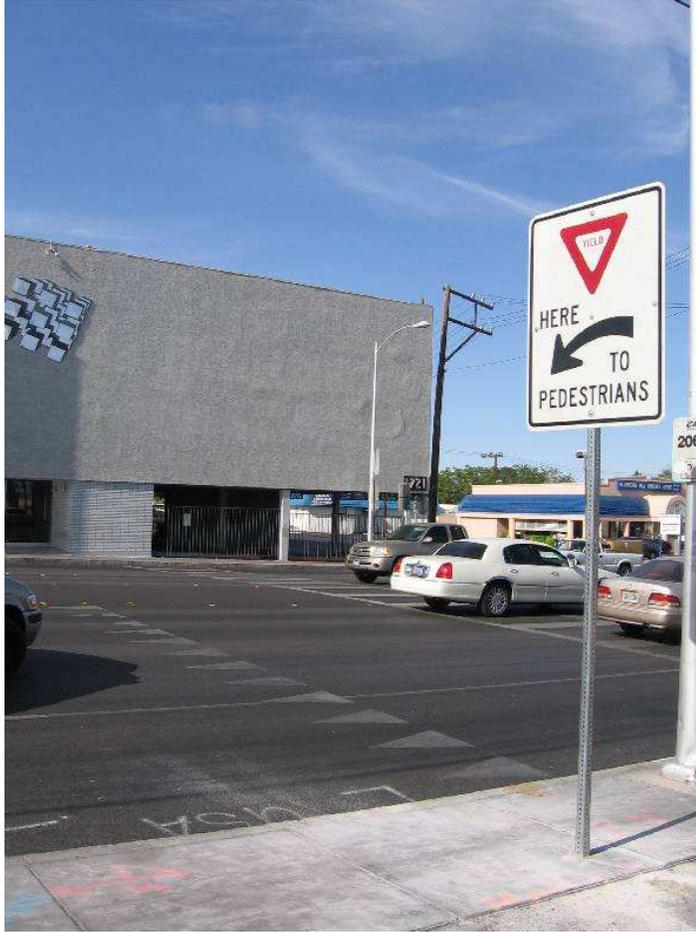
**Figure 48: “Advanced Yield Markings” installed at Site 19**

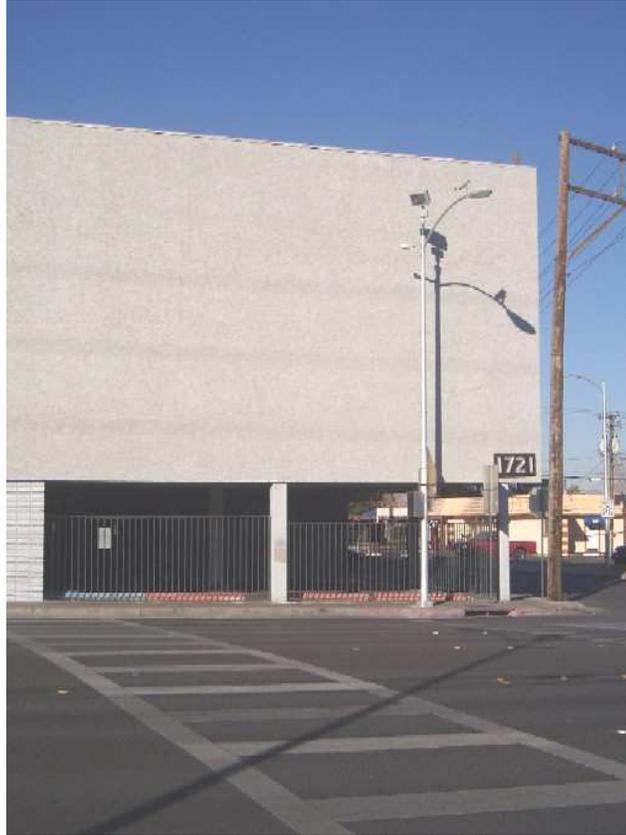
**Figure 49: Smart Lighting**

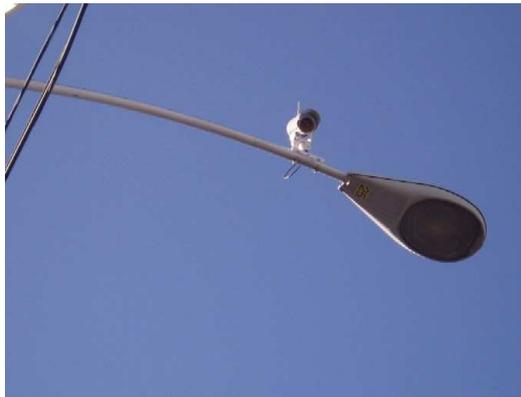
**Figure 50: Automatic Pedestrian Detection**
