Pedestrian Hybrid Beacon Guide – Recommendations and Case Study

FHWA Safety Program

U.S. Department of Transportation
Federal Highway Administration

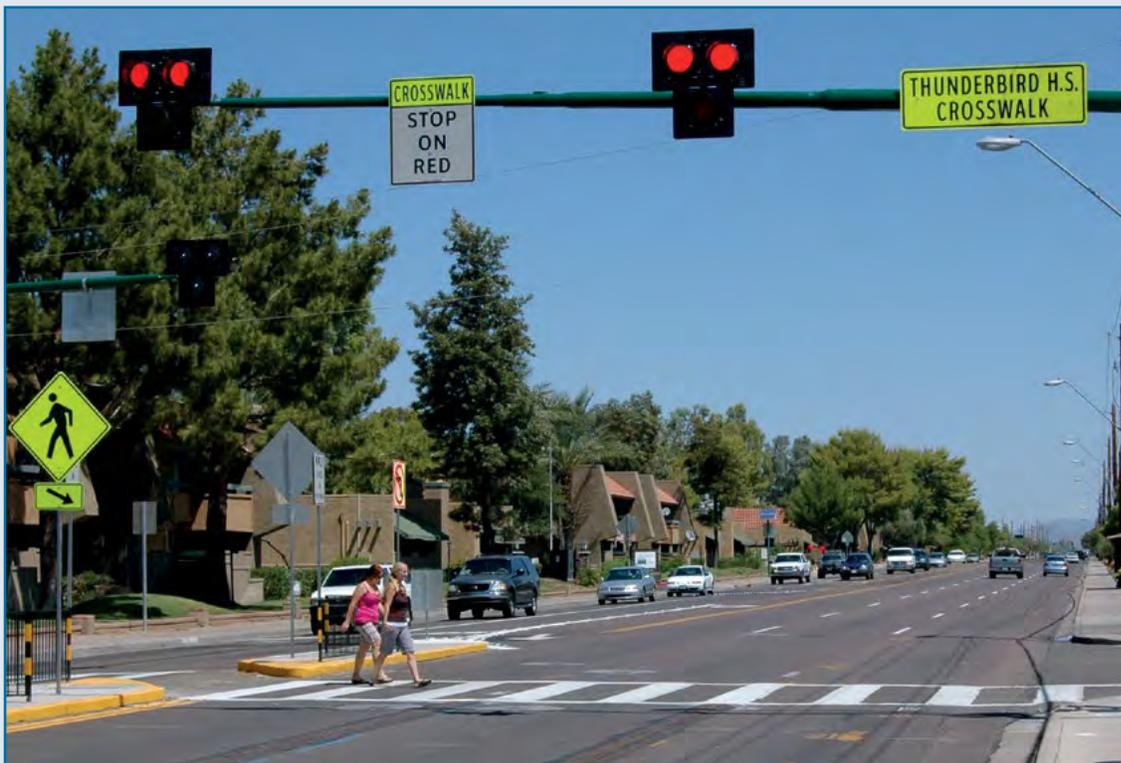
Figure 1. A PHB in Phoenix Arizona provides protection for pedestrians near a high school. Photo Credit: Mike Cynecki

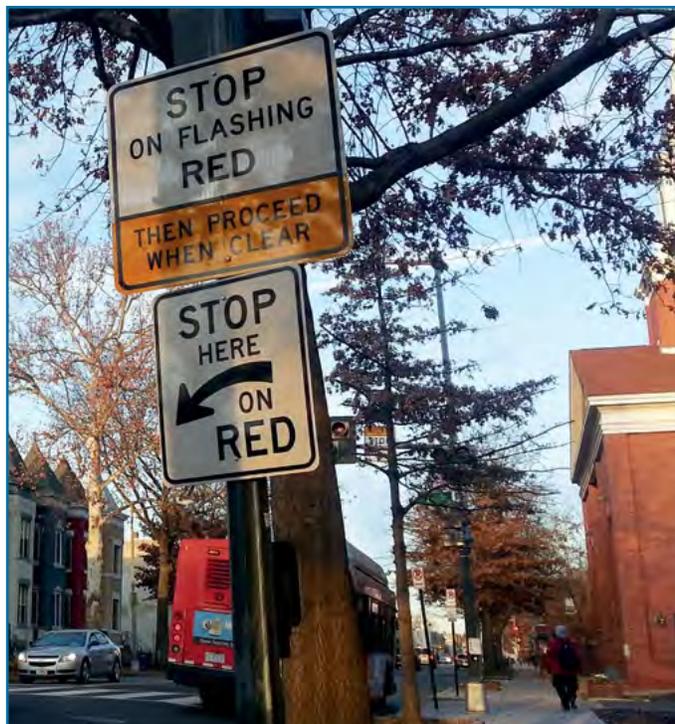
Figure 2. A PHB in Washington DC provides protection for pedestrians near a church.
Photo Credit: Stephanie Sneary

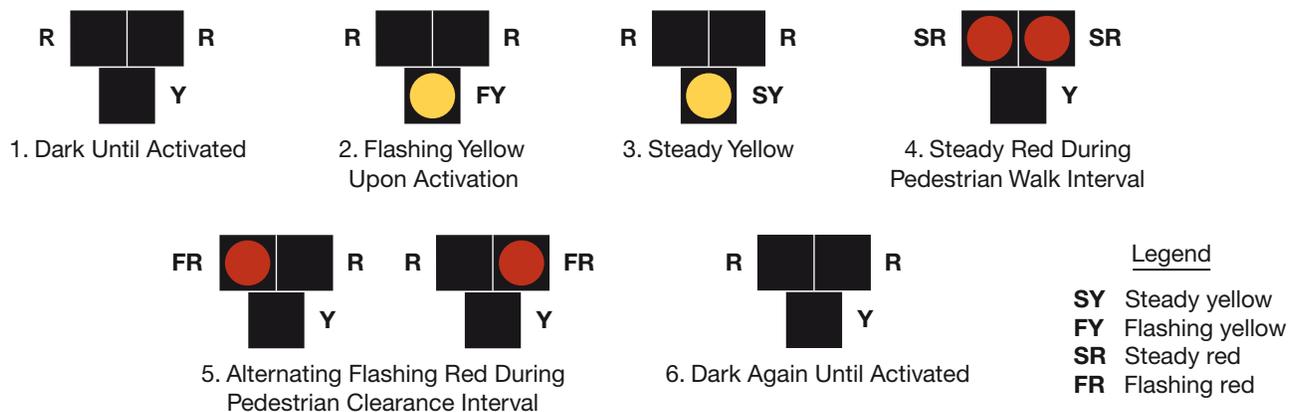
The design of the PHB consists of two horizontally-arranged red lenses above a single yellow lens. As shown in Figure 3 below, the signal face for drivers remains unlit or “dark” until the pedestrian activates the system. While the signal is dark, the pedestrian display shows a Don’t Walk indication. To activate the PHB pedestrians push an accessible button located on a pole or post at the roadside. The actuated beacon then begins to flash yellow to warn motorists that the beacon has been activated. This brief flashing yellow interval is followed by a steady yellow interval, then by a steady red signal indicating motorists need to come to a complete stop and wait at the stop line. While motorists are seeing the steady red indication, the Walk sign is lit for pedestrians, allowing them to cross the roadway. After the pedestrian WALK phase ends, the pedestrian signal indication changes to a flashing DON’T WALK to notify pedestrians not to begin crossing. During the flashing Don’t Walk phase, the PHB displays alternating flashing red lights to drivers. The flashing red indicates to drivers that they are to stop and yield to pedestrians in the crosswalk, and can proceed once pedestrians are clear.

Figure 3. Corresponding Display Sequence for PHB and Pedestrian Signal

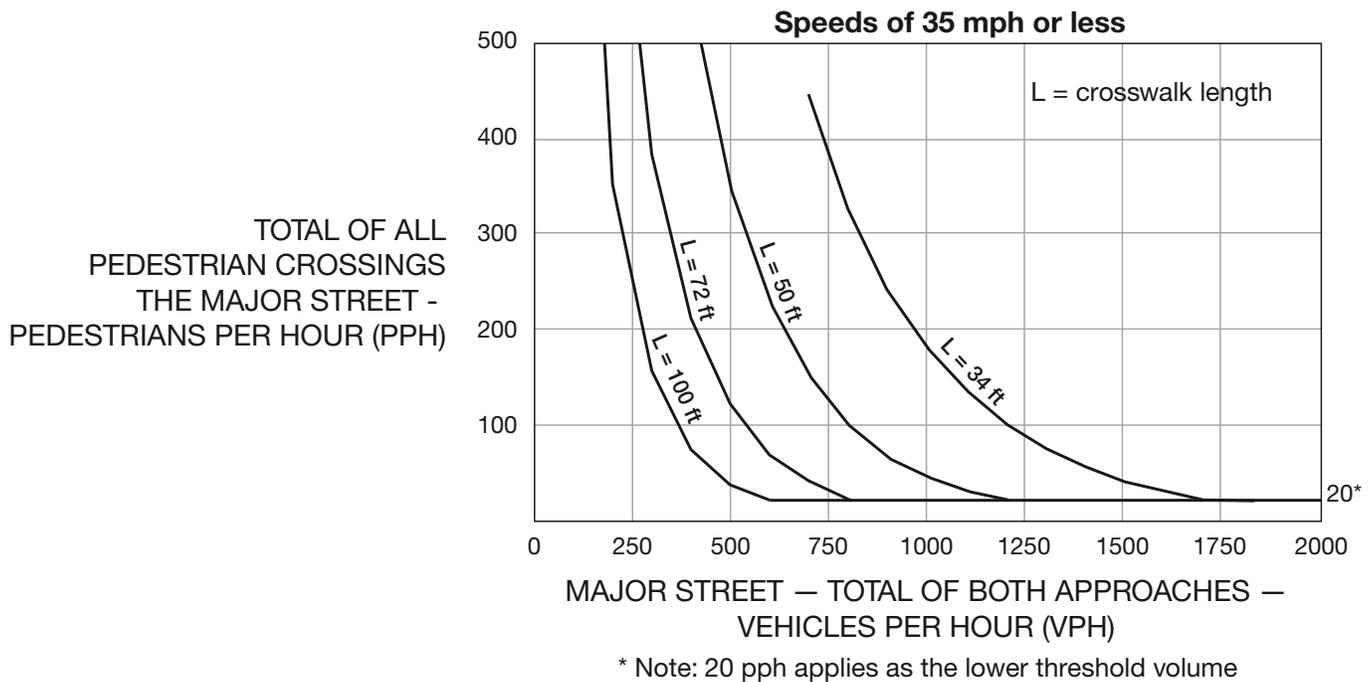
Figure 4. MUTCD Figure that shows recommended thresholds for consideration of PHBs

Chapter 4F of the MUTCD contains provisions on how PHBs can be installed and used in conjunction with signs and pavement markings to warn and control traffic at locations where pedestrians enter or cross a street or highway. The MUTCD also identifies factors for agencies to consider in determining the use of PHBs, including pedestrian and traffic volumes, roadway speeds, and sight distance. Two charts, one for roadways with speeds of 35 mph or less (MUTCD Figure 4F-1), and one for speeds greater than 35 mph (MUTCD Figure 4F-2), provide warranting criteria for the use of PHBs based on engineering studies of the volume of pedestrians and vehicles and the length of the crosswalk. Figure 4 shows MUTCD Figure 4F-1 which identifies thresholds, shown with curves, for various crosswalk lengths based on the number of pedestrians and traffic volume realized on roadways with traffic speeds of 35 mph or less. If pedestrian and volume points mapped exceed the curve, a PHB should be considered. If a street or highway being crossed has a raised median that is wide enough to serve as a pedestrian refuge area, then each half of the street may be considered separately.ⁱ

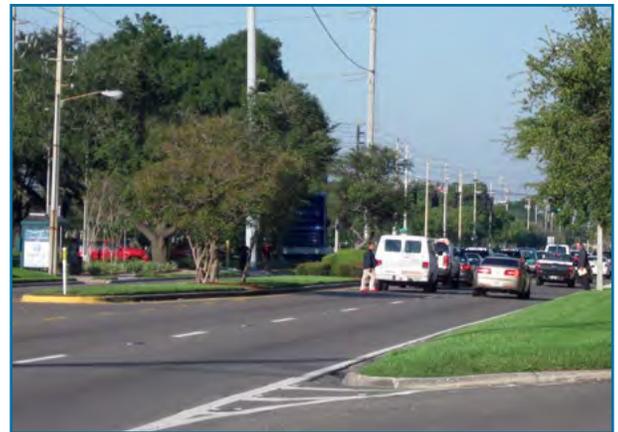
Figure 5. A busy section of a multi-lane, high-volume, high-speed roadway creates pedestrian challenges.
Photo Credit: Theo Petritsch

Multi-lane, high-volume, high-speed roadways are barriers to pedestrian mobility. Some pedestrians may choose not to make a trip that involves crossing a busy roadway, and these roads pose additional safety and mobility issues for children and people with disabilities. On these types of facilities, pedestrian crossings are primarily located at signalized intersections. Signals are often timed to minimize motorists delay and maximize capacity or vehicle throughput. The distance pedestrians must travel to reach signalized intersections, combined with long traffic signal cycles, results in frequent pedestrian crossings at mid-block or uncontrolled locations. In 2012, a total of 4,743 pedestrians were killed, with 76,000 injured in traffic crashes. Nearly three quarters (73 percent) of pedestrian fatalities occurred at mid-block locations compared to intersections.⁶ On multi-lane undivided roadways, pedestrians must judge gaps in multiple streams of traffic to successfully complete a crossing. On higher speed roadways motorists are less inclined (or less able) to stop for pedestrians in crosswalks — some communities have yielding rates of less than 2 percent at marked and signed mid-block crosswalks.⁷

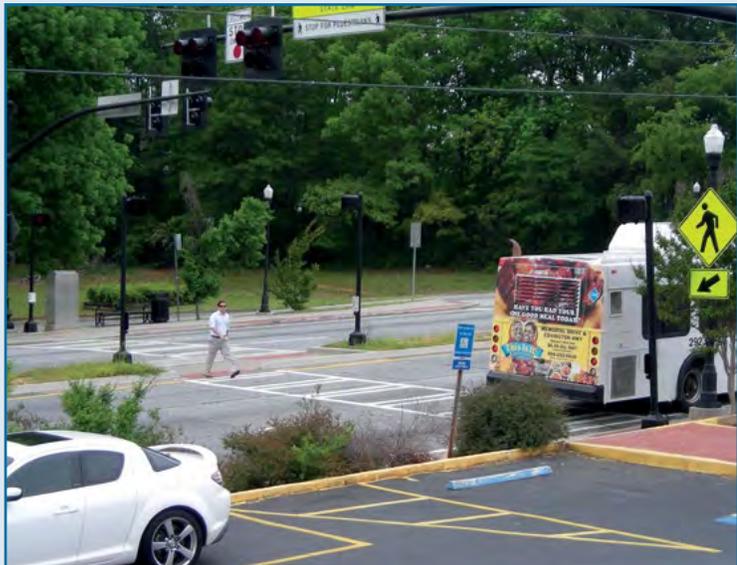
Figure 6. PHB protects pedestrians crossing Buford Highway. Photo credit: Bruce Landis

In all, four pedestrian hybrid beacons were installed in the Doraville/Chamblee area of Buford Highway. Each was placed near a transit stop. The PHBs are located away from intersecting roadways, and advance pedestrian crossing signs and advance stop lines were used at each crossing. A modified ladder crosswalk pattern was used for the pedestrian crossing. The PHBs are designed as two-stage crossings.

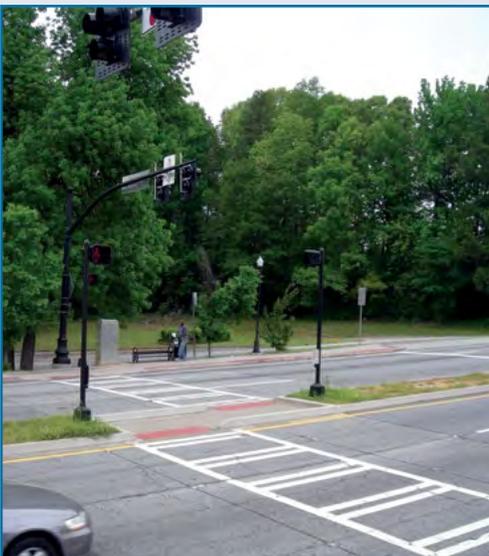
Figure 7. PHB installed on Buford Highway near pedestrian attractors: a transit stop. Photo credit: Bruce Landis

Raised medians were installed on the approaches to the PHB crosswalks. In addition, the crosswalks were offset within the median. The offset crosswalks were intended to encourage pedestrians to look at the oncoming traffic. Additionally, the offset in the median reinforces that the PHB must be activated for the second half of the crossing.
