ROAD SAFETY AUDITS: CASE STUDIES

U.S. Department of Transportation
Federal Highway Administration

1. Report No. FHWA-SA-06-17	2. Government Accession No.	3. Recipient's Catalog No.	
4. Title and Subtitle <i>Road Safety Audits: Case Studies</i>		5. Report Date December 2006

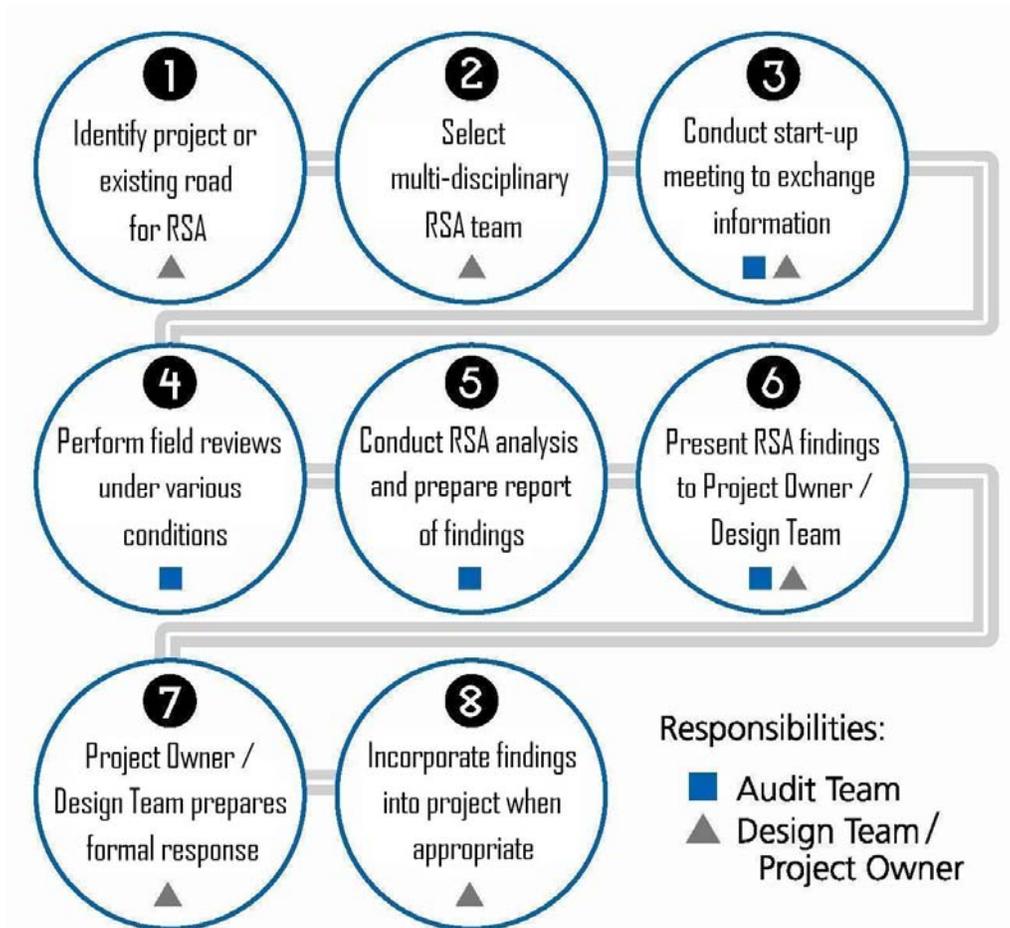
FIGURE 1 RSA PROCESS

The eight steps of an RSA are shown in Figure 1, and are discussed below with reference to the case studies.

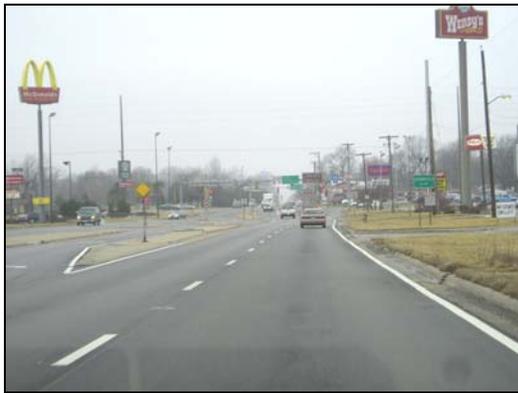
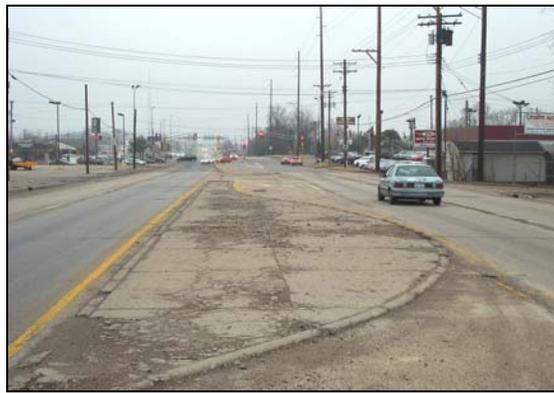
FIGURE A.1 VIEWS OF RSA SITE (ILLINOIS DOT RSA)

Clear Lake Avenue (looking west toward intersection with Dirksen Parkway)

Dirksen Parkway (looking south toward intersection with Clear Lake Avenue)

The intersection of Clear Lake Avenue and Dirksen Parkway was designated a high accident location for six consecutive years (1998 through 2003), and the intersection of Hill Street and Clear Lake Avenue was designated a high accident location in 2003. In response, the Illinois Department of Transportation (IDOT) developed plans to upgrade Clear Lake Avenue between Dirksen Parkway and the I-72/I-55 interchange. The scope of the planned improvements, shown in FIGURE A.2, included:

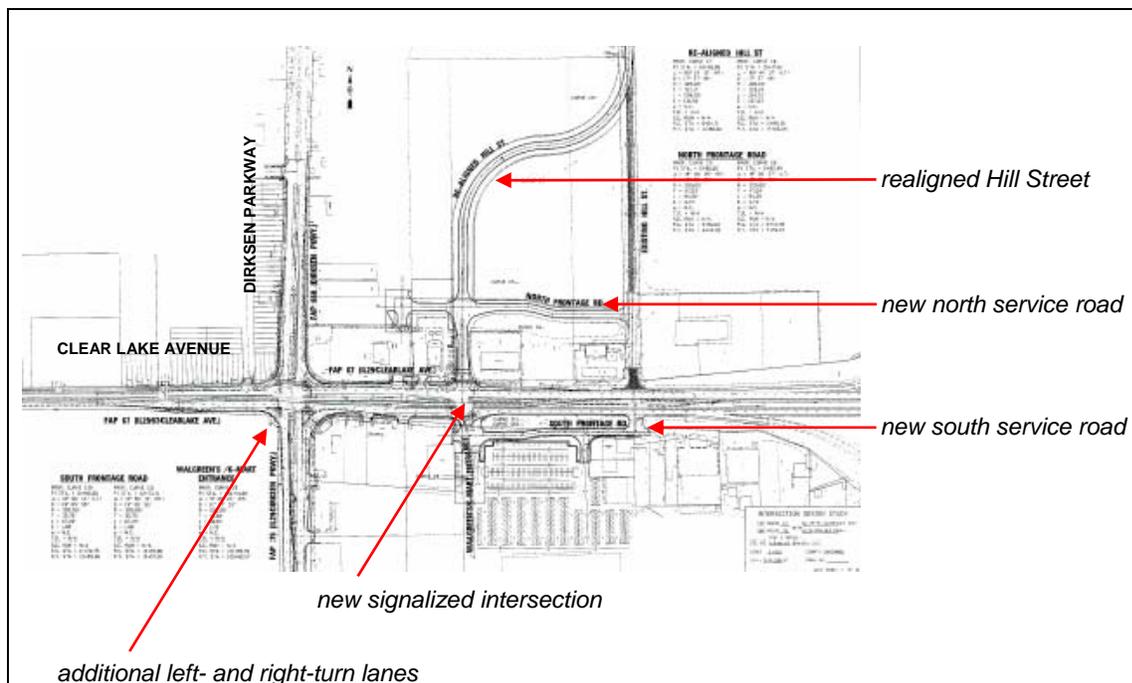
FIGURE A.2 RSA PROJECT (ILLINOIS DOT RSA)

- access consolidation and construction of two new service roads intersecting Clear Lake Avenue at a new signalized intersection east of Dirksen Parkway;
- realignment of Hill Street (a local road) to intersect Clear Lake Avenue at new signalized intersection;
- dual left turn lanes on all legs of the intersection of Clear Lake Avenue and Dirksen Parkway, and dual right turn lanes on the southeast corner of the intersection.

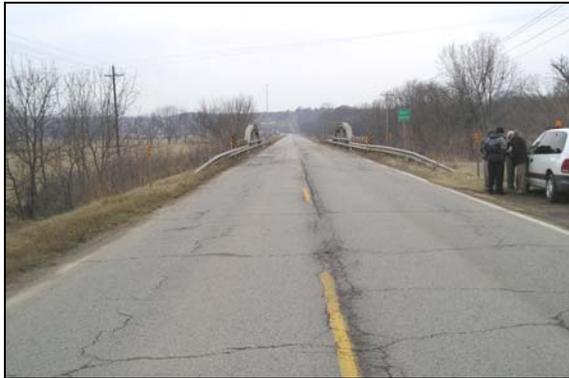
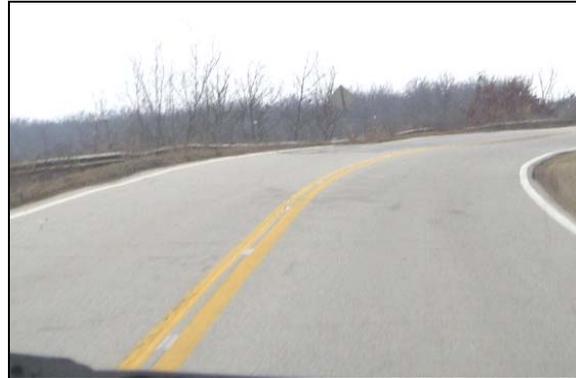
FIGURE A.3 VIEWS OF RSA SITE (OKLAHOMA DOT RSA)

*Buck Creek bridge
(planned improvements include repaving, bridge
improvements, and 8' paved shoulders)*

*adjacent "incidental" section
(planned improvements include repaving and 2' paved
shoulders)*

- replacing existing bridges over Buck Creek and Turkey Creek, including reconstructing the approach roadways as two 12-foot lanes with 8-foot paved shoulders;
- between the bridges, widening shoulders to provide a continuous 8-foot paved shoulder and adding one channelized right turn lane at the unsignalized intersection with Bowring Road, a section-line road;
- resurfacing a 1.2-mile "incidental section" west of Buck Creek (12-foot lanes with 2-foot paved shoulders) to connect with an adjacent segment of US 60 further west that had been recently overlaid.

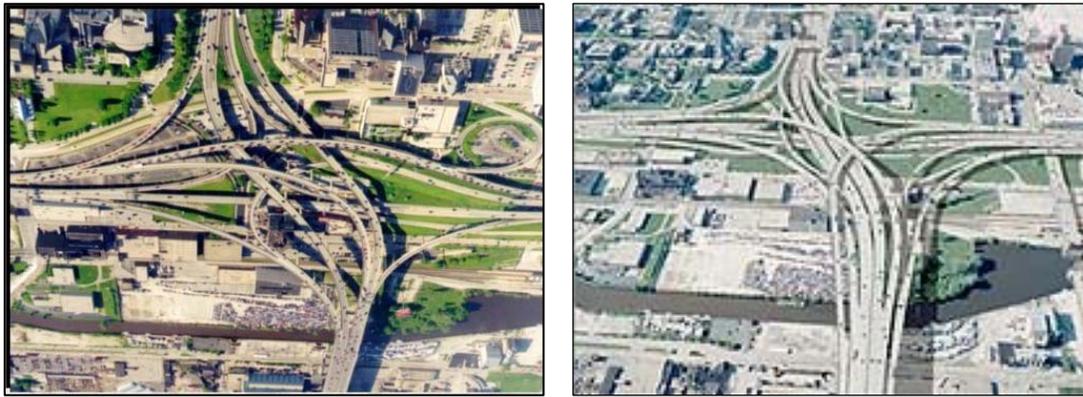
*Existing Interchange**Improved Interchange (simulation)***FIGURE A.5 EXISTING INTERCHANGE AND PROPOSED IMPROVEMENTS**

The planned reconstruction includes upgrades and improvements include:

- replacement of left-side ramps with conventional right-side ramps,
- lengthening or elimination of existing short weaving sections,
- increased curve radii on ramps,
- lane continuity and consistency for through traffic,
- increased capacity on system ramps,
- increased barrier height.

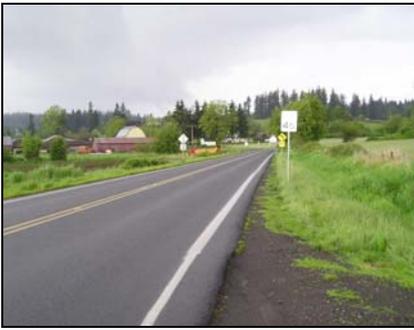
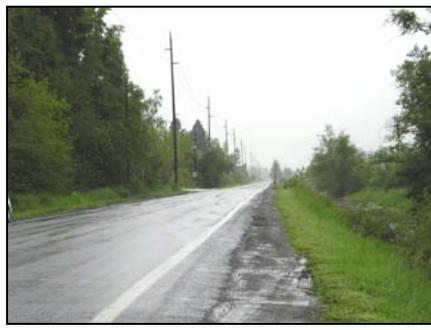
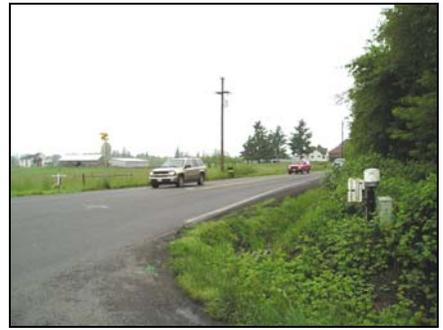
FIGURE A.6 VIEWS OF RSA SITE (CLARK COUNTY RSA)

Ward Road near Davis Road

172nd Avenue near Ward Road

182nd Avenue at 119th Street

The planned improvements affected three roads: Ward Road (also known as 182nd Avenue), 172nd Avenue, and 119th Street, shown in FIGURE A.6. In addition to functioning as major rural collectors, these roads provided access to adjacent properties (residential and farm) and a small farming town. Improvements, numbered and shown in FIGURE A.7, included:

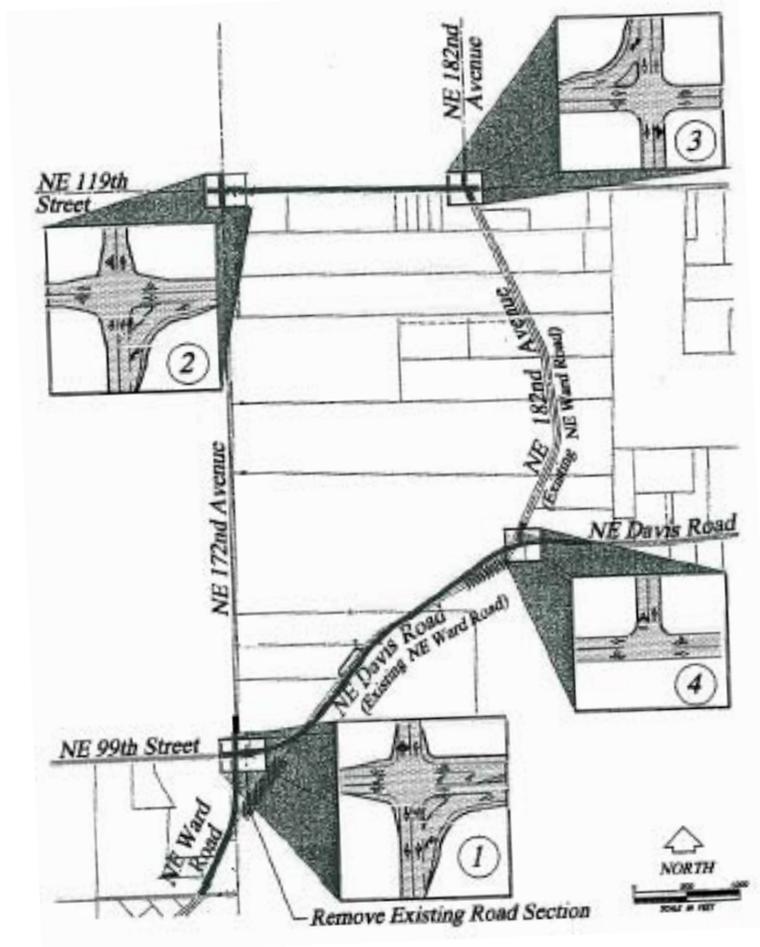
FIGURE A.7 RSA PROJECT (CLARK COUNTY RSA)

- 1) realignment of Ward Road between 172nd Avenue and Davis Road (involving abandonment of an existing road section on structure), and introduction of a new four-way signalized intersection;
- 2 and 3) intersection improvements at the STOP-controlled intersections of 119th Street / 172nd Avenue and 119th Street / 182nd Avenue, including the introduction of a free right turn lane on one approach;
- 4) reconfiguration of the existing Ward Road / Davis Road intersection, and relocating the STOP sign from Davis Road to 182nd Street.

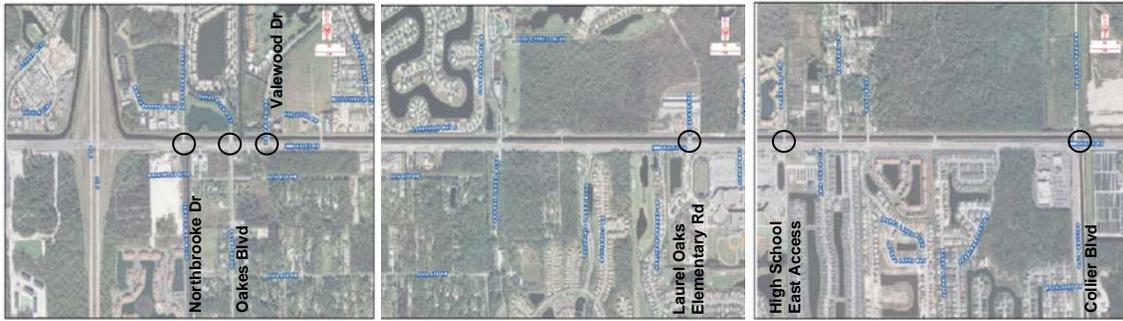
FIGURE A.8 RSA SEGMENT (COLLIER COUNTY RSA)

Signalized intersections shown.

Immokalee Road, a County road, is a major east/west arterial connecting residential areas in western Collier County with I-75, US Highway 41, and the City of Naples. The RSA section of the roadway, shown in FIGURE A.8, was widened from two lanes to four lanes in 2002. The four-lane cross-section, shown in FIGURE A.9, was a divided arterial roadway with two through lanes in each direction, a grass median (up to about 40 feet wide), and turning lanes at signalized intersections. The corridor was adjacent to low-density residential, commercial, and institutional land uses, including the North Naples Fire Station No. 42, Gulf Coast High School, Laurel Oaks Elementary School, and several churches.

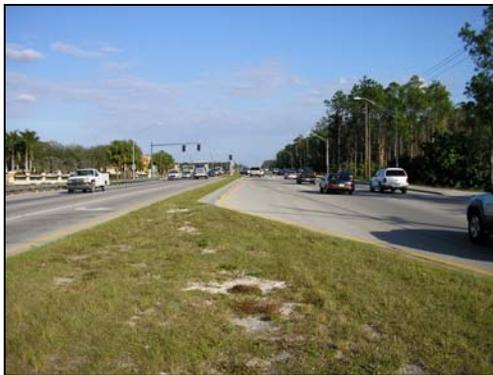
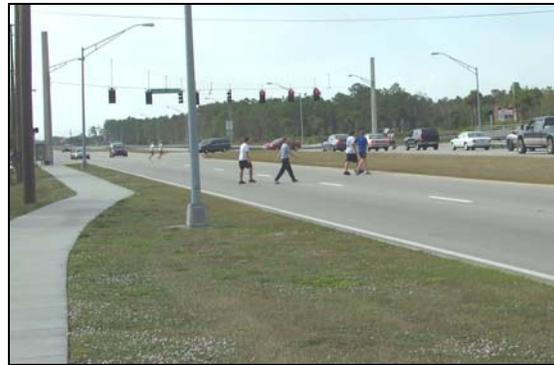
FIGURE A.9 VIEWS OF RSA SITE (COLLIER COUNTY RSA)

Immokalee Road near Valewood Drive

Immokalee Road in front of schools

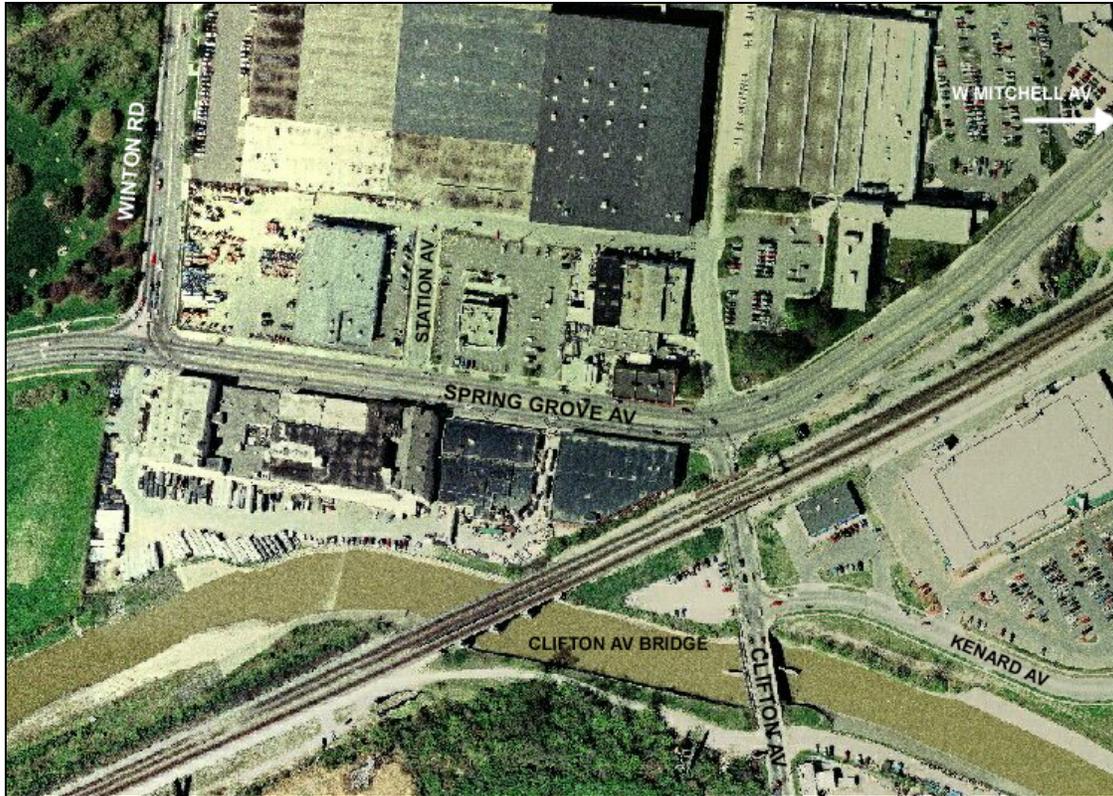
FIGURE A.10 RSA SITE (CINCINNATI)

- Clifton Avenue bridge widening to accommodate four 10-foot lanes and a 10-foot painted median strip,
- traffic signal improvements at the intersection of Spring Grove Avenue and West Mitchell Avenue,

- other possible improvements to Spring Grove Avenue in connection with the planned upgrade.

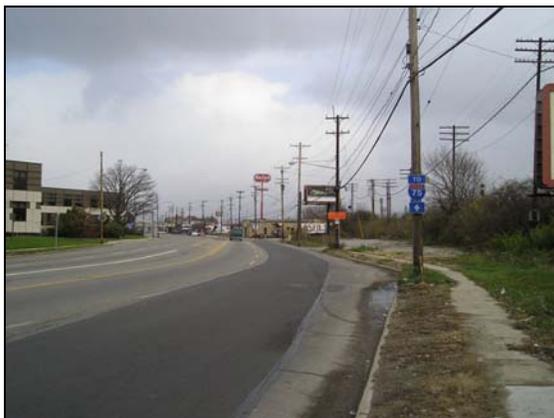
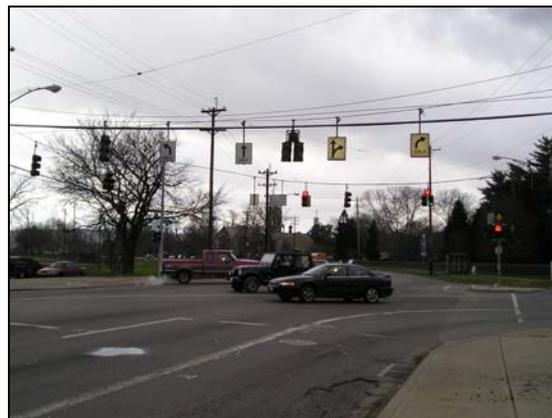
FIGURE A.11 VIEWS OF RSA SITE (CINCINNATI RSA)

Spring Grove Avenue

intersection of Winton Road and Spring Grove Avenue

4	<i>road cross section:</i> The cross section of Spring Grove Avenue includes apparent inconsistencies.	B	<ul style="list-style-type: none"> Design the new cross-section with uniform lane widths.
5	<i>pedestrian facilities:</i> Pedestrian facilities need upgrading and maintenance.	C	<ul style="list-style-type: none"> Provide consistent levels of lighting and upgrade lighting at crosswalks. Review warrant for upgrading crosswalk markings near Station Avenue. Improve sidewalk conditions.

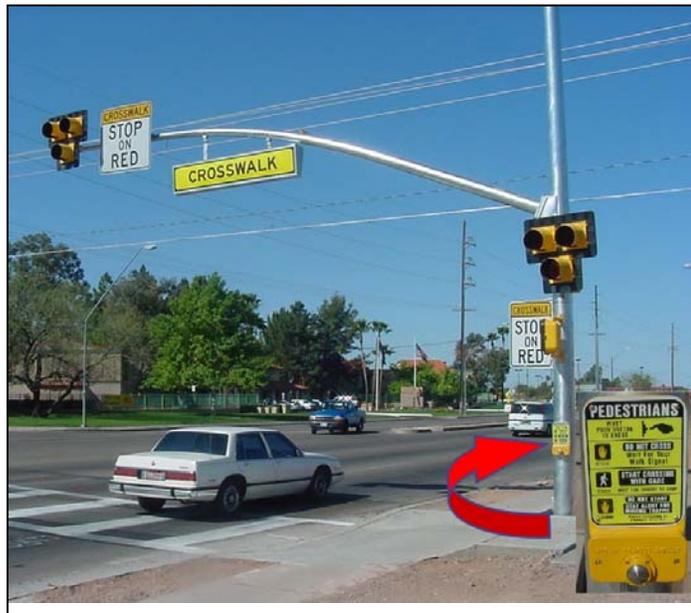
FIGURE A.12 HAWK PEDESTRIAN SIGNAL

HAWK (**H**igh-Intensity **A**ctivated **C**ross**W**alk) signals are a type of traffic control beacon for marked pedestrian crosswalks, developed by the City of Tucson and implemented in Tucson and elsewhere in Arizona. The City of Tucson received approval from FHWA to experiment with this device; it is not yet adopted in the *Manual of Uniform Traffic Control Devices*. The innovative HAWK signal, shown in FIGURE A.12, incorporates elements from fire station signals and school bus flashing displays, as well as from European pedestrian signal displays, to provide a familiar signal sequence for drivers and pedestrians. The HAWK signal is activated by a pedestrian

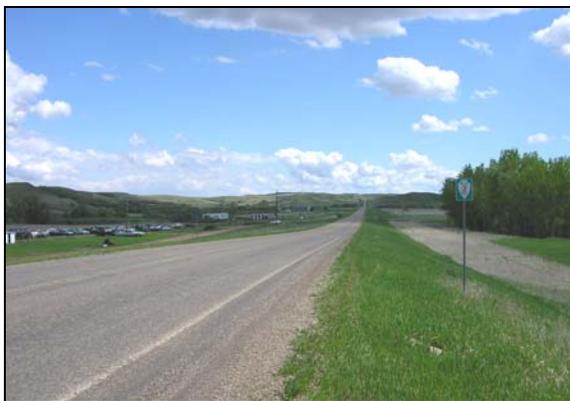
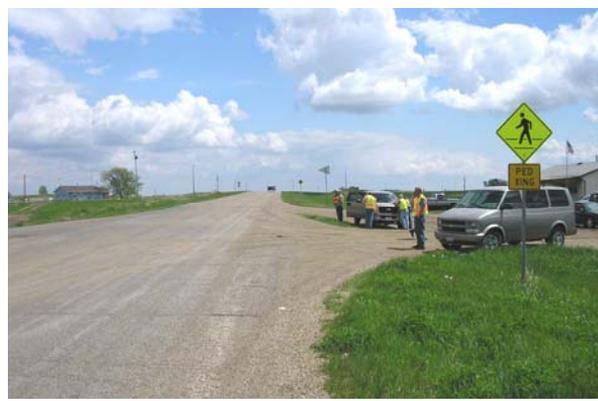
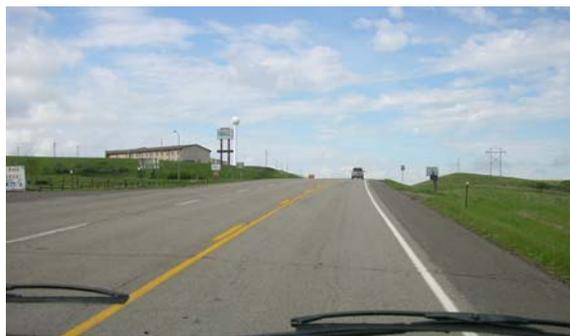
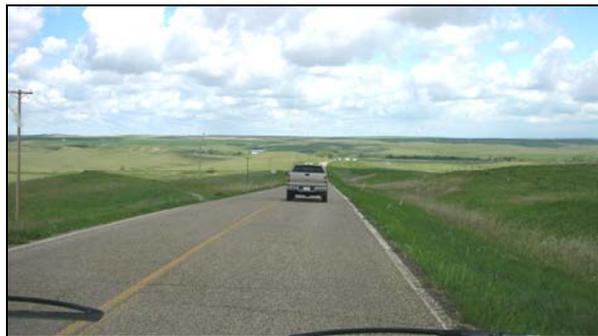
FIGURE A.13 VIEWS OF RSA SITES (STANDING ROCK SIOUX TRIBE RSA)

BIA3 at intersection with ND24 south of Fort Yates, ND

BIA 3 / Hwy 1806 in Kenel, SD

US 12 at Grand River Casino (left), near Mobridge, SD

BIA 44 west of Mahto, SD

Roads studied during this RSA included ND 24 and Highway 1806 (part of BIA 3), US 12, and community access roads. Typical reservation roadways are shown in FIGURE A.13. The RSA team drove these roads to identify safety issues associated with road geometry, traffic operations, and maintenance. Although bridge inspection is not a usual part of the RSA process, the RSA team was asked to observe possible maintenance issues associated with a bridge on BIA 3 at Four-Mile Creek. RSA findings associated with the bridge were included in the RSA report.

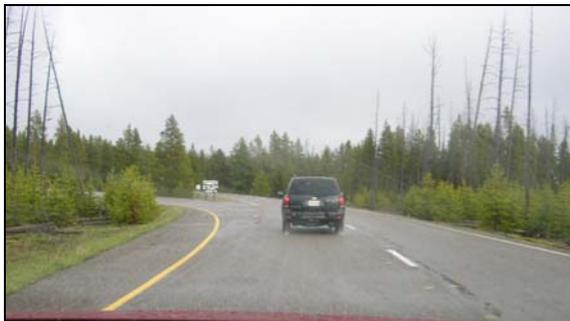
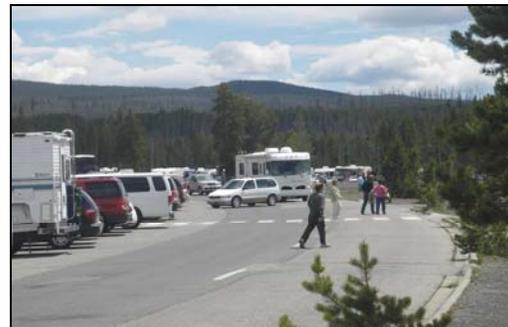
FIGURE A.15 VIEWS OF RSA SITE (YELLOWSTONE NATIONAL PARK)

Old Faithful Road

part of main parking area near Old Faithful geyser

Since construction of the interchange replacement was expected to start no sooner than 2009, about four years after the RSA, the RSA also included a review of existing roads to identify low-cost countermeasures that could be implemented on an interim basis before the start of the planned improvements. The focus of the RSA was the existing Old Faithful Road between the Old Faithful interchange and the geyser site, including the geyser parking area, as shown in FIGURES A.14 and A.15. The key findings and suggestions of the RSA are summarized in TABLE A.12. In its response, the owner undertook to consider the RSA team's observations in the final choice of design options for access to the Old Faithful area, and to incorporate the RSA team's interim suggestions for pedestrian safety into planned improvements to the Old Faithful area.
