# An Evaluation of High-Visibility Crosswalk Treatment - Clearwater, Florida

REPORT NO. FHWA-RD-00-105

August 2000

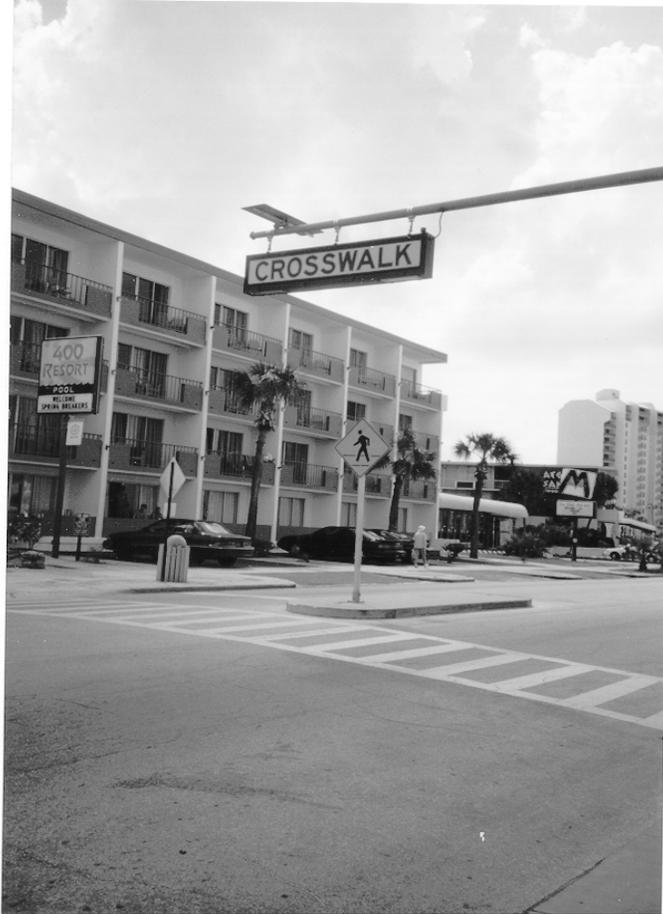
Figure 1. Experimental Site—Daylight, Gulfview Boulevard at 5<sup>th</sup> Street, Looking South.

Pedestrian facilities installed at the south legs of S. Gulfview Boulevard included 2.4-m- (8-ft-) wide, high-visibility ladder crosswalks and pedestrian refuge islands measuring 1.5 m (5 ft). At both sites, the refuge island was perpendicular to the crosswalk markings. Three crossing signs (MUTCD W11A-2) were located on both sides of the roadway and on the refuge islands. In addition, a novel internally illuminated overhead crosswalk sign was suspended directly over the crosswalks in the middle of the intersections. The rectangular signs were bright yellow with bold black letters that said “CROSSWALK.” At night, two large lamps shined onto the crosswalk markings and onto pedestrians crossing the roadway. Sidewalks were installed on both sides of the street. Except for sidewalks there were no pedestrian facilities on the stop controlled north legs of the intersections, and the crossings were unmarked.

Both experimental sites were in the heart of a beach community and resort area where pedestrians traveled to the beach on the Gulf of Mexico. Numerous motels, restaurants, and shops were located on the east side of the street; parking lots and the beach were to the west. Pedestrian and vehicular traffic was nearly continual all day until about midnight. Figure 1 shows the experimental overhead crosswalk sign and crosswalk markings during daylight. Figure 2 shows the illuminated crosswalk sign and downward facing lamps at night.

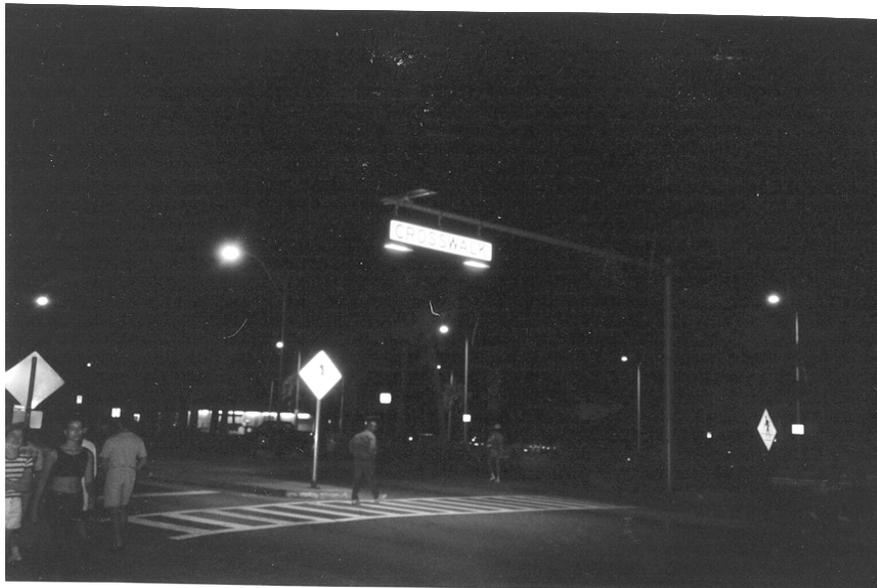
Figure 2. Experimental Site—at Night, Gulfview Boulevard at 3<sup>rd</sup> Street, Looking South.

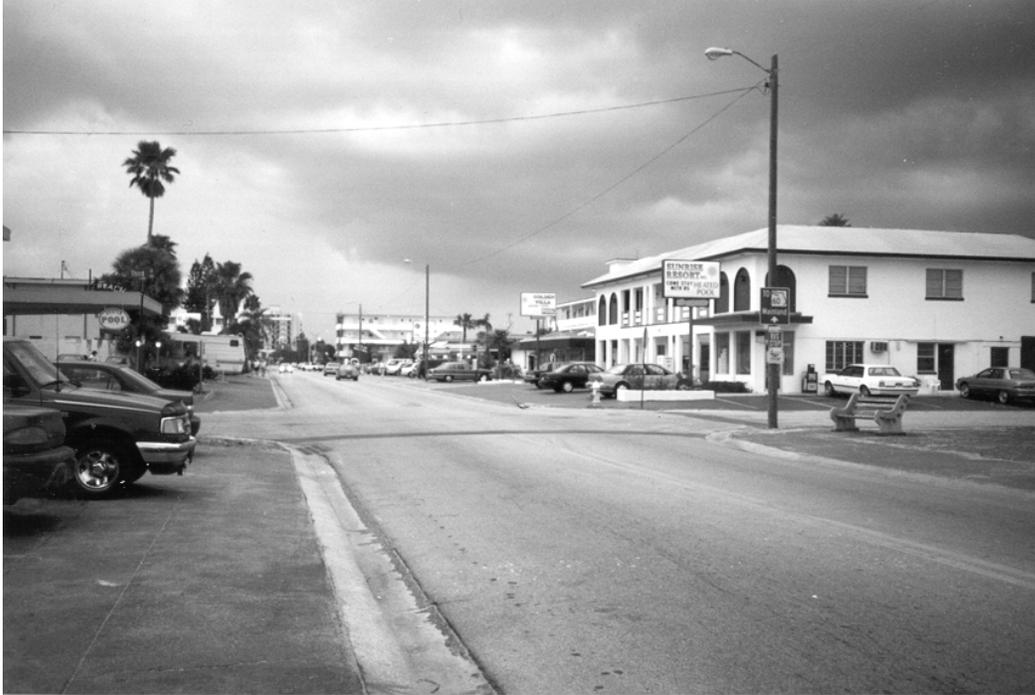
Figure 3. Control Site 2,  
Coronado Drive at 3<sup>rd</sup> Street, Looking South.

The intersection of Coronado Drive and 3<sup>rd</sup> Street was one of two control sites. Site 2 was located one block east of the experimental sites and was a four-leg intersection that was stop-controlled on 3<sup>rd</sup> Street. A pedestrian bench and bus stop were located on the northeast side of the intersection. There were no other pedestrian facilities (except for sidewalks) at this location, and the crosswalks were unmarked.

Coronado Drive was a north/south arterial through street with one lane in each direction, no turn lanes, no refuge island, and a posted speed limit of 40 km/h (25 mi/h). The stop-controlled cross street, 3<sup>rd</sup> Street, was a two-way road with one lane in each direction. Parking was not permitted on any of the four legs of the intersection. Numerous motels and restaurants and some private cottages were located nearby. Pedestrian and vehicular traffic was nearly continual all day until midnight and was beach and vacation oriented. Control Site 2 is shown in Figure 3.

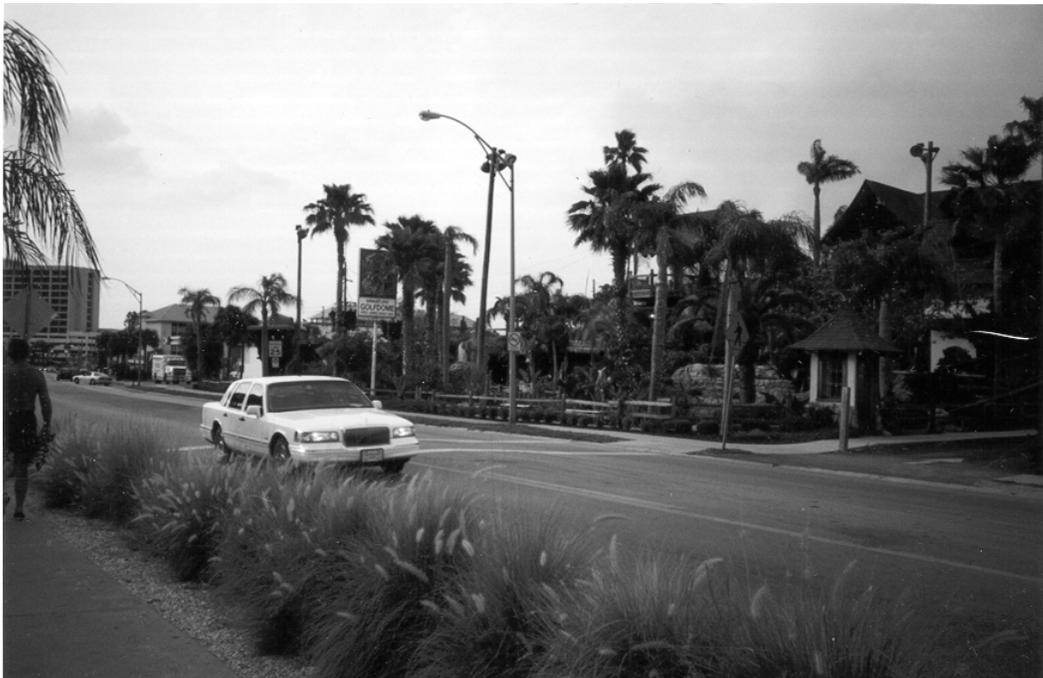
Figure 4. Control Site 4,  
Mid-Block S. Gulfview Boulevard, Looking North.

The other control site was a mid-block marked crosswalk location on S. Gulfview Boulevard about 0.8 km (0.5 mi) south of experimental Site 1. Gulfview Boulevard was a major arterial with one southbound through lane and one southbound lane turning into a miniature golf course parking lot. There was neither a raised median nor a refuge island. There was one northbound through lane and the speed limit was 40 km/h (25 mi/h). There were sidewalks on both sides of the street, and the crosswalk was marked with standard parallel lines. Curb cuts were provided at both sides of the crossing. There were two crosswalk signs (MUTCD W11A), one facing each direction posted at the marked crosswalk, as well as advance warning signs (MUTCD W11s) upstream from the crosswalk.
