Minnesota Roundabout

A Scott County Success Story

FHWA-SA-09-013

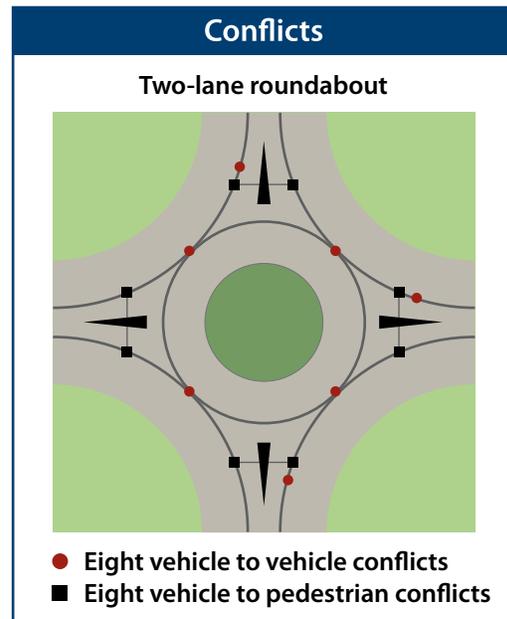
Figure 2: Eight vehicle conflict points
Source: FHWA *Roundabouts: An Informational Guide*

Roundabouts are circular intersections with specific design and traffic control features. These features include yield control of all entering traffic, channelized approaches, and appropriate geometric curvature to ensure that travel speeds on the circulatory roadway are typically less than 30 miles per hour (mph). Also, traffic movement is possible only in a counter-clockwise direction within the roundabout. Federal Highway Administration's (FHWA) *Roundabouts: An Informational Guide* provides more information on the defining characteristics and definitions for each of the key features of a roundabout (see Figures 2 and 3)[5].

Roundabout intersections eliminate a number of vehicle conflict points typically associated with traditional intersections. A four-legged, single-lane roundabout has 75 percent fewer vehicle conflict points than a traditional stop-controlled intersection[5]. Roundabouts also enhance safety by reducing vehicle speeds both in and through the intersection.

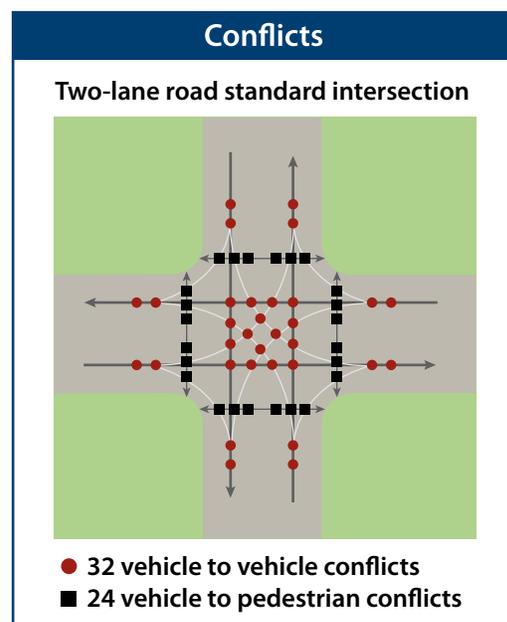
Figure 3: 32 vehicle conflict points
Source: FHWA *Roundabouts: An Informational Guide*

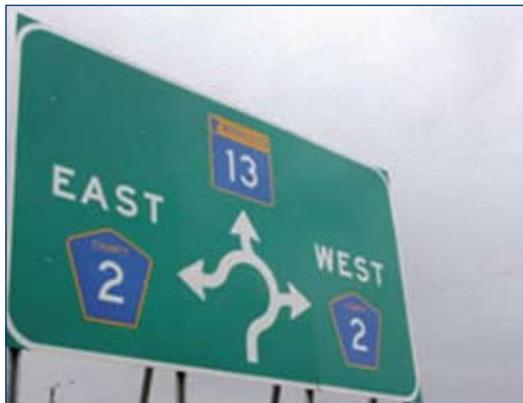
Figure 4: Sign on the approach to the roundabout

Scott County experienced no implementation issues with the roundabout. Because of the rural environment in which the roundabout was located, the design of the curb and apron were modified to allow wide farm vehicles and large snow removal vehicles to effectively maneuver through the roundabout. In addition, the roundabout design incorporated additional signage (as shown in Figure 4), extended medians and curbs, and a raised center mound to visually convey to drivers the need to slow down and navigate the turn.

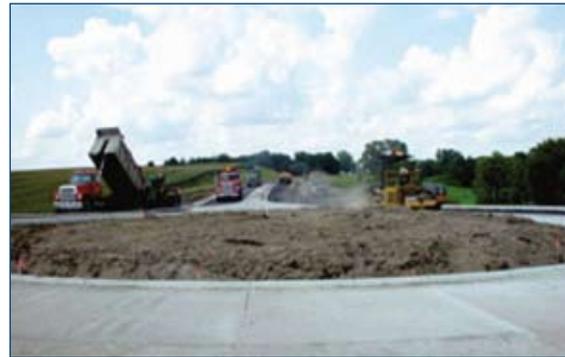
Figure 5: Construction of the roundabout

The construction of the roundabout took place in 2005 and lasted 90 days. During this time, both State Highway 13 and Scott County Road 2 were closed at the intersection, and motorists were advised to follow the posted detour routes during the closure. Figure 5 shows the construction techniques during construction.
