Accelerating Roundabout Implementation in the United States - Volume VII of VII

Human Factor Assessment of Traffic Control Device Effectiveness

PUBLICATION NO. FHWA-SA-15-075

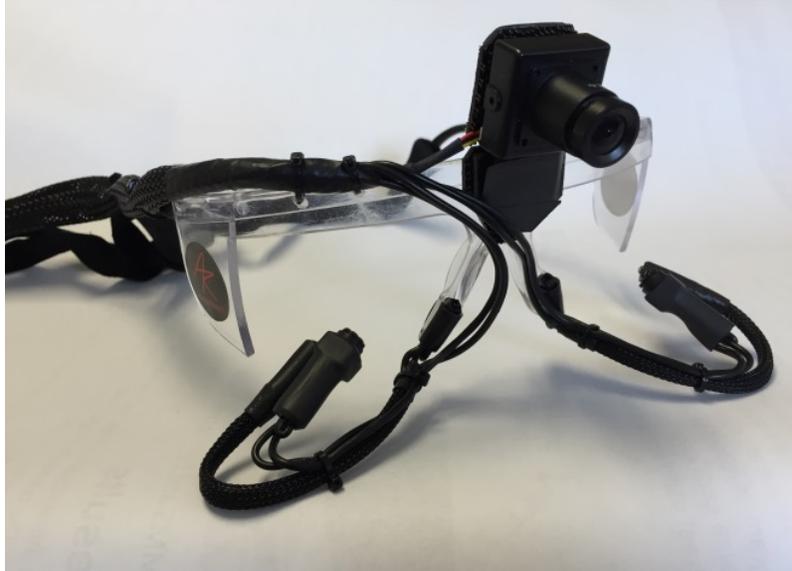
Figure 1. Photo. ViewPoint eye tracker goggles.

The study used a ViewPoint eye tracker, a head-mounted system that uses infrared lights and cameras mounted on a plastic frame to track the movement of the wearer's eyes (Figure 1). The eye tracker also includes a forward-facing color camera to record the scene in front of the wearer. After calibration, the eye tracker provides a video recording of the scene with the wearer's gaze point overlaid on the photo, as well as the XY coordinates of the gaze point and fixation times, among other variables. A screenshot is shown in Figure 2.

The frames are connected to a laptop with a cable that runs behind the wearer's right ear. This cable is clipped to the wearer's shirt to prevent pulling on the frames, and allows unrestricted movement of the wearer's head. The system calculates eye movement with an accuracy of between 0.25 and 1 degrees of visual arc, and a spatial resolution of approximately 0.15 degrees of visual arc.

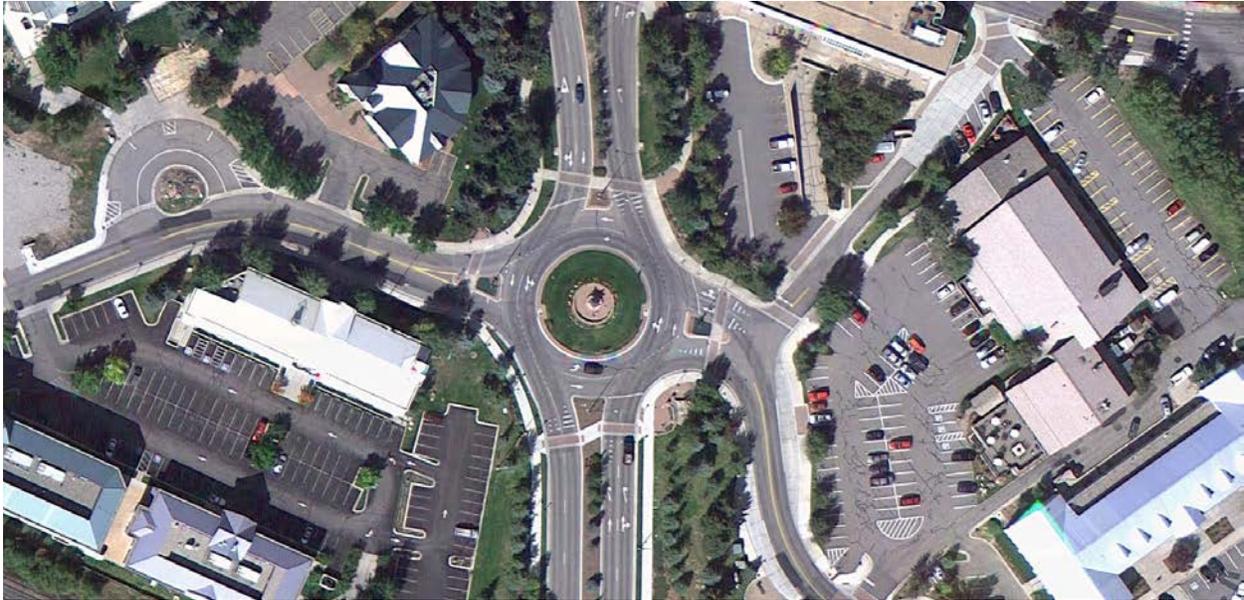
This roundabout, completed in 1997, is illustrated in figure 20. Observed volumes and erratic maneuvers are provided in table 8.

Figure 20. Photo. Avon Rd./Benchmark Rd., Avon, CO (Source: Google Maps 2015)

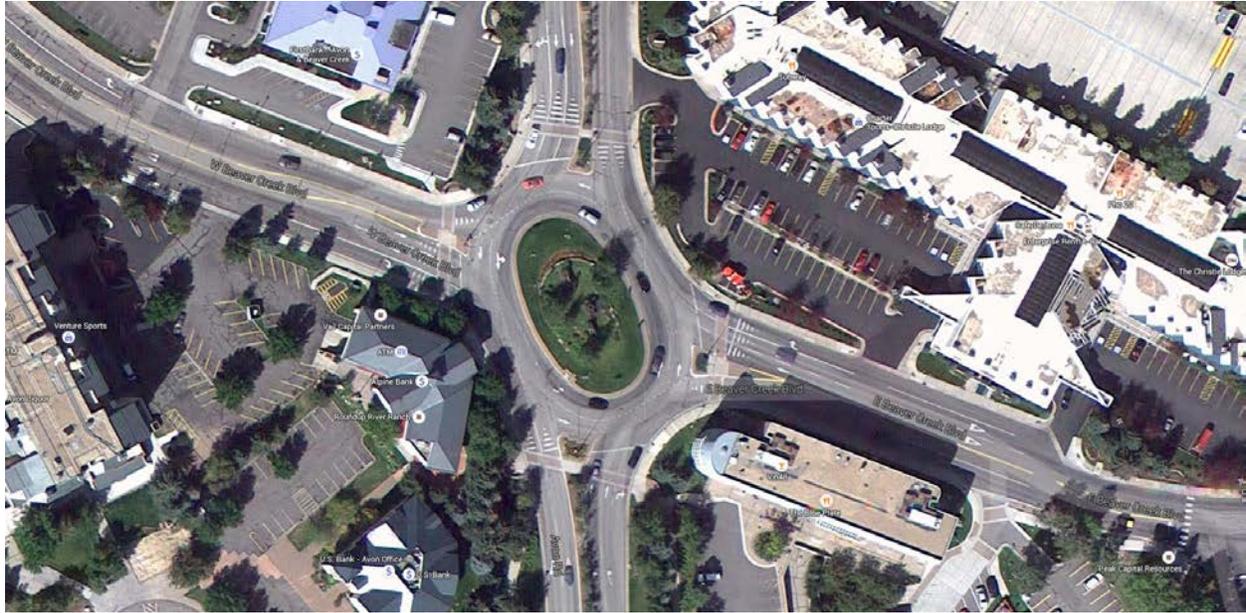
This roundabout, completed in 1997, is illustrated in figure 21. Observed volumes and erratic maneuvers are provided in table 9.

Figure 21. Photo. Avon Rd./Beaver Creek Blvd., Avon, CO (Source: Google Maps 2015)

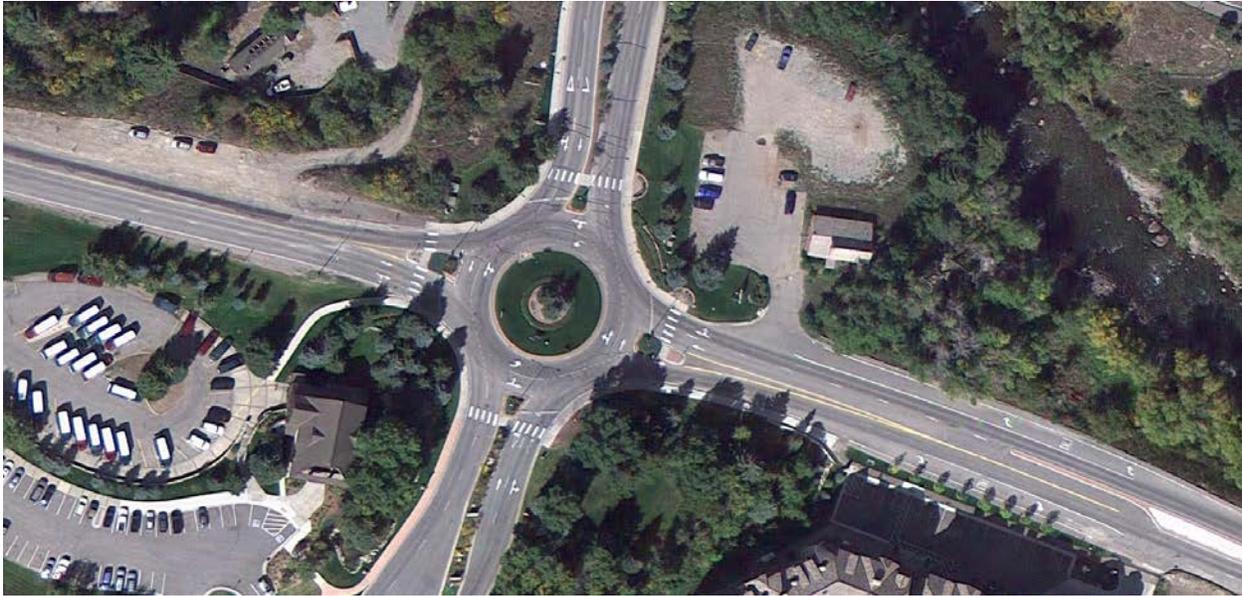
This roundabout, completed in 1997, is illustrated in figure 22. Observed volumes and erratic maneuvers are provided in table 10.

Figure 22. Photo. Avon Rd./US 6, Avon, CO (Source: Google Maps 2015)

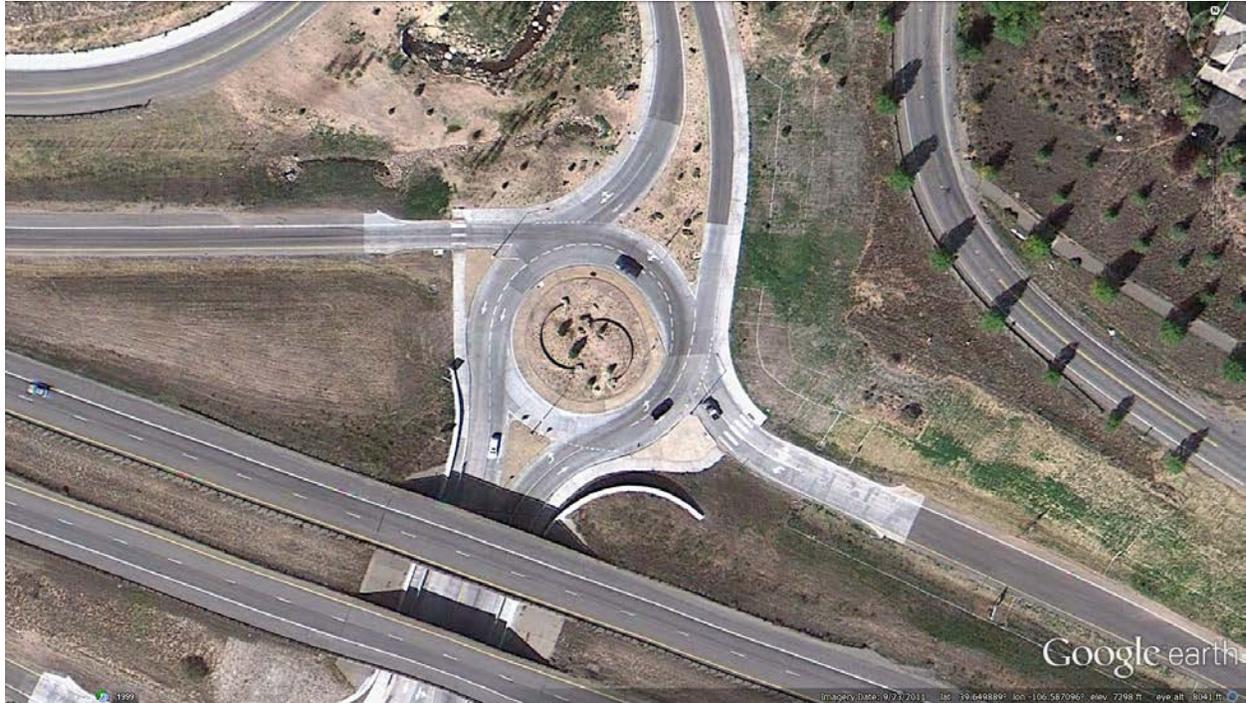
This roundabout, completed in 2010, is illustrated in figure 23. Observed volumes and erratic maneuvers are provided in table 11.

**Figure 23. Photo. Edwards Access Rd./Beard Creek Rd./I-70 WB Ramps, Edwards, CO
(Source: Google Earth 2011)**

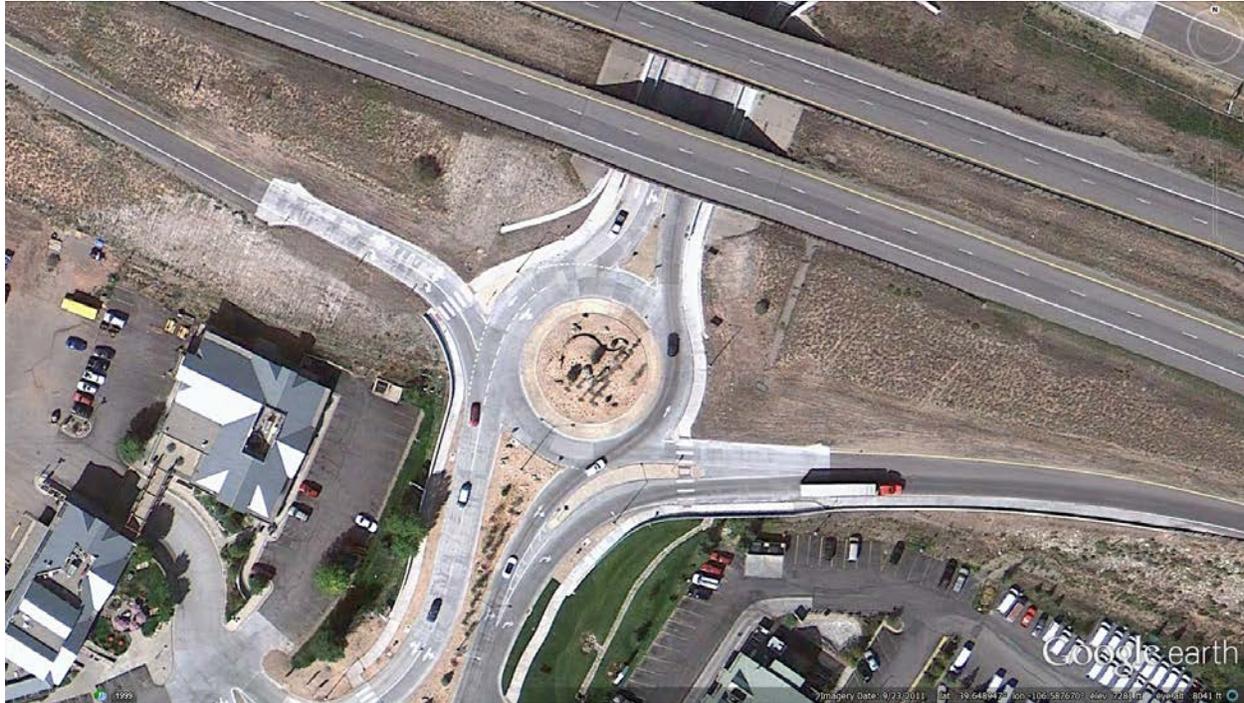
This roundabout, completed in 2010, is illustrated in figure 24. Observed volumes and erratic maneuvers are provided in table 12.

Figure 24. Photo. Edwards Access Rd./I-70 EB Ramps, Edwards, CO (Source: Google Earth 2011)

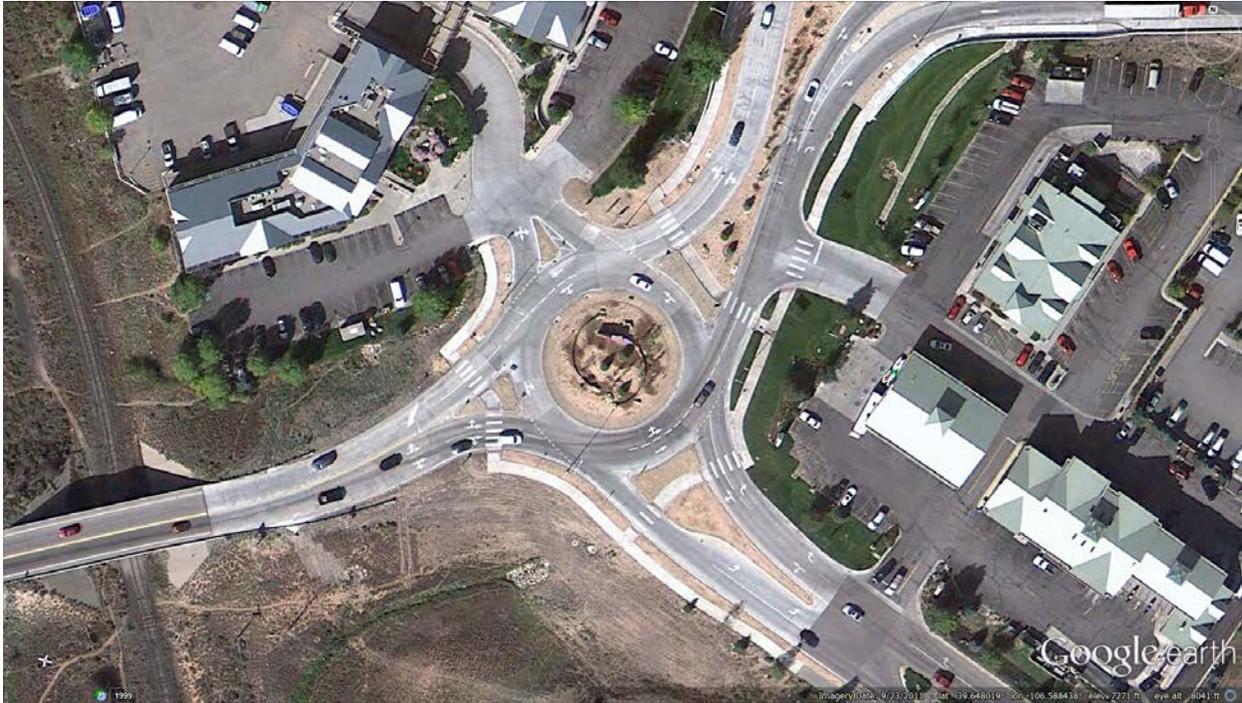
This roundabout, completed in 2010, is illustrated in figure 25. Observed volumes and erratic maneuvers are provided in table 13.

Figure 25. Photo. Edwards Access Rd./Miller Ranch Rd., Edwards, CO (Source: Google Earth 2011)

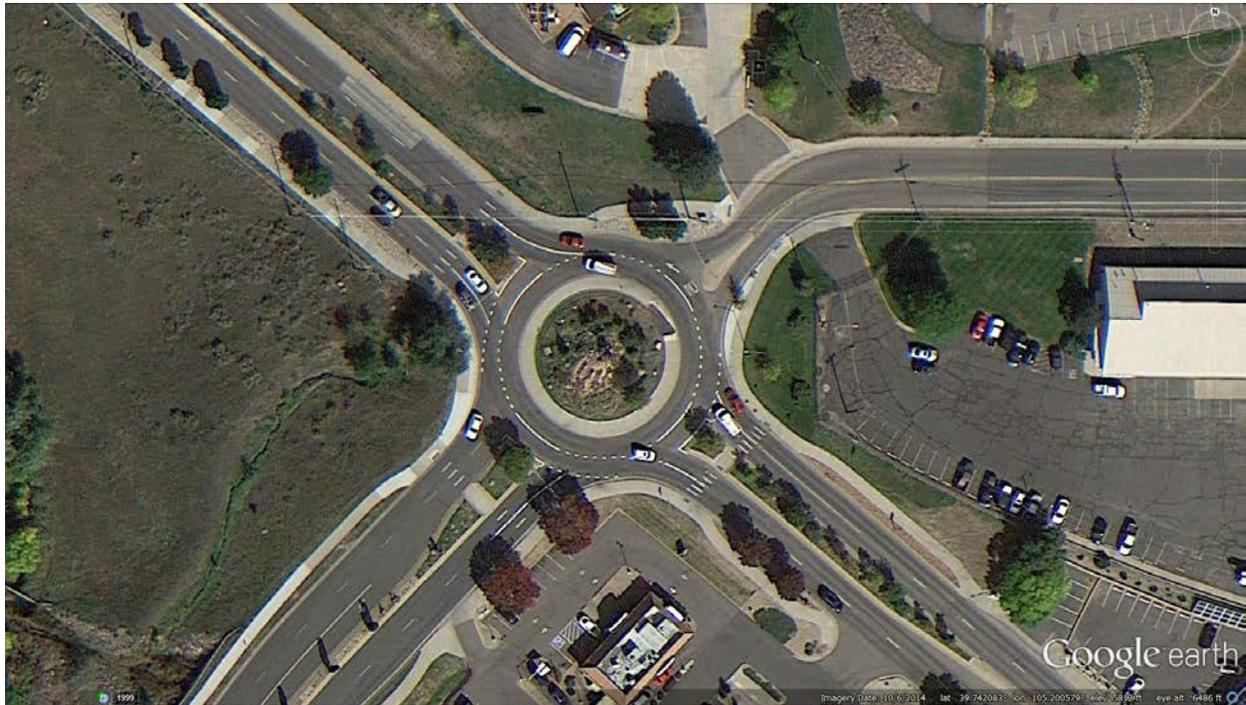
This roundabout, completed in 1998, is illustrated in figure 26. Observed volumes and erratic maneuvers are provided in table 14.

Figure 26. Photo. S. Golden Rd./Johnson St./16th Ave., Golden, CO (Source: Google Earth 2014)

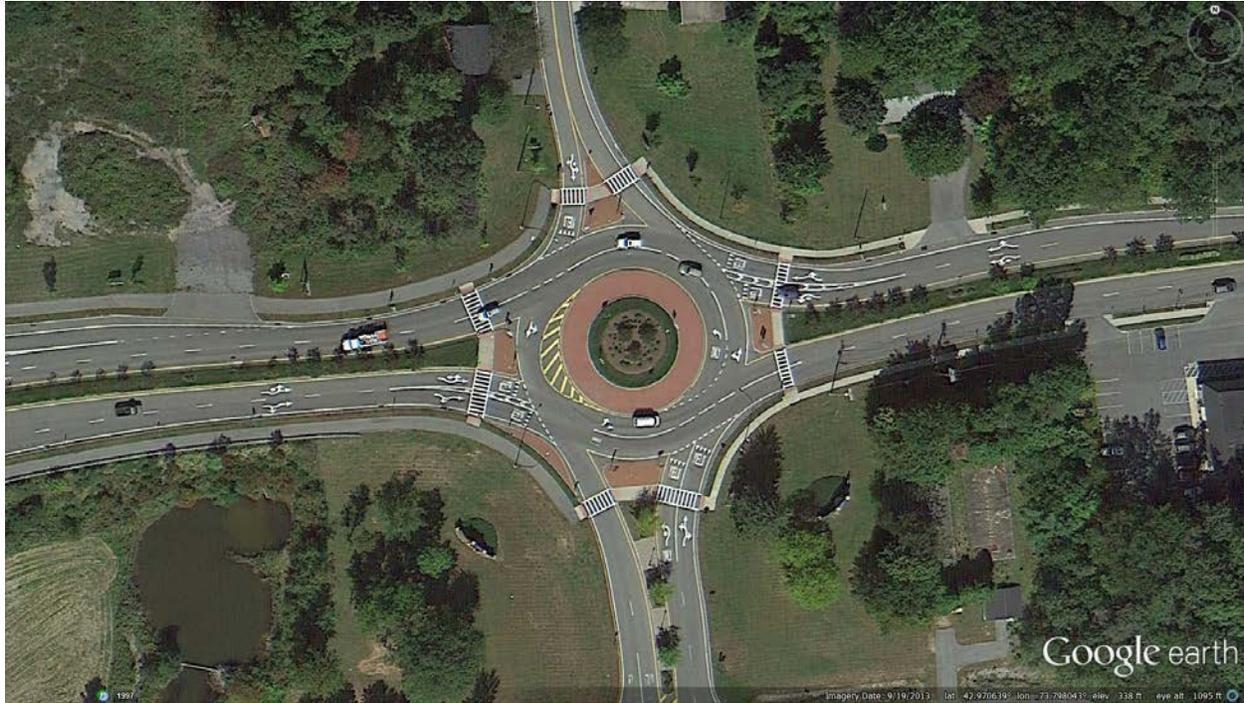
This roundabout, completed in 2006, is illustrated in figure 29. Observed volumes and erratic maneuvers are provided in table 17.

Figure 29. Photo. SR 67/Blacksmith Dr./Kelch Dr., Malta, NY (Source: Google Earth 2013)

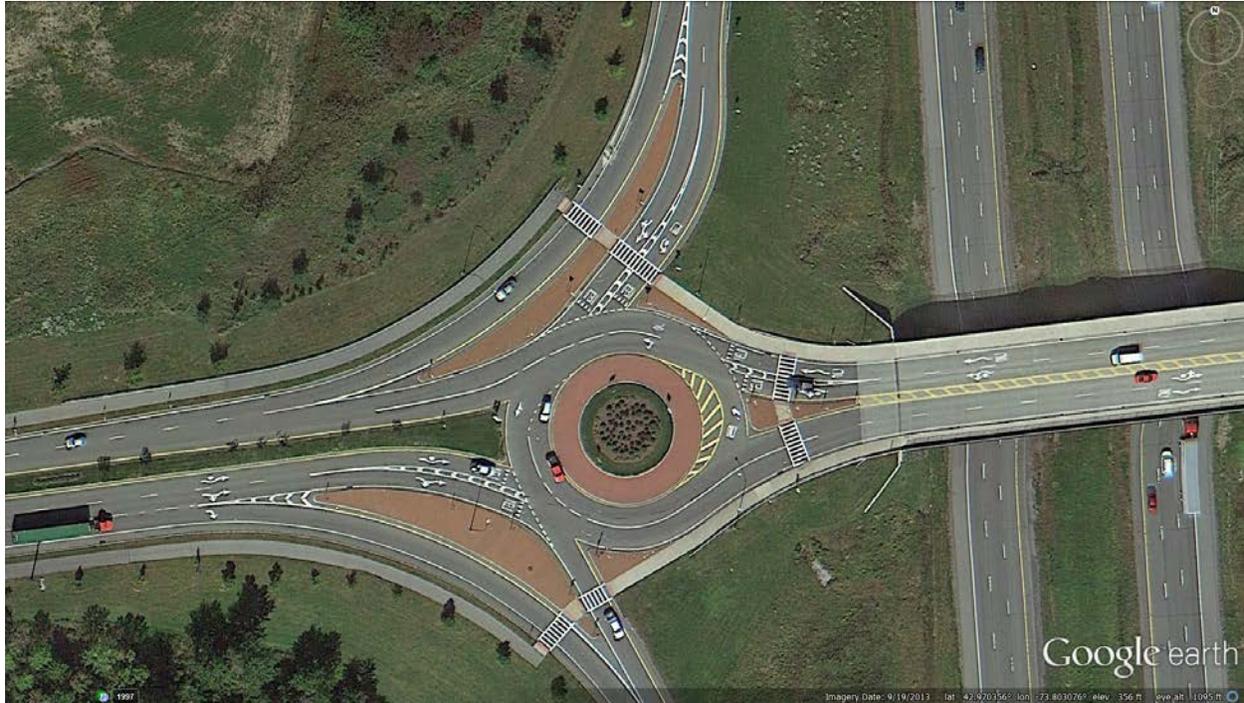
This roundabout, completed in 2006, is illustrated in figure 30. Observed volumes and erratic maneuvers are provided in table 18.

Figure 30. Photo. SR 67/I-87 SB Ramps, Malta, NY (Source: Google Earth 2013)

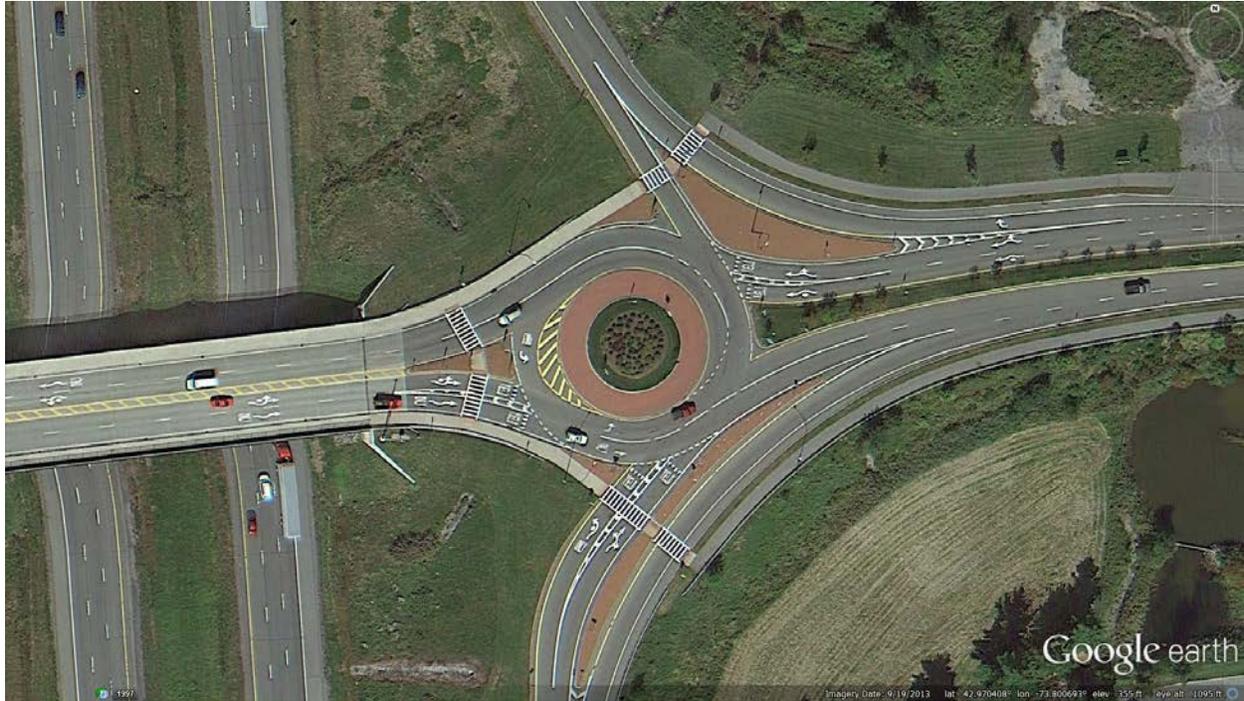
This roundabout, completed in 2006, is illustrated in figure 31. Observed volumes and erratic maneuvers are provided in table 19.

Figure 31. Photo. SR 67/I-87 NB Ramps, Malta, NY (Source: Google Earth 2013)

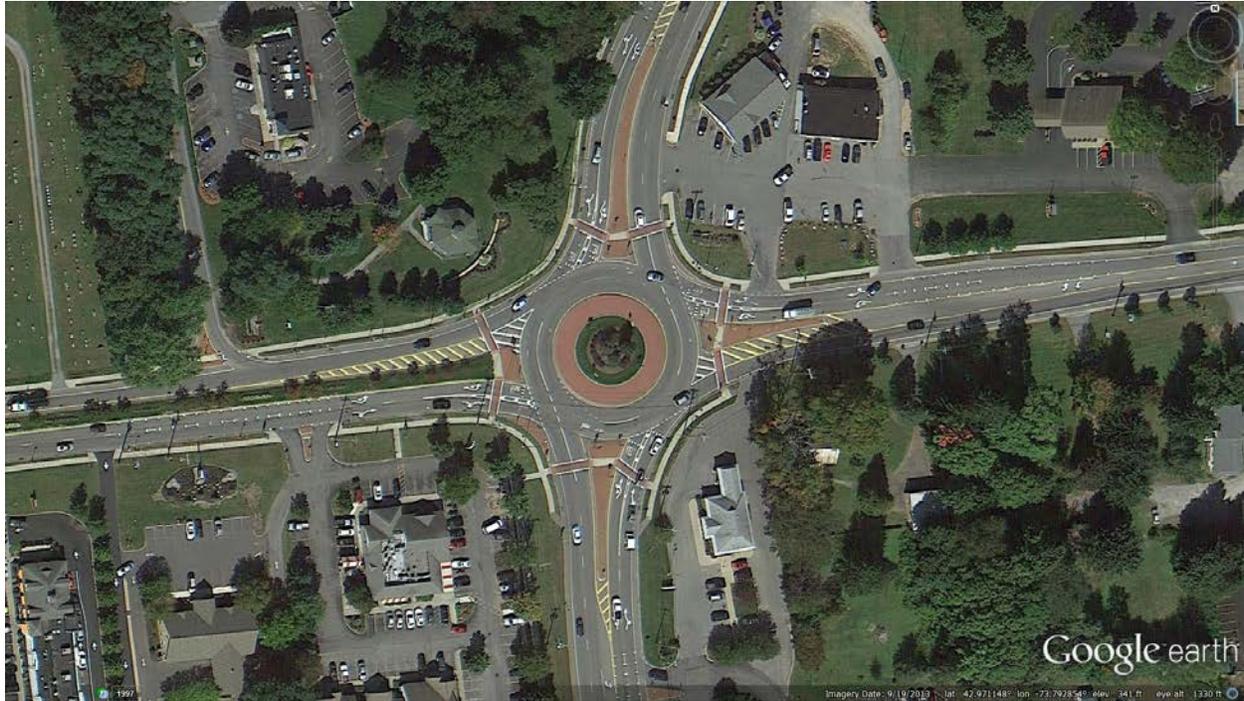
This roundabout, completed in 2006, is illustrated in figure 32. Observed volumes and erratic maneuvers are provided in table 20.

Figure 32. Photo. SR 67/US 9, Malta, NY (Source: Google Earth 2013)

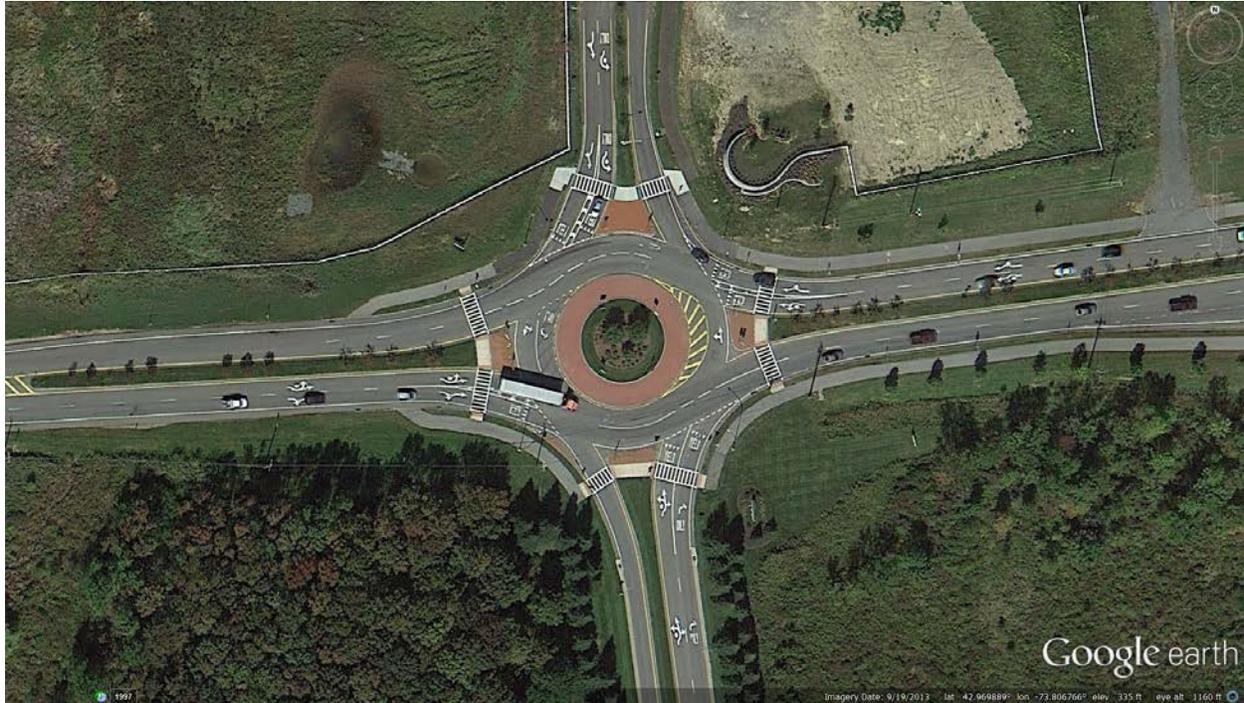
This roundabout, completed in 2006, is illustrated in figure 33. Observed volumes and erratic maneuvers are provided in table 21.

Figure 33. Photo. SR 67/State Farm Blvd., Malta, NY (Source: Google Earth 2013)

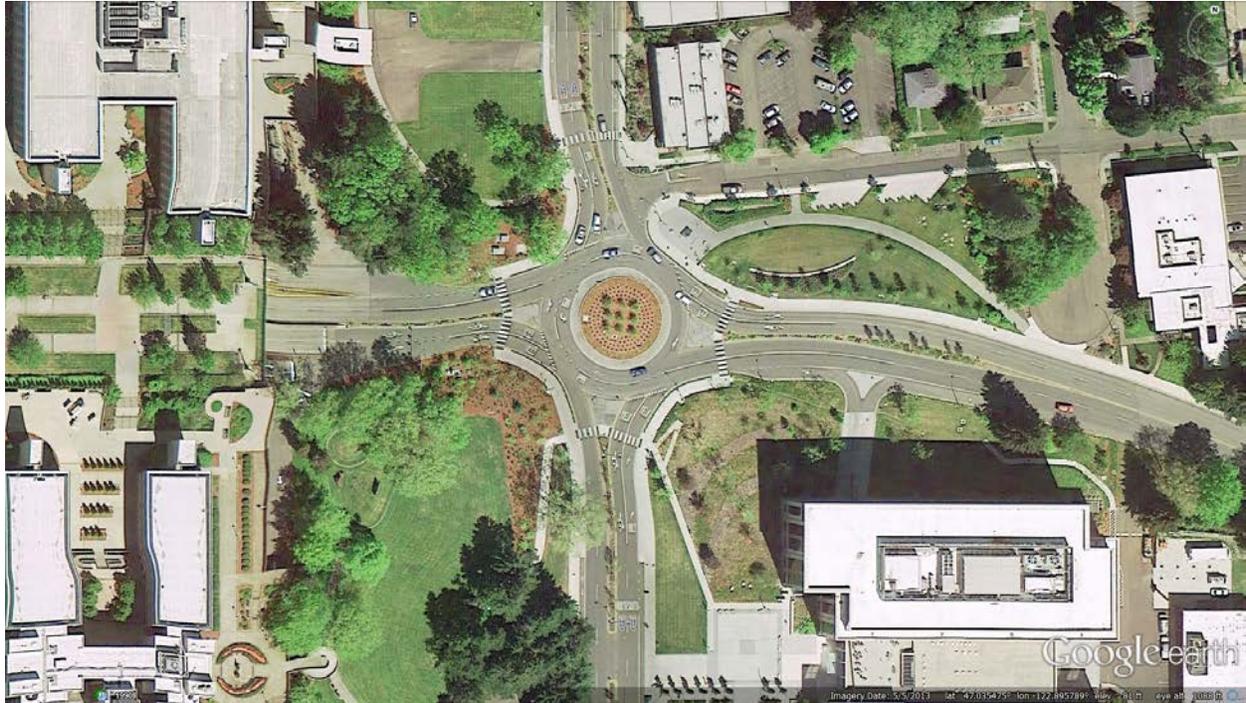
This roundabout, completed in 2010, is illustrated in figure 34. Observed volumes and erratic maneuvers are provided in table 22.

Figure 34. Photo. 14th Ave./Jefferson St., Olympia, WA (Source: Google Earth 2013)

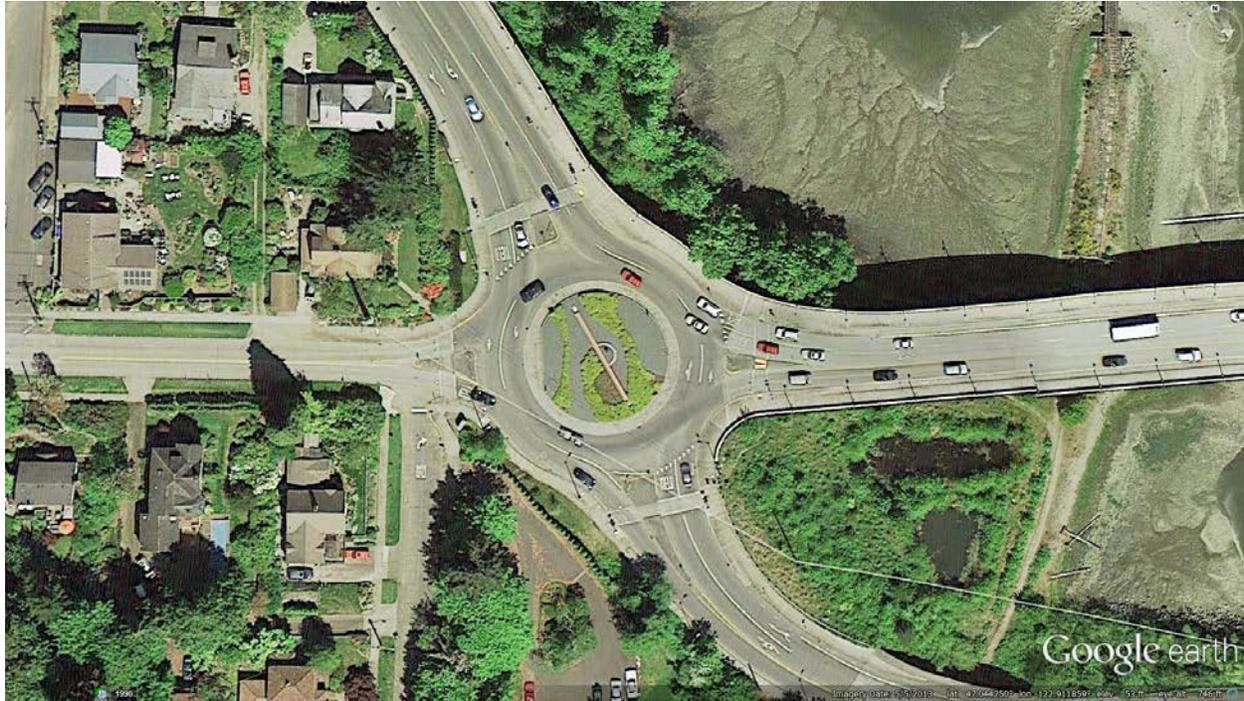
This roundabout, completed in 2004, is illustrated in figure 35. Observed volumes and erratic maneuvers are provided in table 23.

Figure 35. Photo. 4th Ave./Olympic Way, Olympia, WA (Source: Google Earth 2013)

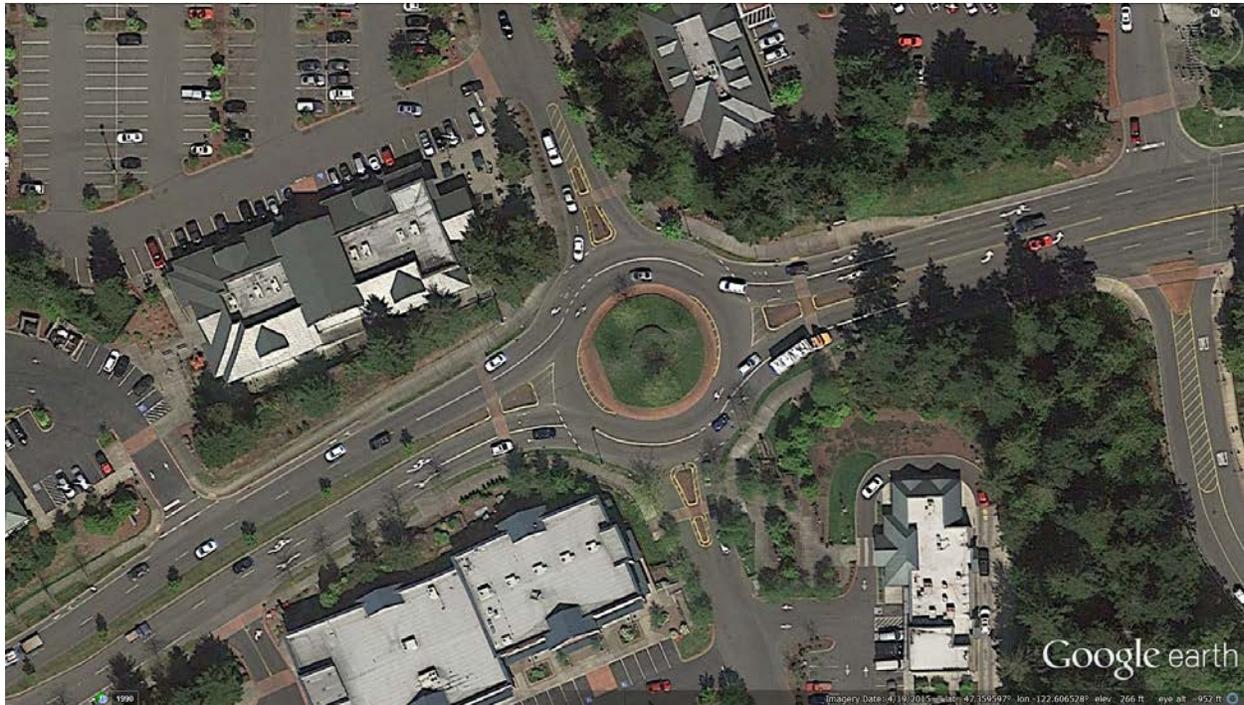
This roundabout, completed in 2002, is illustrated in figure 36. Observed volumes and erratic maneuvers are provided in table 24.

Figure 36. Photo. Borgen Blvd./51st Ave. NW, Gig Harbor, WA (Source: Google Earth 2015)

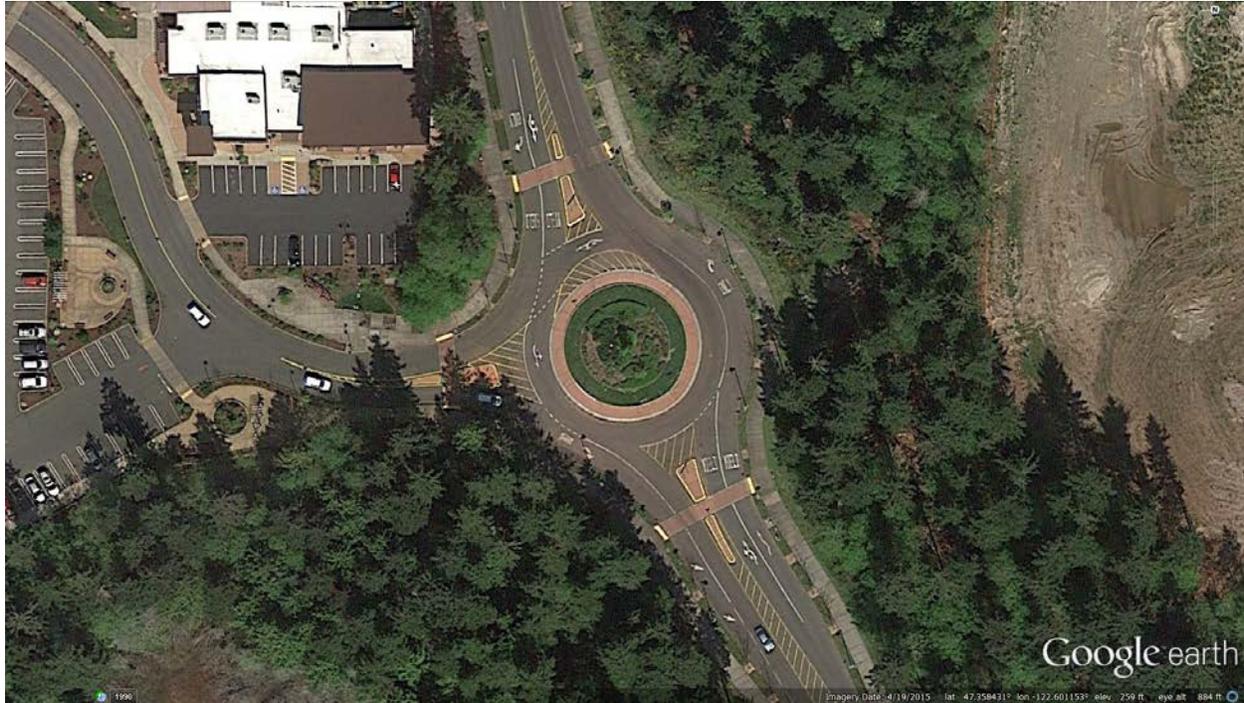
This roundabout, completed in 2008, is illustrated in figure 37. Observed volumes and erratic maneuvers are provided in table 25.

Figure 37. Photo. Harbor Hill Dr./Development Entrance, Gig Harbor, WA (Source: Google Earth 2015)

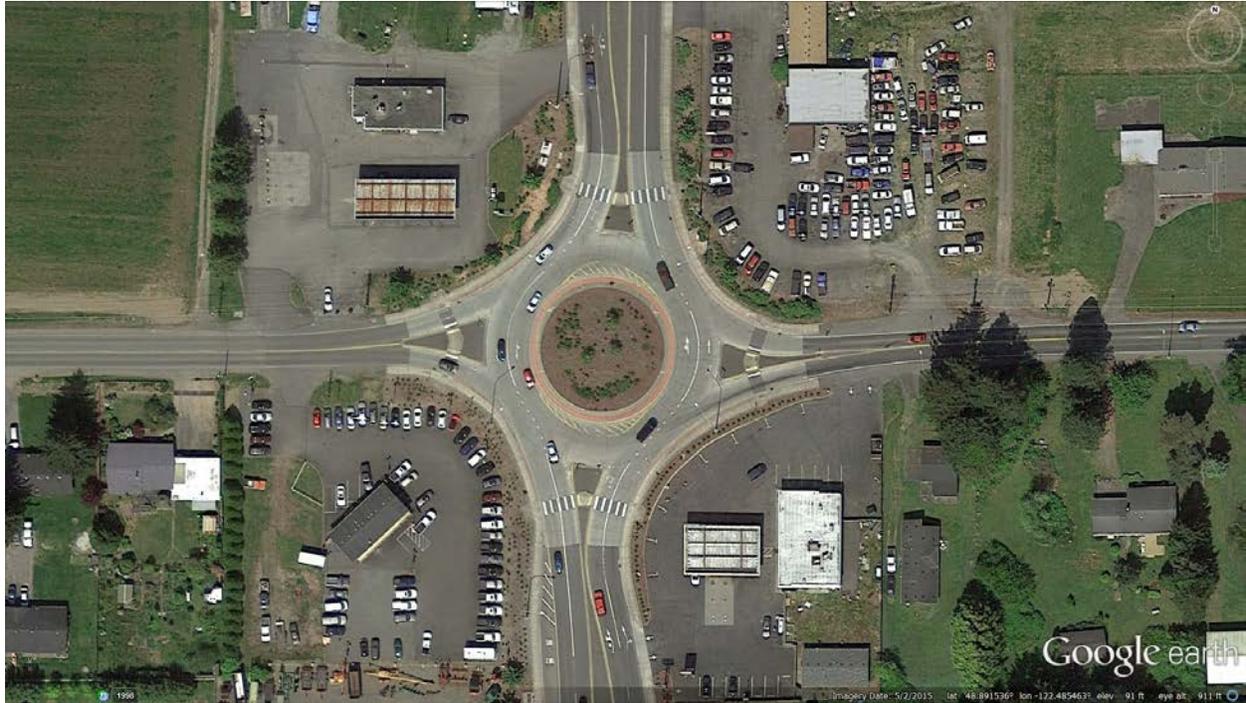
This roundabout, completed in 2009, is illustrated in figure 38. Observed volumes and erratic maneuvers are provided in table 26.

Figure 38. Photo. SR 539/Pole Rd., Lynden (Whatcom County), WA (Source: Google Earth 2015)

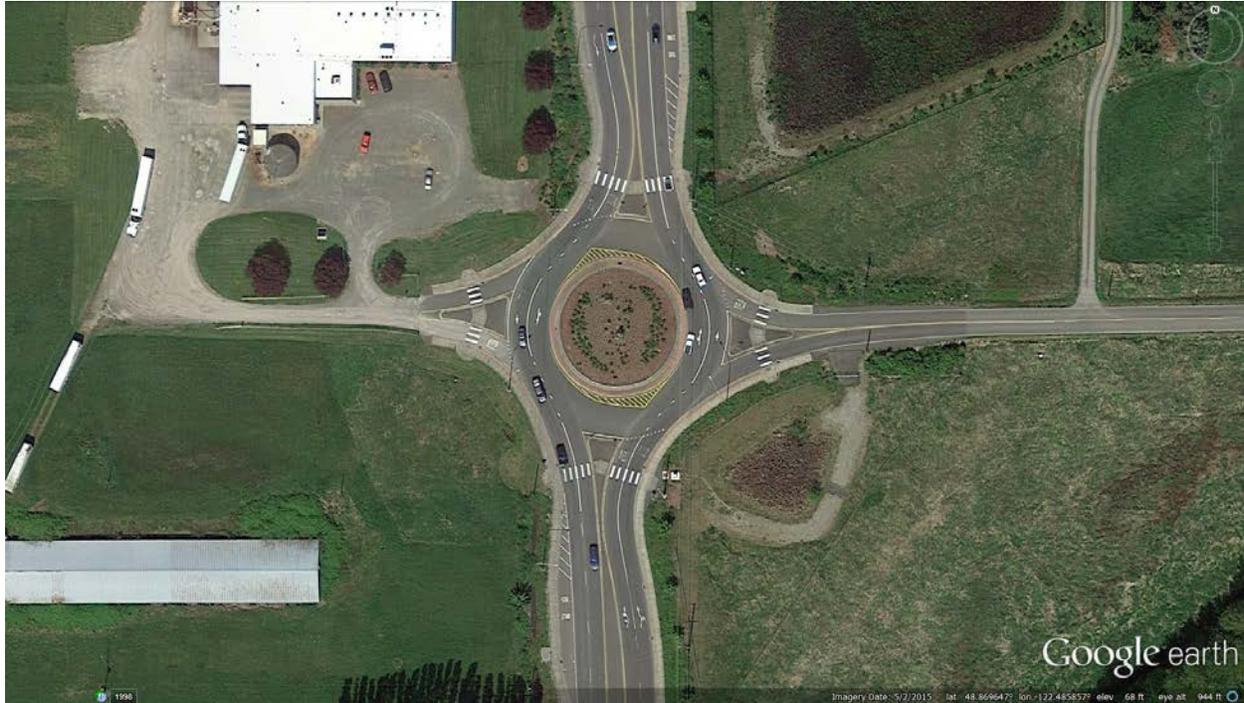
This roundabout, completed in 2009, is illustrated in figure 39. Observed volumes and erratic maneuvers are provided in table 27.

Figure 39. Photo. SR 539/Ten Mile Rd., Lynden (Whatcom County), WA (Source: Google Earth 2015)

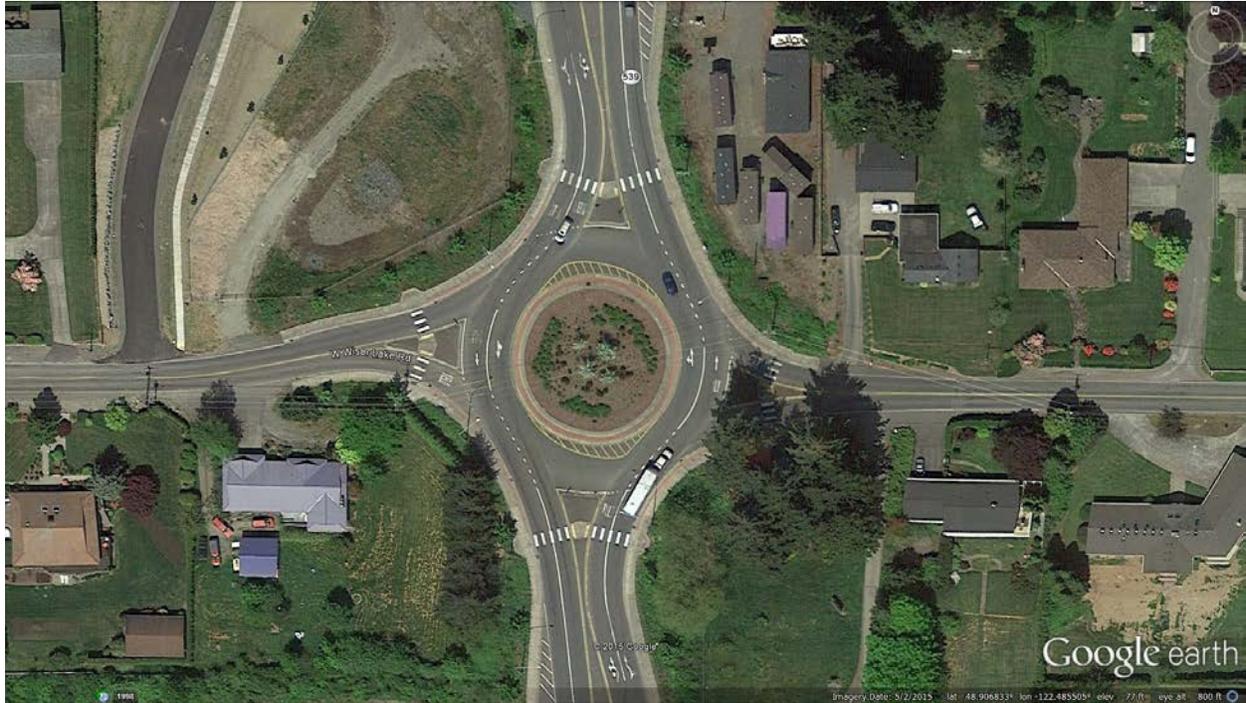
This roundabout, completed in 2009, is illustrated in figure 40. Observed volumes and erratic maneuvers are provided in table 28.

Figure 40. Photo. SR 539/Wiser Lake Rd., Lynden (Whatcom County), WA (Source: Google Earth 2015)

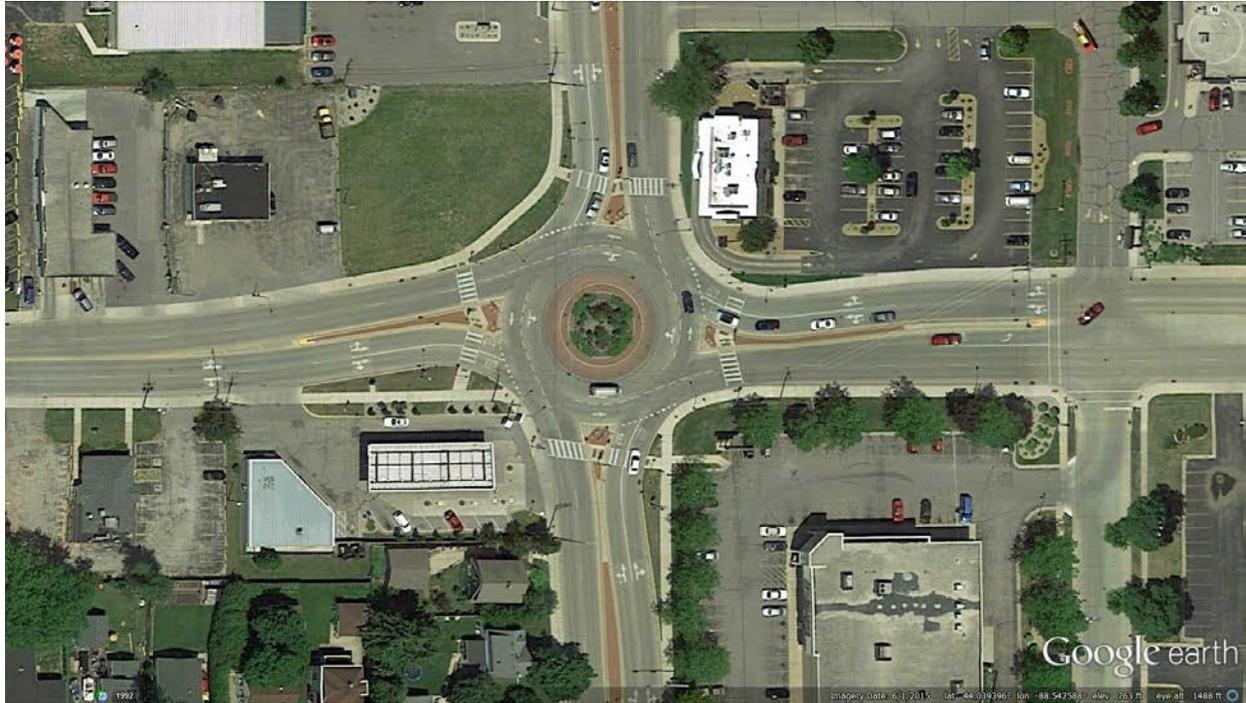
This roundabout, completed in 2010, is illustrated in figure 41. Observed volumes and erratic maneuvers are provided in table 29.

Figure 41. Photo. Jackson St./Murdock Ave., Oshkosh, WI (Source: Google Earth 2015)

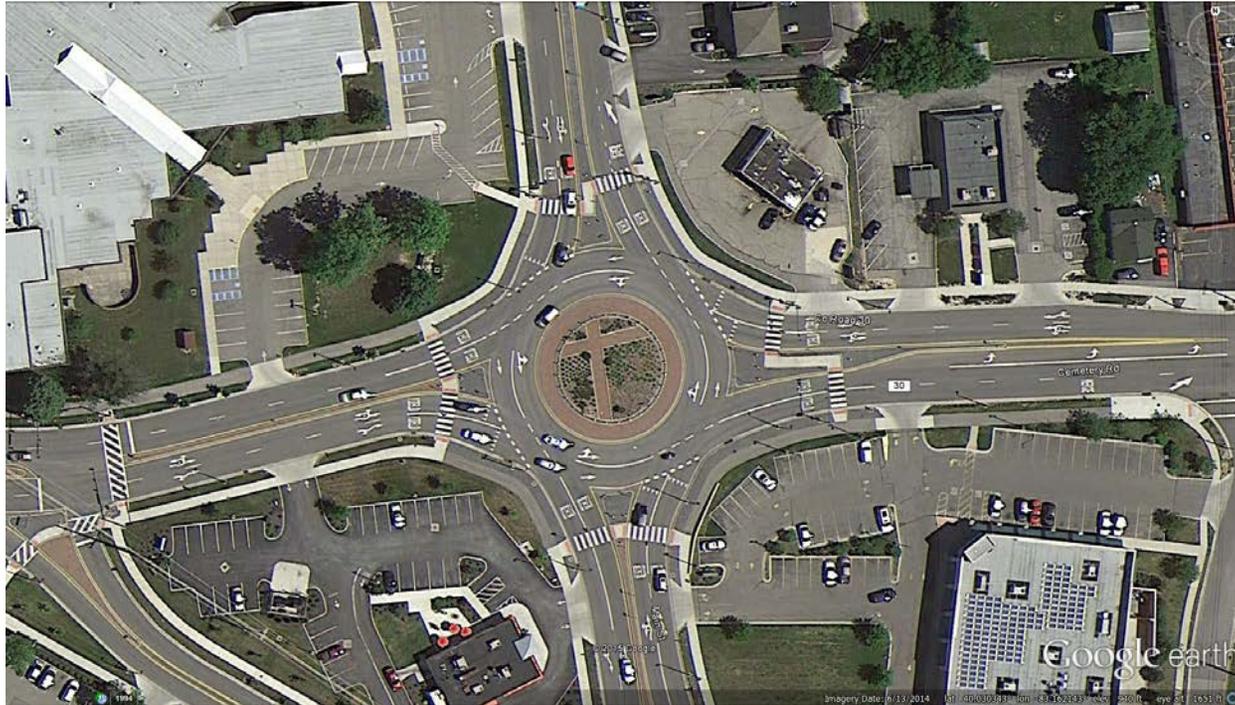
This roundabout, completed in 2009, is illustrated in figure 42. Observed volumes and erratic maneuvers are provided in table 30.

Figure 42. Photo. Main St./Cemetery Rd., Hilliard, OH (Source: Google Earth 2014)

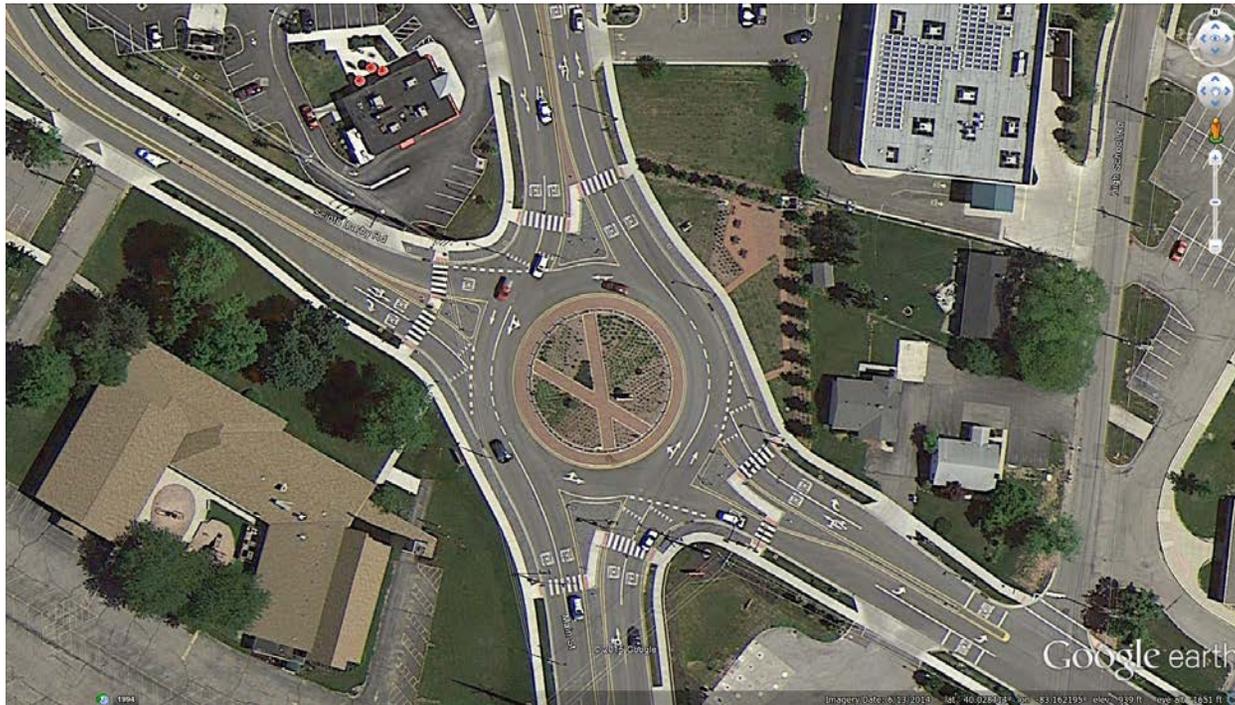
This roundabout, completed in 2009, is illustrated in figure 43. Observed volumes and erratic maneuvers are provided in table 31.

Figure 43. Photo. Main St./Scioto Darby Rd., Hilliard, OH (Source: Google Earth 2014)

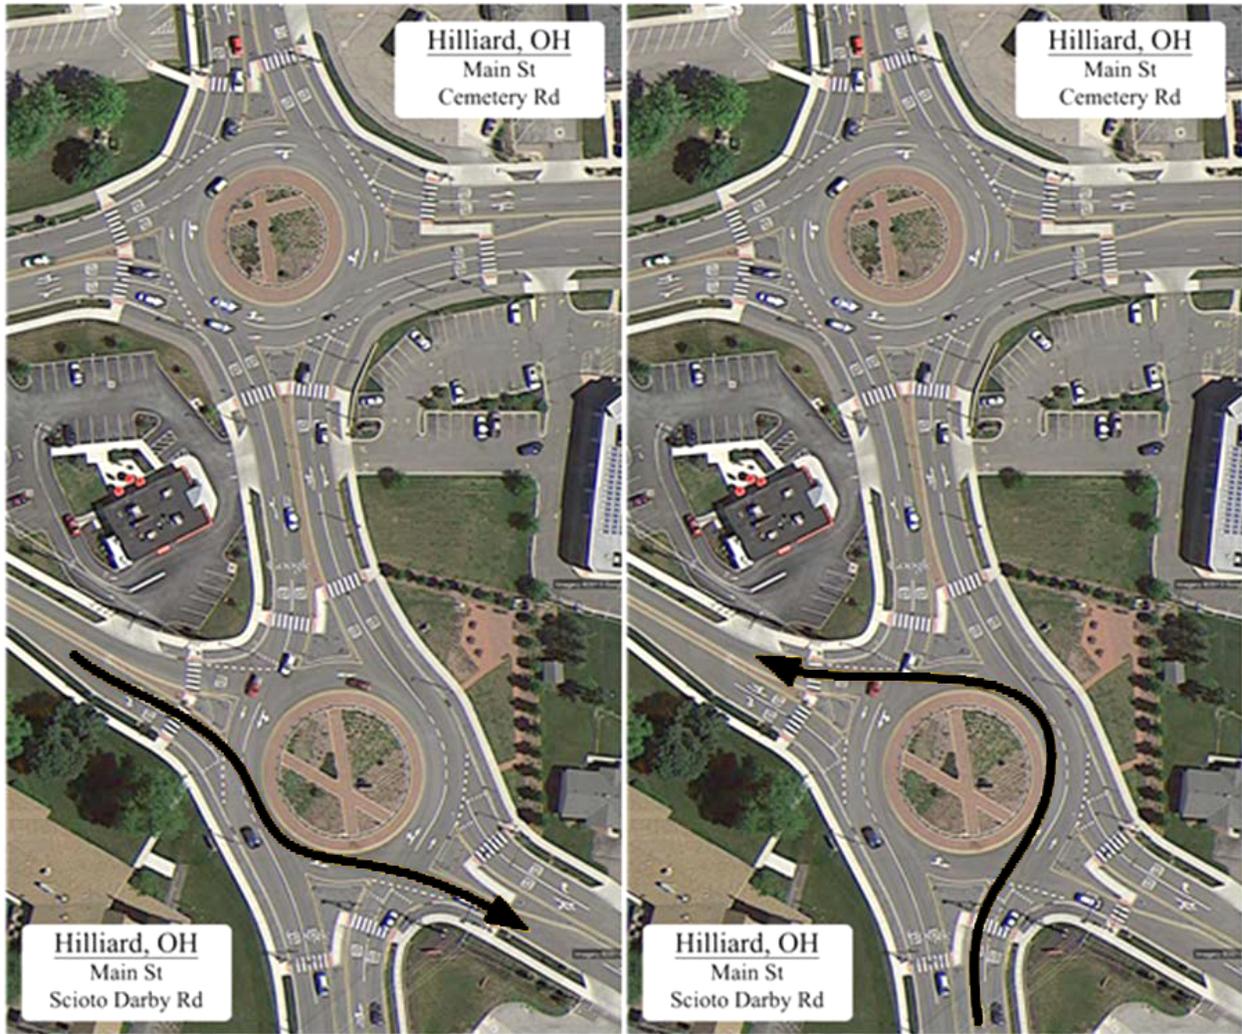
The maneuvers performed by the participant drivers at each of the roundabouts in Hilliard, OH, are shown in figure 51, figure 52, figure 53, figure 54, figure 55, and figure 56.

Figure 55. Diagrams. Hilliard OH roundabout - Main St. and Scioto Darby St.
