Accelerating Roundabout Implementation in the United States - Volume VII of VII

Human Factor Assessment of Traffic Control Device Effectiveness

PUBLICATION NO. FHWA-SA-15-075

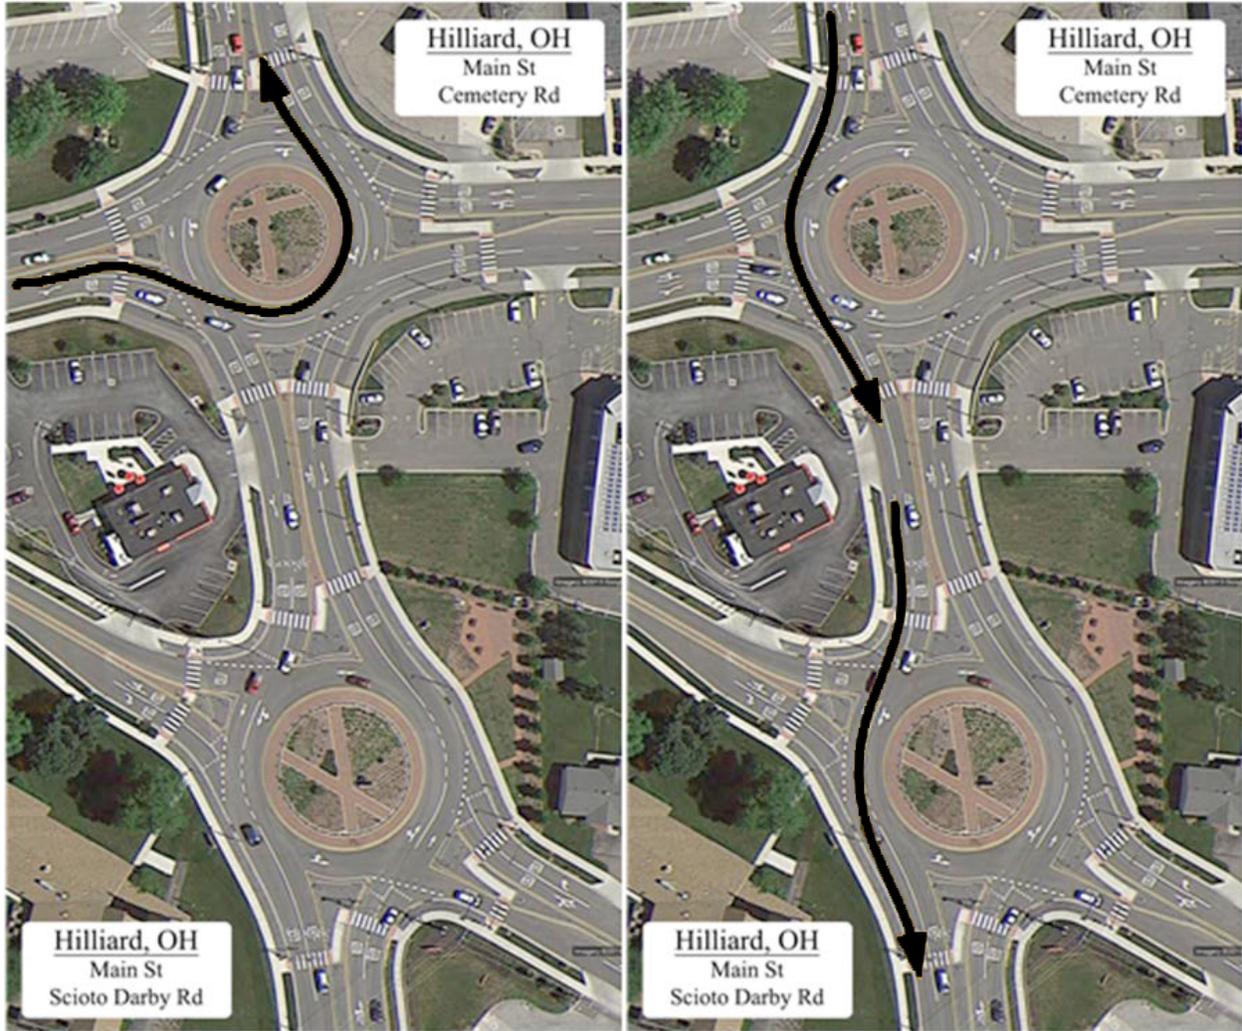
The maneuvers performed by the participant drivers at each of the roundabouts in Hilliard, OH, are shown in figure 51, figure 52, figure 53, figure 54, figure 55, and figure 56.

Figure 56. Diagrams. Hilliard OH roundabout - Main St. and Cemetery Rd.

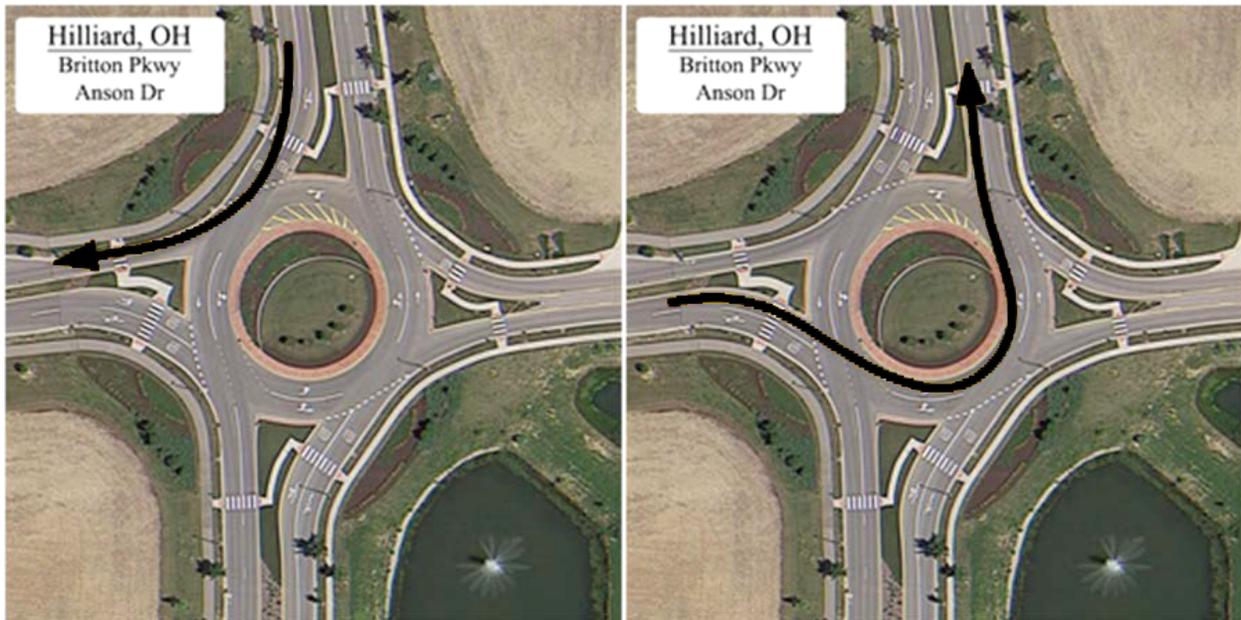
Figure 59. Diagrams. Hilliard, OH roundabout – Britton Pkwy and Anson Dr.

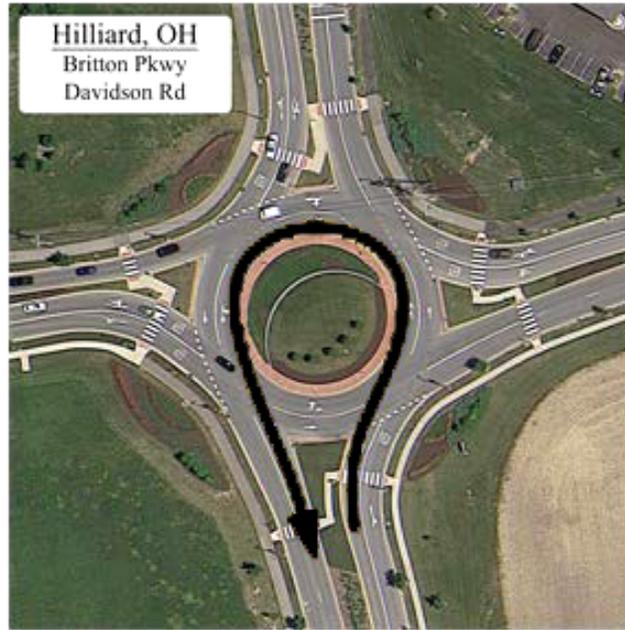
Figure 60. Diagram. Hilliard, OH roundabout – Britton Pkwy and Davidson Rd.

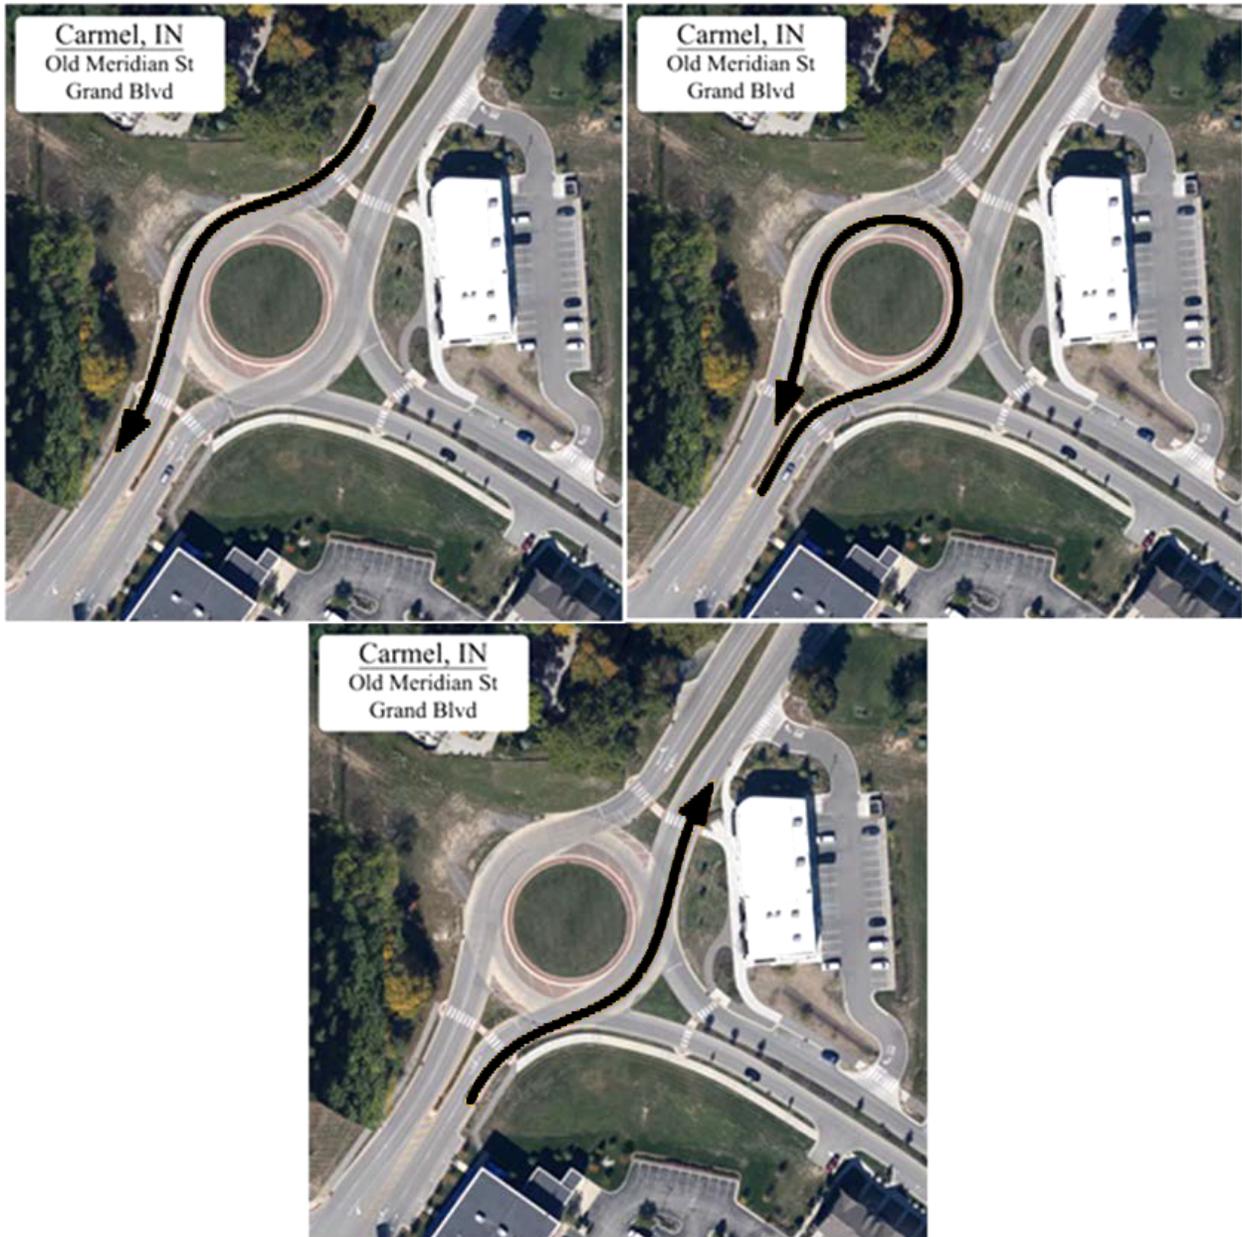
The maneuvers performed by the participant drivers at each of the roundabouts in Carmel, IN are shown in figure 57, figure 58, figure 59, and figure 60.

Figure 61. Diagrams. Carmel, IN roundabout – Old Meridian St. and Grand Blvd.

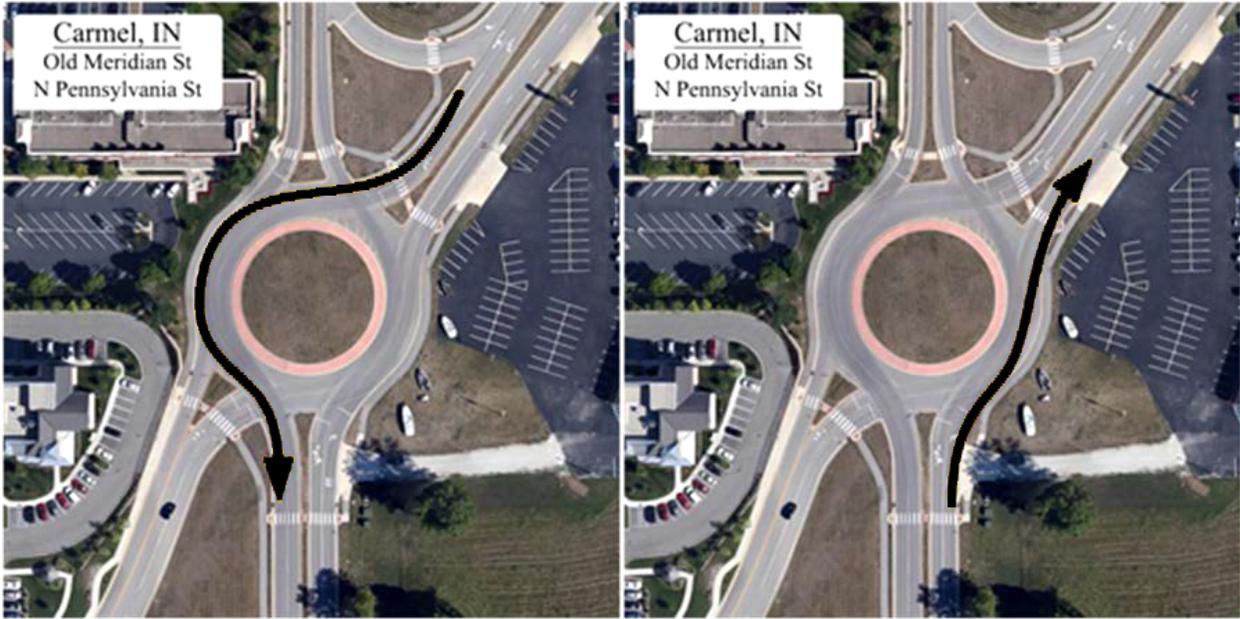
Figure 62. Diagrams. Carmel, IN roundabout – Old Meridian St. and N. Pennsylvania St.

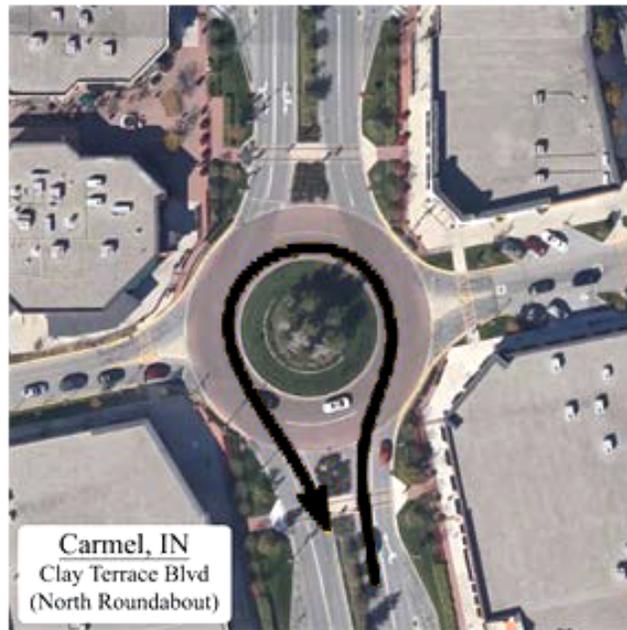
Figure 63. Carmel, IN roundabout – Clay Terrace Blvd, North Roundabout.

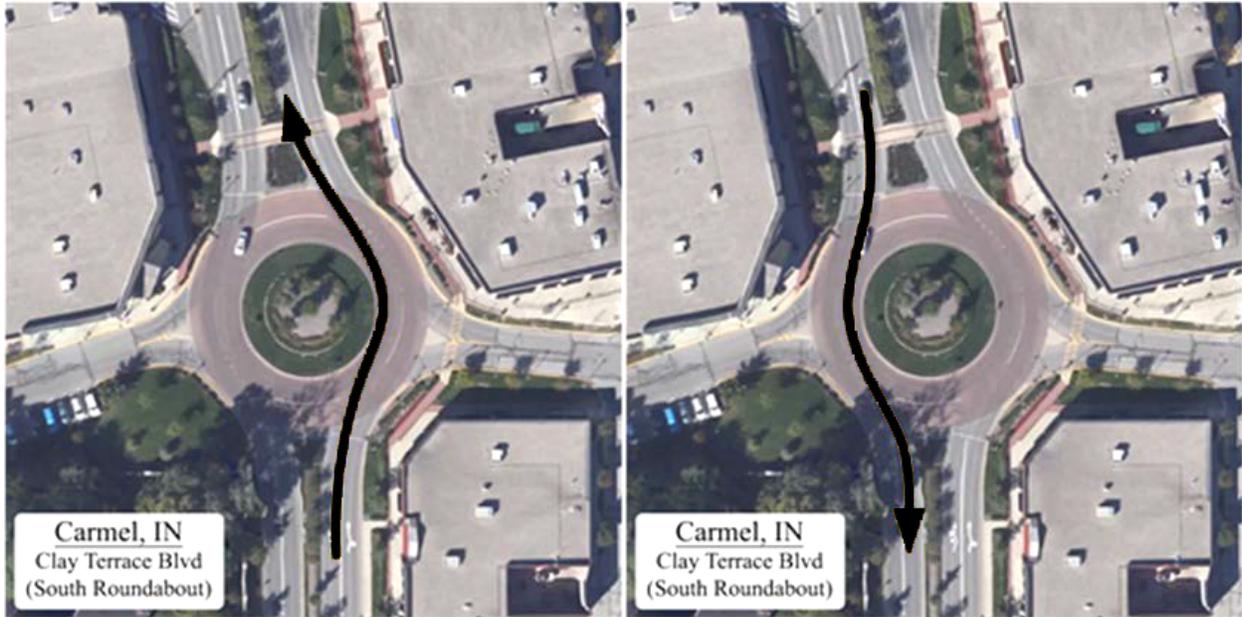
Figure 64. Carmel, IN roundabout – Clay Terrace Blvd, South Roundabout.
