Test Your Knowledge - Question1

This section guides you through a series of situations and you are asked to "click on" the correct answer. It's designed to heighten your awareness of various pedestrian issues. Please send us your [comments](#) and feel free to share this with others.

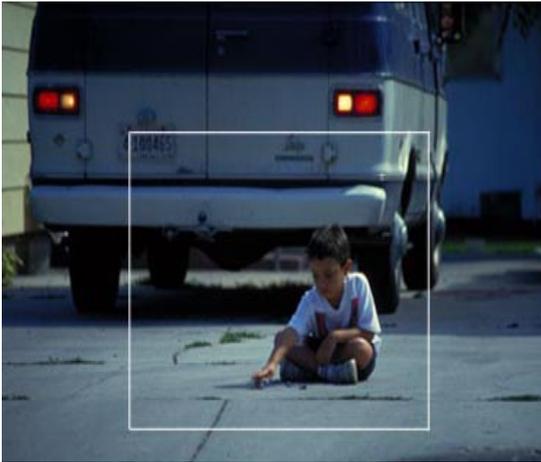
What is wrong in the picture?

b. Children are not always aware of dangers around them.

Correct! Drivers should always walk around their vehicle before driving off.

Children aged 5 to 14 constitute only 14 percent of the population, yet accounted for 27 percent of the pedestrian collisions during 1998. Young pedestrians, under 15 years of age, experience a pedestrian collision involvement rate twice that of all pedestrians.

The youngest students of 5 to 8 years in age are particularly over-involved in midblock dartout crashes. They cannot be treated as short adults; they are not able to judge the speed of approaching vehicles, nor the adequacy of gaps in traffic, and their peripheral vision is not as well developed. Young children are also often inattentive and careless streets.

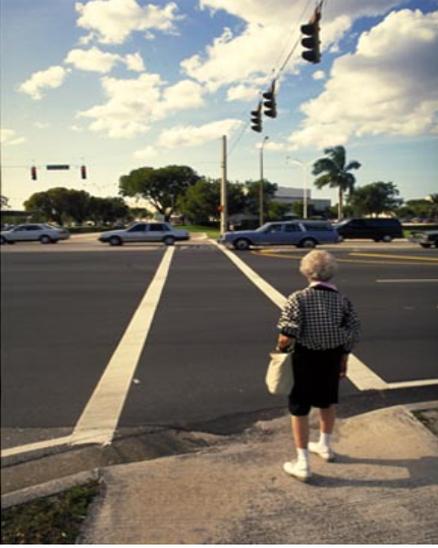
What is wrong in the picture?

- a. Elderly people should not cross the street unaided.
- b. The station wagon is too far out in the intersection.
- c. The crossing is too long and has no medians.

c. The crossing is too long and has no medians.

Correct! This long crosswalk does not cater to the elderly.

To accommodate the shorter stride and slower gait of the older pedestrian, and their exaggerated "startup" time before leaving the curb, the pedestrian crossing time should reflect a slower than normal (4.0 ft/s or 1.22 m/s - MUTCD, 1988) walking speed.

In addition, a refuge median can be installed with an additional pedestrian "push button" in case any pedestrian become trapped in the center of the road while crossing.

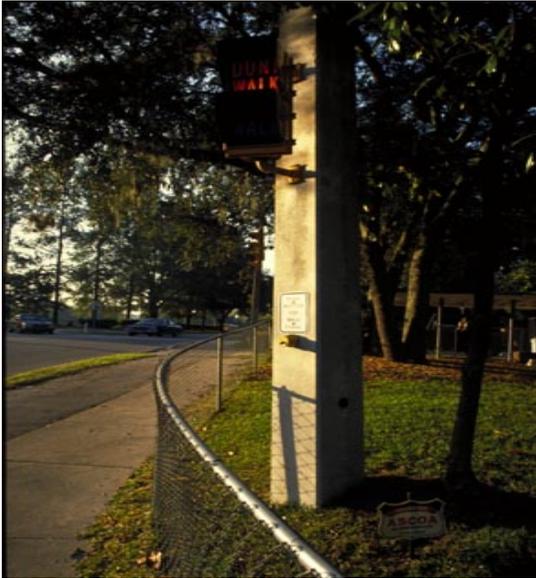
What is wrong in the picture?

- a. The crosswalk push button is inside the fence.
- b. The sidewalk is too wide for the street.
- c. The crosswalk signal is too dim to read properly.

a. The crosswalk pushbutton is inside the fence.

Correct! By being inside the fence, the pushbutton is not accessible to all users (e.g. wheelchair users and younger children).

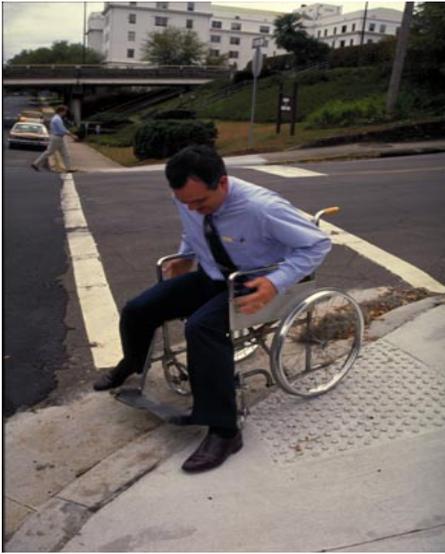
What is wrong in the picture?

- a. The crosswalk lines are overlapped too much by the new asphalt.
- b. People in wheelchairs should not use crosswalks.
- c. The crosswalk ramp is too steep.

c. The crosswalk ramp is too steep.

Correct! The slope of the crosswalk ramp is too steep for this disabled person to roll up or down it in safety.

The running slope of a new curb ramp may not exceed 1 in 12. Curb ramps in alteration where it is technically infeasible to meet the new construction requirements may have a maximum slope of 1 in 10.

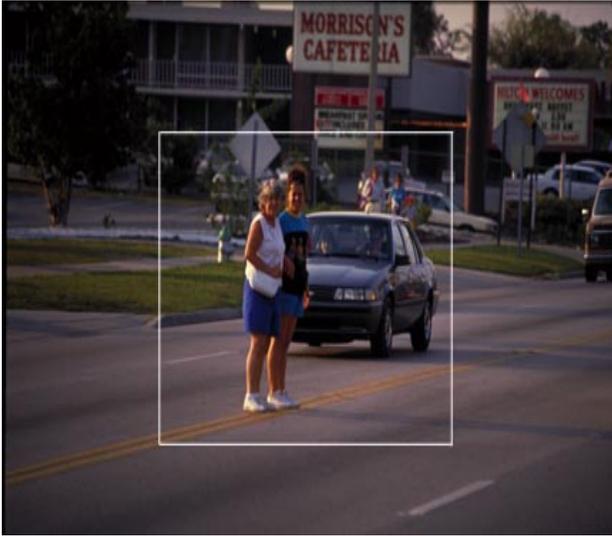
What is wrong in the picture?

c. This is poor pedestrian behavior.

Correct! Before crossing, stop at the curb, edge of the road, or corner before proceeding. Look left-right-left, and if its clear, begin crossing, looking over your shoulder for turning vehicles. Continue to check for traffic while crossing.

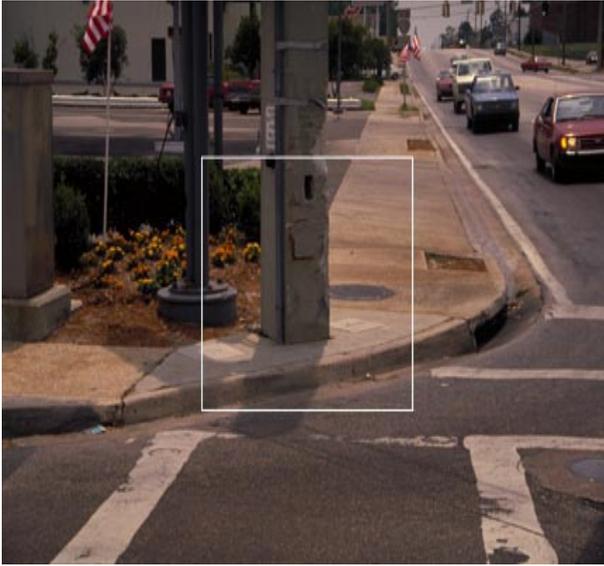
c. The utility pole is blocking the sidewalk.

Correct! The utility pole does not leave enough room for easy access by pedestrians to the crosswalk or sidewalk.

In this situation wheelchair users will not be able to negotiate the sidewalk.

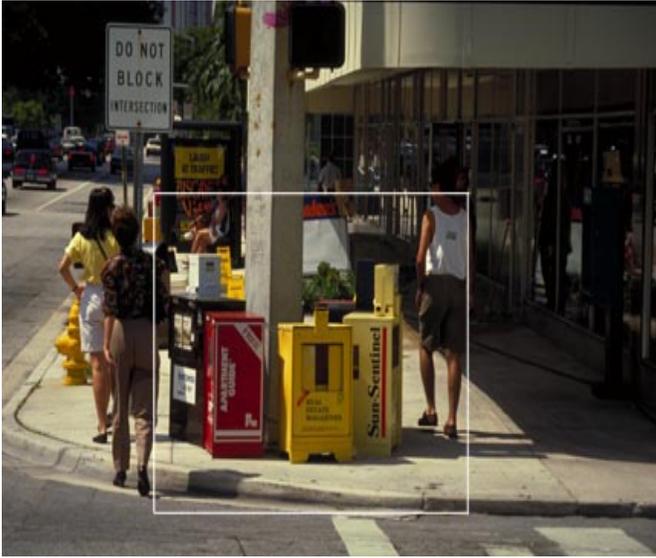
b. The newspaper vending machines block direct access to the crosswalk.

Correct! The crowd of newspaper vending machines very close to the street corner make it difficult to access the crosswalk. Also visibility between the pedestrian and driver are compromised.

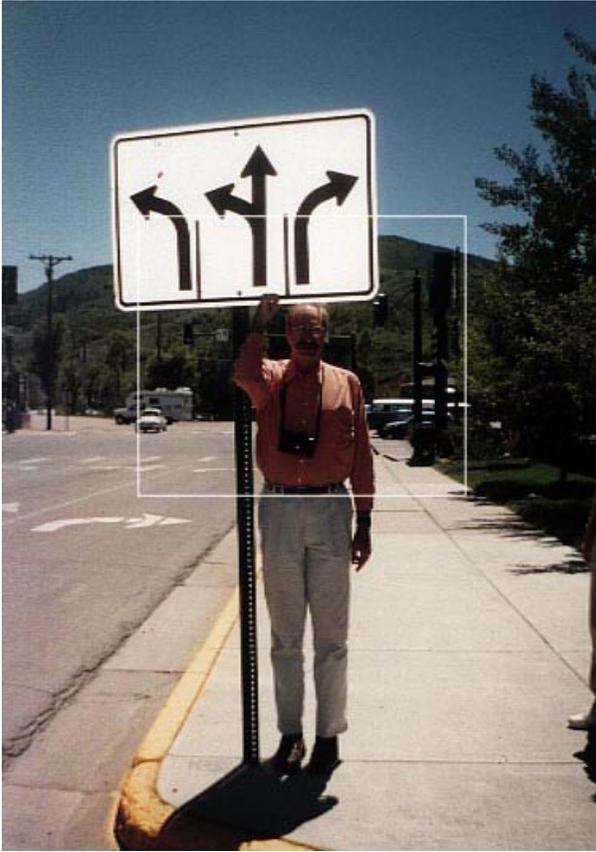
b. The arrow sign is not far enough off the ground.

Correct! The Manual on Uniform Traffic Control Devices (MUTCD) section 2A.23 requires a minimum clearance of 7 feet. -

In business, commercial and residential districts where parking and/or pedestrian movement is likely to occur or where there are other obstructions to view, the clearance to the bottom of the sign shall be at least 7 feet. The height to the bottom of a secondary sign mounted below another sign may be 1 foot less than the appropriate height specified above.

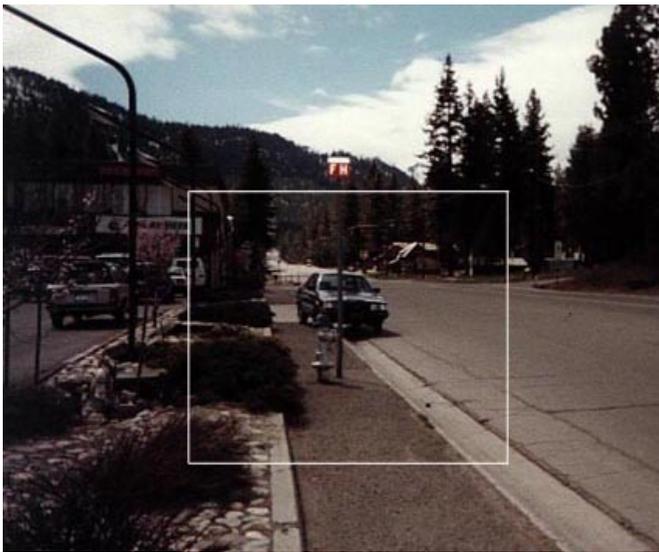
c. The hydrant blocks easy access to this sidewalk.

Correct! For people using wheelchairs, there is no easy way to get around the fire hydrant. It's easy to adjust the landscaping to accommodate an additional clearance of at least 3 feet in this area.

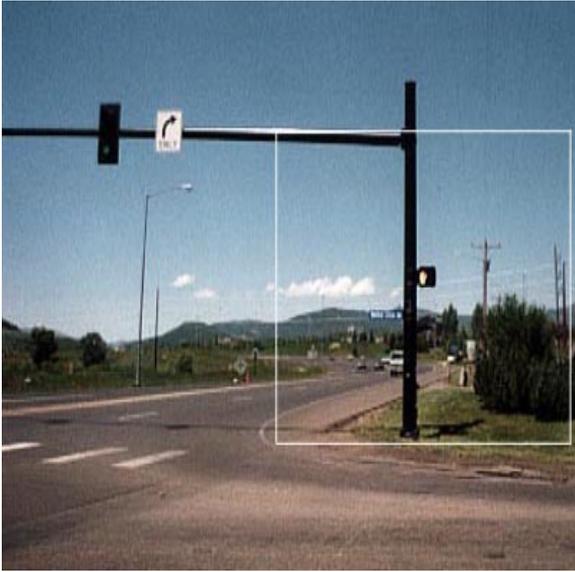
c. The "Don't Walk" signal is the wrong color.

Correct! The hand symbol indicates that you shouldn't cross the road, but it is the wrong color. It should be Portland orange.

In addition, this intersection can be more accommodating to the pedestrian by the use of stop bars, and additional crosswalk markings.

4. When illuminated, the DON'T WALK indication shall be Portland orange conforming to the Pedestrian Traffic Control Signal Indications, with all except the letters or symbols obscured by an opaque material.

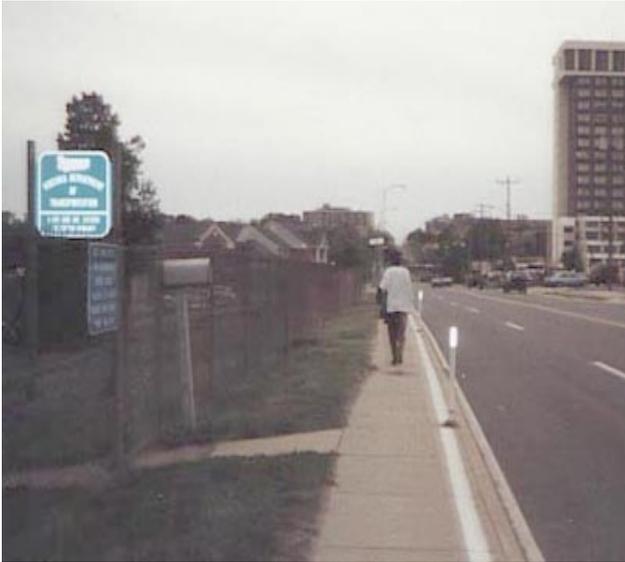
a. The roadway abuts the sidewalk and can result in problems for the pedestrian.

Correct! Whenever the roadway abuts the sidewalk (as in the top picture), wide vehicles using the road can create a dangerous situation for pedestrians. Pedestrians can be hit by the mirrors of large vehicles protruding out over the walkway.

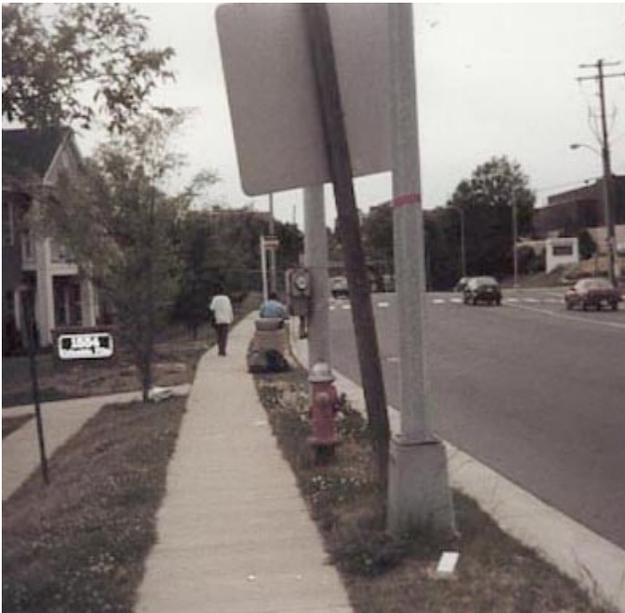
In the lower picture (farther down the road from the top picture) there is good design with a "buffer strip" between the roadway and the walkway.

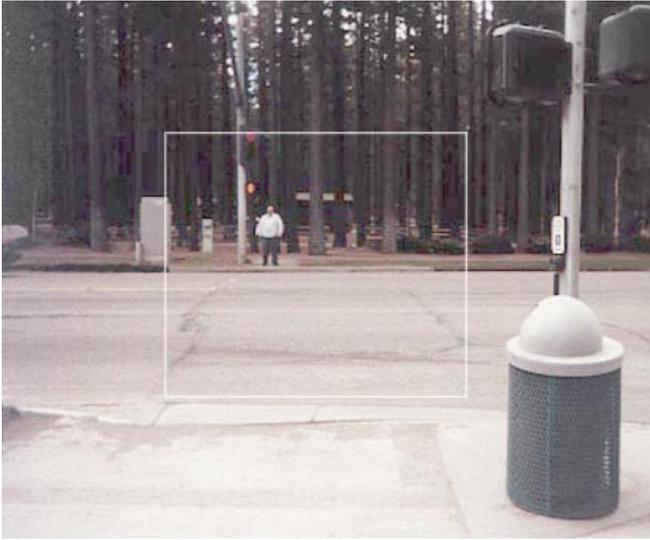
b. There is no wheelchair-accessible ramp on the far side of the crosswalk.

Correct! The ramp on this side of the crosswalk is accessible to disabled persons, but there is no ramp on the far side of the street.

In addition, the intersection can be made more accommodating to the pedestrian by the use of stop lines and cross-walk markings.
