# Arlington County Finds the Best Spots for Rectangular Rapid Flashing Beacons

Arlington, Virginia

## Case Study: Arlington County Finds the Best Spots for Rectangular Rapid Flashing Beacons

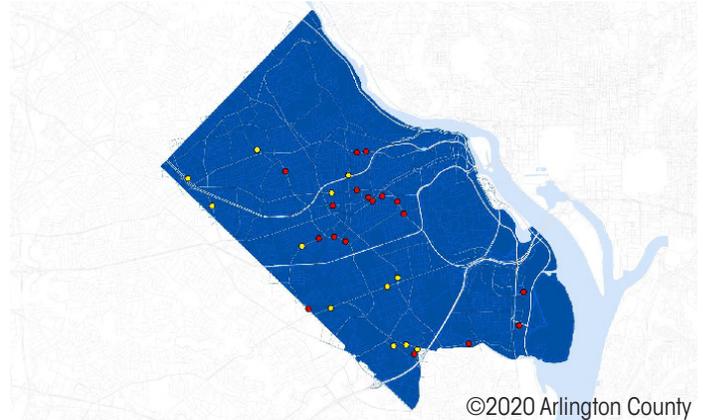
Arlington County, Virginia, has a high level of transit accessibility because of its proximity to the Washington, D.C. metropolitan area, leading to increased pedestrian activity. To systemically improve pedestrian safety, Arlington County installed 10 RRFBs at active pedestrian crossings through the end of 2017. Subsequently the County has planned the installation of 20 more by the end of 2020 (figure 1).

Figure 1. Graphic. RRFB locations, existing and planned.

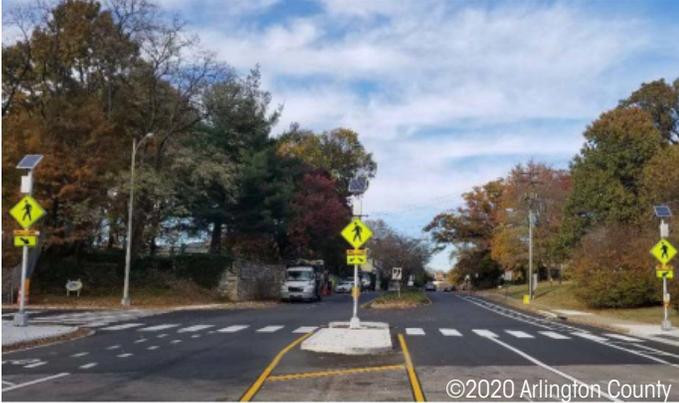
Figure 2. Photo. RRFB evaluation site on N. Quincy St. at 15th St. N.
