U.S. Department
of Transportation
**Federal Highway
Administration**

In Reply Refer To:
HSST-1/CC-167

- Delta Crash Cushion

Request for Federal Aid Reimbursement Eligibility of Highway Safety Hardware

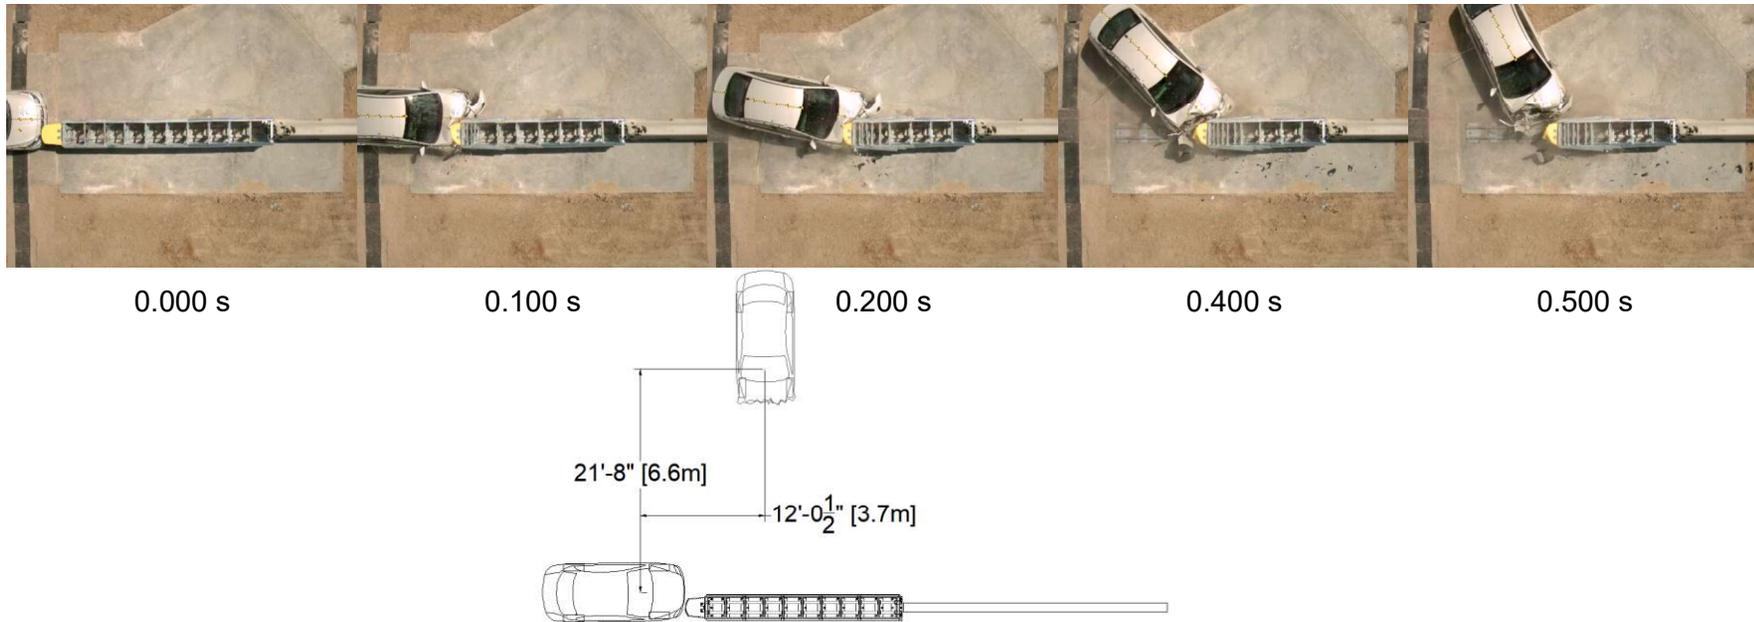
Figure 8 Summary of Test 3-30

MASH 2016 Test 3-30 Summary

General Information	
Test Agency.....	Applus IDIADA KARCO
Test No.....	P40224-01
Test Designation.....	3-30
Test Date.....	08/12/20
Test Article	
Name / Model.....	Delta
Type.....	Crash Cushion
Crash Cushion Length.....	21.0 ft. (6.4 m)
Road Surface.....	Smooth, clean concrete
Test Vehicle	
Type / Designation.....	1100C
Year, Make, and Model.....	2016 Hyundai Accent
Test Inertial Mass.....	2,427.2 lbs (1,101.0 kg)
Gross Static Mass.....	2,604.7 lbs (1,181.5 kg)

Impact Conditions	
Impact Velocity.....	63.22 mph (101.74 km/h)
Impact Angle.....	0.5°
Location / Orientation.....	16.7 in. (245 mm) right
Kinetic Energy.....	324.3 kip-ft (439.7 kJ)
Minimum KE Required.....	288 kip-ft (390 kJ)
Exit Conditions	
Exit Velocity.....	N/A
Exit Angle.....	N/A
Final Vehicle Position.....	12.0 ft. (3.7 m) down stream 21.7 ft. (6.6 m) left
Exit Box Criteria Met.....	N/A
Vehicle Snagging.....	None
Vehicle Pocketing.....	None
Vehicle Stability.....	Satisfactory
Maximum Roll Angle.....	-8.1 °
Maximum Pitch Angle.....	-16.6 °
Maximum Yaw Angle.....	-99.2 °

Occupant Risk	
Longitudinal OIV.....	37.1 ft/s (11.3 m/s)
Lateral OIV.....	3.9 ft/s (1.2 m/s)
Longitudinal RA.....	-18.2 g
Lateral RA.....	3.5 g
THIV.....	37.7 ft/s (11.5 m/s)
PHD.....	18.2 g
ASI.....	1.14
Test Article Deflections	
Static.....	10.0 ft. (3.0 m)
Dynamic.....	10.0 ft. (3.0 m)
Working Width.....	N/A
Debris Field.....	N/A
Vehicle Damage	
Vehicle Damage Scale.....	12-FD-5
CDC.....	12FDEW2
Maximum Intrusion.....	1.9 in. (49 mm) at toepan

Required Test Number	Narrative Description	Evaluation Results
3-30 (1100C)	<p>Applus IDIADA KARCO Engineering Project# P40224-01 conducted on August 12, 2020. Test 3-30 involves an 1100C test vehicle impacting the Delta end-on at a nominal impact speed and angle of 62 mph (100 km/h) and 0°, respectively, with the vehicle offset one quarter of its width. Test 3-30 is designed to examine vehicle trajectory and occupant risk.</p> <p>The test vehicle, a 2016 Hyundai Accent with a test inertial weight of 2,427.2 lbs (1,101.0 kg), impacted the Delta at a speed and angle of 63.22 mph (101.74 km/h) and 0.5°, respectively. Upon impact the test vehicle crushed the front attenuation module and collapsed the first three attenuation stages of the Delta. The vehicle came to a controlled stop remained stable throughout the impact event and did not exceed Roll or Pitch angles of 75°. The Occupant Impact Velocities and Ride Down Acceleration were within the acceptable range per MASH. There was no occupant compartment penetration and minimal occupant compartment deformation. The Delta met all the requirements of MASH Test 3-30.</p>	PASS

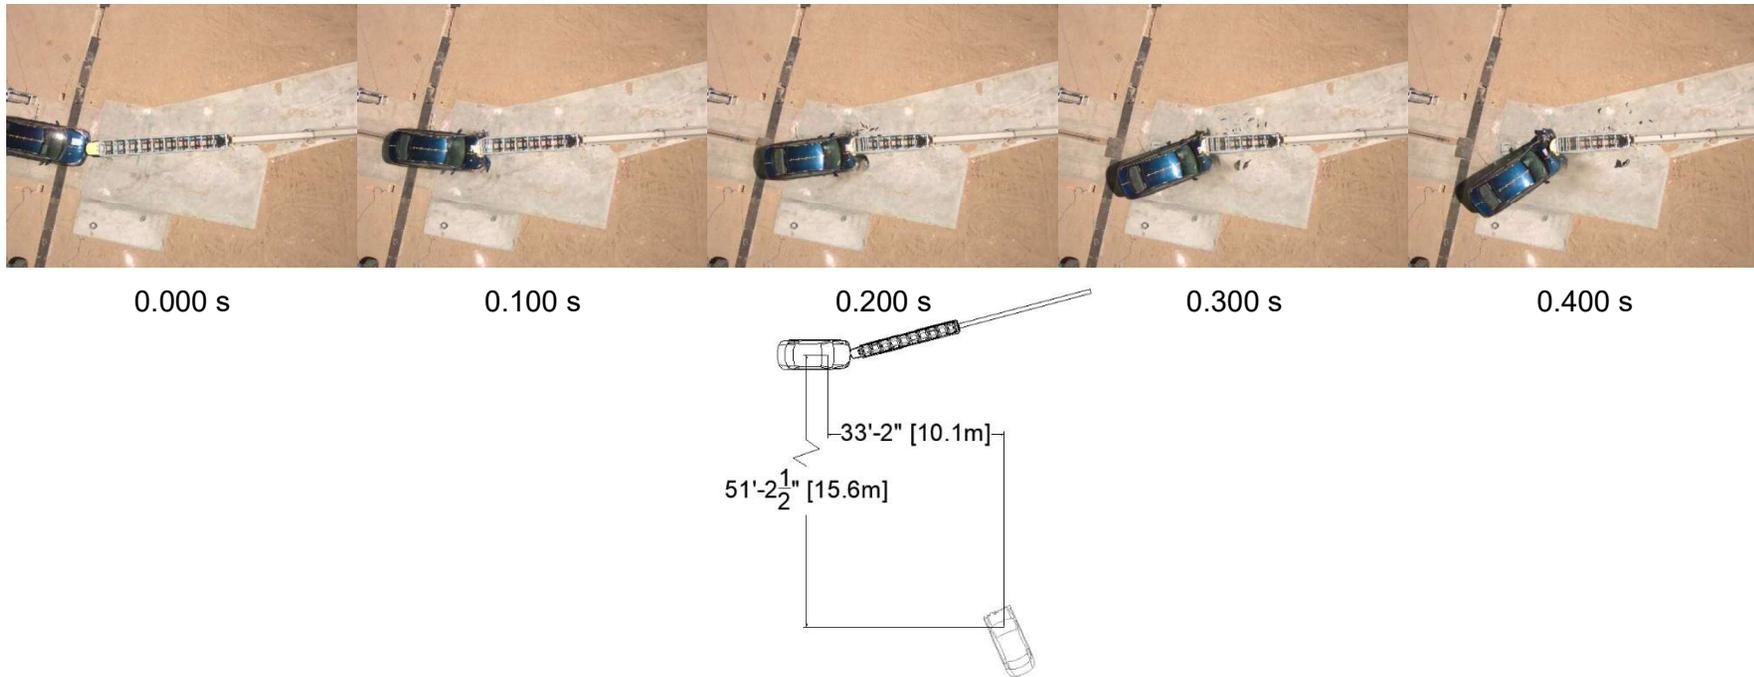
Figure 8 Summary of Test 3-32

MASH 2016 Test 3-32 Summary

General Information	
Test Agency.....	Applus IDIADA KARCO
Test No.....	P40196-01
Test Designation.....	3-32
Test Date.....	07/21/20
Test Article	
Name / Model.....	Delta
Type.....	Crash Cushion
Crash Cushion Length.....	21.0 ft. (6.4 m)
Road Surface.....	Smooth, clean concrete
Test Vehicle	
Type / Designation.....	1100C
Year, Make, and Model.....	2016 Hyundai Accent
Test Inertial Mass.....	2,453.7 lbs (1,113.0 kg)
Gross Static Mass.....	2,616.8 lbs (1,187.0 kg)

Impact Conditions	
Impact Velocity.....	62.70 mph (100.90 km/h)
Impact Angle.....	15.2°
Location / Orientation.....	at article centerline
Kinetic Energy.....	322.4 kip-ft (437.2 kJ)
Minimum KE Required.....	288 kip-ft (390 kJ)
Exit Conditions	
Exit Velocity.....	N/A
Exit Angle.....	N/A
Final Vehicle Position.....	33.2 ft. (10.1 m) down stream
	51.2 ft. (15.6 m) right
Exit Box Criteria Met.....	N/A
Vehicle Snagging.....	None
Vehicle Pocketing.....	None
Vehicle Stability.....	Satisfactory
Maximum Roll Angle.....	-37.6 °
Maximum Pitch Angle.....	36.2 °
Maximum Yaw Angle.....	117.6 °

Occupant Risk	
Longitudinal OIV.....	38.4 ft/s (11.7 m/s)
Lateral OIV.....	3.3 ft/s (1.0 m/s)
Longitudinal RA.....	-17.6 g
Lateral RA.....	3.5 g
THIV.....	38.7 ft/s (11.8 m/s)
PHD.....	17.6 g
ASI.....	1.29
Test Article Deflections	
Static.....	9.9 ft. (3.0 m)
Dynamic.....	9.9 ft. (3.0 m)
Working Width.....	N/A
Debris Field.....	N/A
Vehicle Damage	
Vehicle Damage Scale.....	11-FD-5
CDC.....	11FDEW3
Maximum Intrusion.....	Negligible

3-32 (1100C)	<p>Applus IDIADA KARCO Engineering Project# P40196-01 conducted on July 21, 2020. Test 3-32 involves an 1100C test vehicle impacting the Delta end-on at a nominal impact speed and angle of 62 mph (100 km/h) and 15°, respectively, with the centerline of the vehicle aligned with the nose of the system. Test 3-32 is designed to examine vehicle trajectory and occupant risk.</p> <p>The test vehicle, a 2016 Hyundai Accent with a test inertial weight of 2,453.7 lbs (1,113.0 kg), impacted the Delta at a speed and angle of 62.70 mph (100.90 km/h) and 15.2°, respectively. Upon impact the test vehicle crushed the attenuation box and collapsed the first three attenuation stages of the Delta. The vehicle remained stable throughout the entire impact event and did not exceed Roll or Pitch angles of 75°. The Occupant Impact Velocities and Ride Down Acceleration were within the acceptable range per MASH. There was no risk of occupant compartment penetration and there was minimal occupant compartment deformation.</p> <p>The Delta met all the requirements of MASH Test 3-32.</p>	PASS

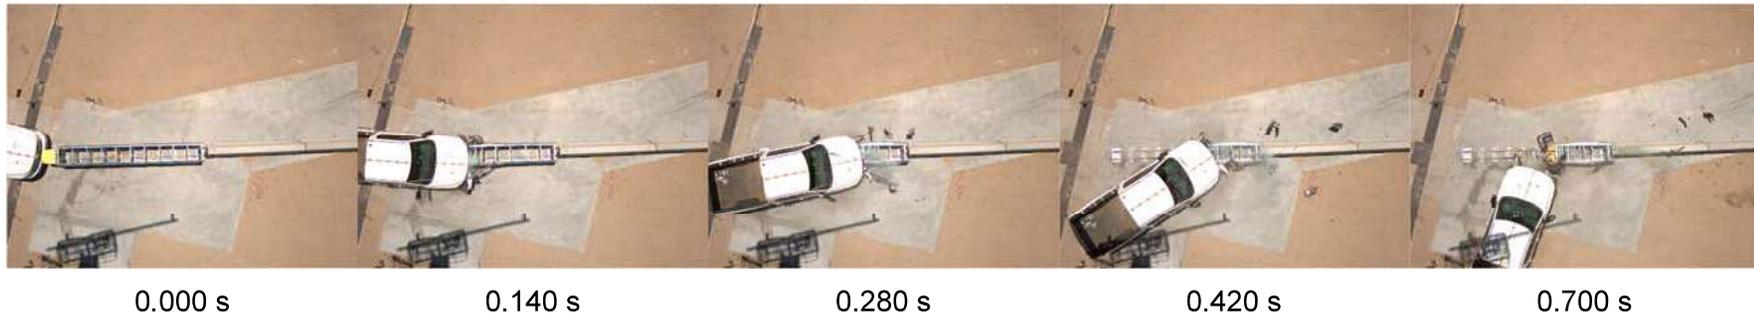
Figure 8 Summary of Test 3-33

MASH 2016 Test 3-33 Summary

General Information	
Test Agency.....	Applus IDIADA KARCO
Test No.....	P40197-01
Test Designation.....	3-33
Test Date.....	07/22/20
Test Article	
Name / Model.....	Delta
Type.....	Crash Cushion
Crash Cushion Length.....	21.0 ft. (6.4 m)
Road Surface.....	Smooth, clean concrete
Test Vehicle	
Type / Designation.....	2270P
Year, Make, and Model.....	2015 RAM 1500
Test Inertial Mass.....	5,037.5 lbs (2,285.0 kg)
Gross Static Mass.....	5,037.5 lbs (2,285.0 kg)

Impact Conditions	
Impact Velocity.....	59.96 mph (96.50 km/h)
Impact Angle.....	15.4°
Location / Orientation.....	at article centerline
Kinetic Energy.....	605.5 kip-ft (820.9 kJ)
Minimum KE Required.....	594 kip-ft (806 kJ)
Exit Conditions	
Exit Velocity.....	N/A
Exit Angle.....	N/A
Final Vehicle Position.....	153.9 ft. (46.9 m) downstream 63.8 ft. (19.4 m) right
Exit Box Criteria Met.....	N/A
Vehicle Snagging.....	None
Vehicle Pocketing.....	None
Vehicle Stability.....	Satisfactory
Maximum Roll Angle.....	-7.8 °
Maximum Pitch Angle.....	-4.9 °
Maximum Yaw Angle.....	144.2 °

Occupant Risk	
Longitudinal OIV.....	29.9 ft/s (9.1 m/s)
Lateral OIV.....	4.6 ft/s (1.4 m/s)
Longitudinal RA.....	-9.8 g
Lateral RA.....	3.2 g
THV.....	30.5 ft/s (9.3 m/s)
PHD.....	9.8 g
ASI.....	0.76
Test Article Deflections	
Static.....	13.9 ft. (4.2 m)
Dynamic.....	13.9 ft. (4.2 m)
Working Width.....	N/A
Debris Field.....	N/A
Vehicle Damage	
Vehicle Damage Scale.....	11-FD-3
CDC.....	11FDEW2
Maximum Intrusion.....	Negligible

3-33 (2270P)	<p>Applus IDIADA KARCO Engineering Project# P40197-01 conducted on July 22, 2020. Test 3-33 involves an 2270P test vehicle impacting the Delta end-on at a nominal impact speed and angle of 62 mph (100 km/h) and 15°, respectively, with the centerline of the vehicle aligned with the nose of the system. Test 3-33 is designed to examine vehicle trajectory and occupant risk.</p> <p>The test vehicle, a 2015 RAM 1500 with a test inertial weight of 5,037.5 lbs (2,285.0 kg), impacted the Delta at a speed and angle of 59.96 mph (96.50 km/h) and 15.4°, respectively. Upon impact the test vehicle crushed the attenuation box and fully collapsed the first four attenuation stages of the Delta. The fifth attenuation stage still had reserve capacity. The vehicle remained stable throughout the entire impact event and did not exceed Roll or Pitch angles of 75°. The Occupant Impact Velocities and Ride Down Acceleration were within the acceptable range per MASH. There was no occupant compartment penetration and there was minimal occupant compartment deformation.</p> <p>The Delta met all the requirements of MASH Test 3-33.</p>	PASS

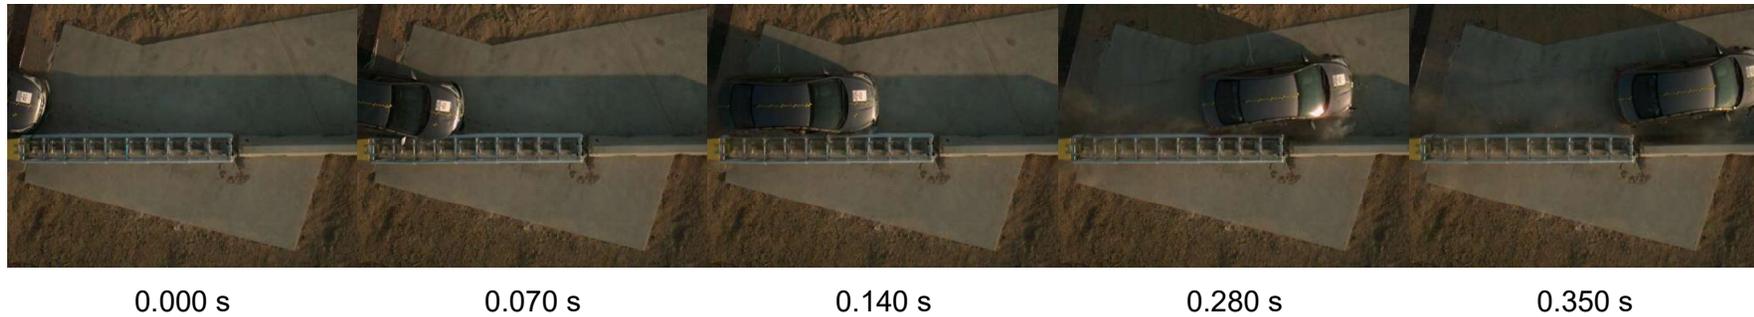
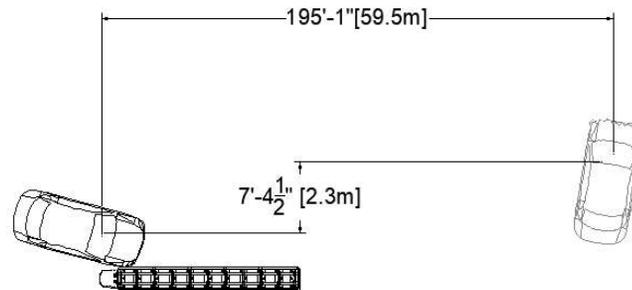
Figure 8 Summary of Test 3-34

MASH 2016 Test 3-34 Summary

General Information	
Test Agency.....	Applus IDIADA KARCO
Test No.....	P40226-01
Test Designation.....	3-34
Test Date.....	08/24/20
Test Article	
Name / Model.....	Delta
Type.....	Crash Cushion
Crash Cushion Length.....	21.0 ft. (6.4 m)
Road Surface.....	Smooth, clean concrete
Test Vehicle	
Type / Designation.....	1100C
Year, Make, and Model.....	2016 Hyundai Accent
Test Inertial Mass.....	2,437.2 lbs (1,105.5 kg)
Gross Static Mass.....	2,594.8 lbs (1,177.0 kg)

Impact Conditions	
Impact Velocity.....	62.51 mph (100.60 km/h)
Impact Angle.....	15.2°
Location / Orientation.....	8.27 in. before CIP
Impact Severity.....	21.9 kip-ft (29.7 kJ)
Minimum IS Required.....	19 kip-ft (26 kJ)
Exit Conditions	
Exit Velocity.....	58.66 mph (94.40 km/h)
Exit Angle.....	4.0°
Final Vehicle Position.....	195.1 ft. (59.5 m) downstream 7.4 ft. (2.3 m) left
Exit Box Criteria Met.....	Yes
Vehicle Snagging.....	None
Vehicle Pocketing.....	None
Vehicle Stability.....	Satisfactory
Maximum Roll Angle.....	7.7°
Maximum Pitch Angle.....	-3.8°
Maximum Yaw Angle.....	25.3°

Occupant Risk	
Longitudinal OIV.....	11.5 ft/s (3.5 m/s)
Lateral OIV.....	20.7 ft/s (6.3 m/s)
Longitudinal RA.....	-2.3 g
Lateral RA.....	-8.4 g
THIV.....	23.6 ft/s (7.2 m/s)
PHD.....	8.5 g
ASI.....	1.51
Test Article Deflections	
Static.....	1.0 in. (26.0 mm)
Dynamic.....	2.4 in. (60.0 mm)
Working Width.....	30.7 in. (781.0 mm)
Debris Field.....	N/A
Vehicle Damage	
Vehicle Damage Scale.....	11-RFQ-2?
CDC.....	01FDEK2 and 01RDES2
Maximum Intrusion.....	Negligible

3-34 (1100C)	<p>Applus IDIADA KARCO Engineering Project# P40226-01 conducted on August 24, 2020. Test 3-34 involves an 1100C test vehicle impacting the Delta the CIP at a nominal speed and angle of 62 mph (100 km/h) and 15°, respectively. The CIP was determined to be 12 in. (305 mm) downstream from the impact head. Test 3-34 is designed to examine vehicle trajectory, stability, and occupant risk.</p> <p>The test vehicle, a 2016 Hyundai Accent with a test inertial weight of 2,437.2 lbs (1,105.5 kg), impacted the Delta at a speed and angle of 62.51 mph (100.60 km/h) and 15.2°, respectively. Upon impact the vehicle was smoothly redirected and exited within the bounds of the exit box. The vehicle remained stable throughout the impact event and did not exceed Roll or Pitch angles of 75°. The Occupant Impact Velocities and Ride Down Acceleration were within the acceptable range per MASH. There was no occupant compartment penetration and there was minimal occupant compartment deformation. The Delta met all the requirements of MASH Test 3-34.</p>	PASS

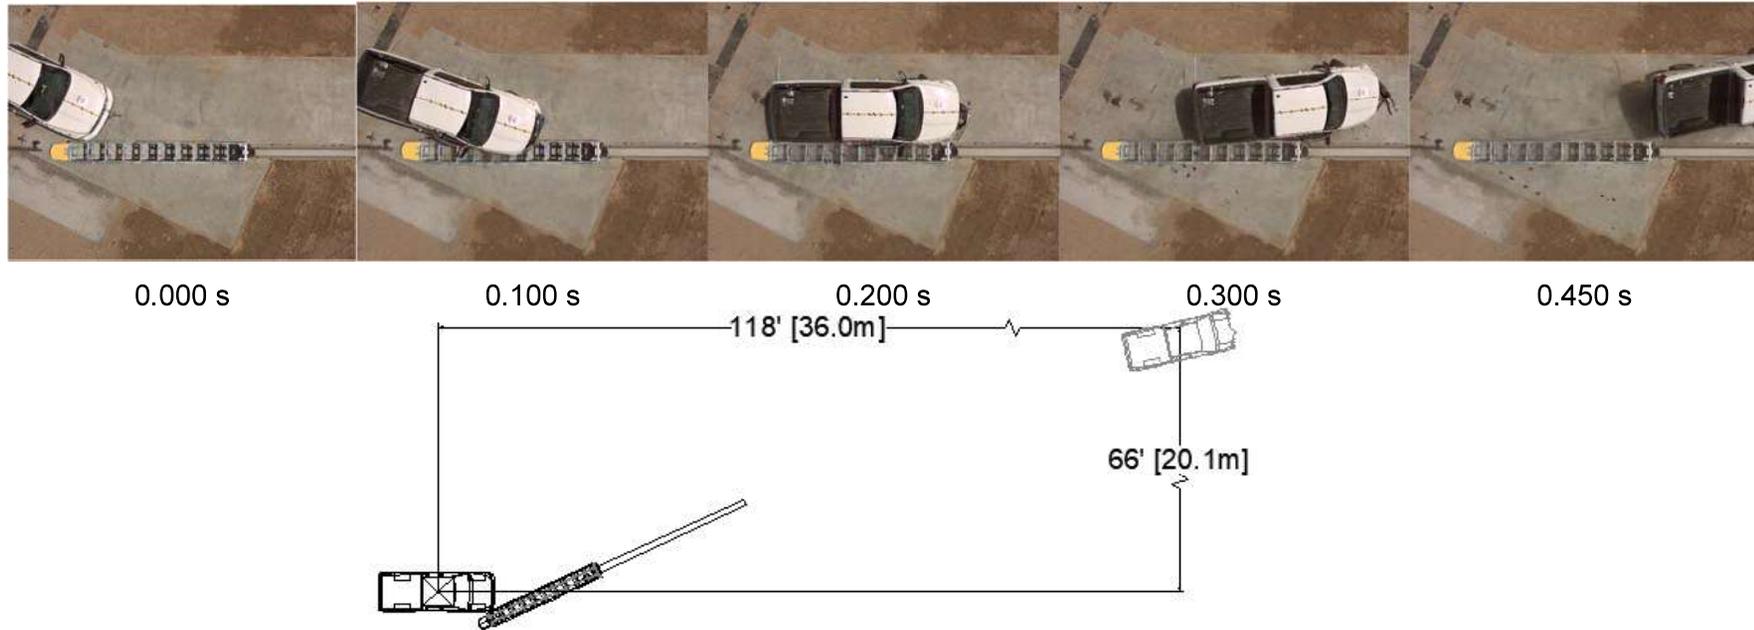
Figure 8 Summary of Test 3-35

MASH 2016 Test 3-35 Summary

<p>General Information</p> <p>Test Agency..... Applus IDIADA KARCO Test No..... P40195-01 Test Designation..... 3-35 Test Date..... 07/15/20</p>	<p>Impact Conditions</p> <p>Impact Velocity..... 62.75 mph (100.98 km/h) Impact Angle..... 25.4° Location / Orientation..... 12.0 in. downstream from impact head Impact Severity..... 122.4 kip-ft (166.0 kJ) Minimum IS Required..... 106 kip-ft (144 kJ)</p>	<p>Occupant Risk</p> <p>Longitudinal OIV..... 19.7 ft/s (6.0 m/s) Lateral OIV..... 23.6 ft/s (7.2 m/s) Longitudinal RA..... -6.7 g Lateral RA..... -7.1 g THIV..... 31.8 ft/s (9.7 m/s) PHD..... 7.2 g ASI..... 1.51</p>
<p>Test Article</p> <p>Name / Model..... Delta Type..... Crash Cushion Crash Cushion Length..... 21.0 ft. (6.4 m) Road Surface..... Smooth, clean concrete</p>	<p>Exit Conditions</p> <p>Exit Velocity..... 54.68 mph (88.00 km/h) Exit Angle..... 5.3° Final Vehicle Position..... 118.0 ft. (36.0 m) downstream 66.0 ft. (20.1 m) left</p>	<p>Test Article Deflections</p> <p>Static..... 1.9 in. (47 mm) Dynamic..... 1.9 in. (47 mm) Working Width..... 32.0 in. (813 mm) Debris Field..... N/A</p>

<p>Test Vehicle</p> <p>Type / Designation..... 2270P Year, Make, and Model..... 2014 RAM 1500 Test Inertial Mass..... 5,055.1 lbs (2,293.0 kg) Gross Static Mass..... 5,055.1 lbs (2,293.0 kg)</p>	<p>Exit Box Criteria Met..... Yes Vehicle Snagging..... None Vehicle Pocketing..... None Vehicle Stability..... Satisfactory Maximum Roll Angle..... 27.0 ° Maximum Pitch Angle..... -18.9 ° Maximum Yaw Angle..... 38.8 °</p>	<p>Vehicle Damage</p> <p>Vehicle Damage Scale..... 01-RFQ-4 CDC..... 01FDEK2 and 01RDES2 Maximum Intrusion..... 5.4 in. (136 mm) at passenger side panel</p>

3-35 (2270P)	<p>Applus IDIADA KARCO Engineering Project# P40195-01 conducted on July 15, 2020. Test 3-35 involves a 2270P test vehicle impacting the Delta the CIP at a nominal speed and angle of 62 mph (100 km/h) and 25°, respectively. The CIP was determined to be 12 in. (305 mm) downstream from the impact head. Test 3-35 is designed to examine the capacity of the Delta to contain and redirect heavy passenger vehicles. The primary concern is vehicle trajectory, stability, and occupant risk.</p> <p>The test vehicle, a 2014 RAM 1500 with a test inertial weight of 5,055.1 lbs (2,293.0 kg), impacted the Delta at a speed and angle of 62.75 mph (100.98 km/h) and 25.4°, respectively. Upon impact the vehicle was smoothly redirected and exited within the bounds of the exit box. The vehicle remained stable throughout the impact event and did not exceed Roll or Pitch angles of 75°. The Occupant Impact Velocities and Ride Down Acceleration were within the acceptable range per MASH. There was no occupant compartment penetration and the occupant compartment deformation limits were not exceeded. The Delta met all the requirements of MASH Test 3-35.</p>	PASS

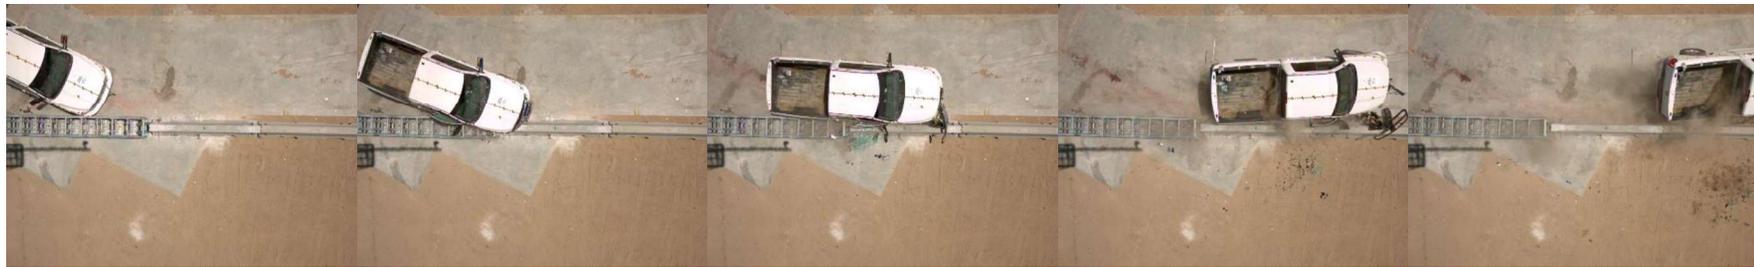
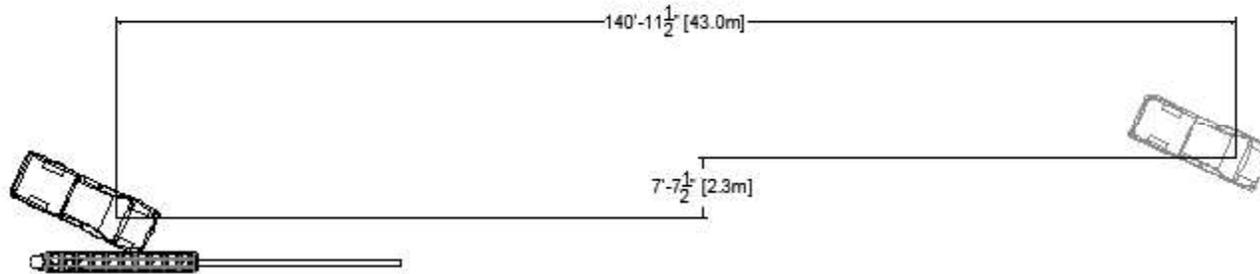
Figure 8 Summary of Test 3-36

MASH 2016 Test 3-36 Summary

General Information	Impact Conditions	Occupant Risk
Test Agency..... Applus IDIADA KARCO	Impact Velocity..... 60.14 mph (96.78 km/h)	Longitudinal OIV..... 19.7 ft/s (6.0 m/s)
Test No..... P40198-01	Impact Angle..... 24.8°	Lateral OIV..... 23.6 ft/s (7.2 m/s)
Test Designation..... 3-36	Location / Orientation..... 7.0 ft. (2.1 m) upstream from rigid backup structure	Longitudinal RA..... -3.7 g
Test Date..... 07/23/20	Impact Severity (IS)..... 106.9 kip-ft (144.9 kJ)	Lateral RA..... -15.9 g
	Minimum IS Required..... 106 kip-ft (144 kJ)	THIV..... 31.2 ft/s (9.5 m/s)
Test Article	Exit Conditions	PHD..... 16.0 g
Name / Model..... Delta	Exit Velocity..... 56.30 mph (90.60 km/h)	ASI..... 1.25
Type..... Crash Cushion	Exit Angle..... 1.1°	Test Article Deflections
Crash Cushion Length..... 21.0 ft. (6.4 m)	Final Vehicle Position..... 141.0 ft. (43.0 m) downstream	Static..... 0.6 in. (15.0 mm)
Road Surface..... Smooth, clean concrete	7.6 ft. (2.3 m) left	Dynamic..... 1.2 in. (31.0 mm)

Exit Box Criteria Met..... Yes	Working Width..... 31.1 in. (791.0 mm)
Test Vehicle	Vehicle Snagging..... None	Debris Field..... N/A
Type / Designation..... 2270P	Vehicle Pocketing..... None	Vehicle Damage
Year, Make, and Model..... 2015 RAM 1500	Vehicle Stability..... Satisfactory	Vehicle Damage Scale..... 01-RFQ-4
Test Inertial Mass..... 5,019.8 lbs (2,277.0 kg)	Maximum Roll Angle..... 27.6 °	CDC..... 01FDAK2 and 01RDAS2
Gross Static Mass..... 5,019.8 lbs (2,277.0 kg)	Maximum Pitch Angle..... -17.3 °	Maximum Intrusion..... 8.2 in. (209 mm) at toepan
	Maximum Yaw Angle..... 41.3 °

3-36 (2270P)	<p>Applus IDIADA KARCO Engineering Project# P40198-01 conducted on July 23, 2020. Test 3-36 involves a 2270P test vehicle impacting the Delta the CIP at a nominal speed and angle of 62 mph (100 km/h) and 25°, respectively. The CIP was determined to be 7 ft. (2.1m) upstream from the rigid backup structure. Test 3-36 is designed to examine the capacity of the Delta to provide sufficient rigidity to prevent severe wheel snag or pocketing at the rigid end of the system. The primary concern is vehicle trajectory, stability, and occupant risk.</p> <p>The test vehicle, a 2015 RAM 1500 with a test inertial weight of 5,019.8 lbs (2,277.0 kg), impacted the Delta at a speed and angle of 60.14 mph (96.78 km/h) and 24.8°, respectively. Upon impact the vehicle was smoothly redirected and exited within the bounds of the exit box. The vehicle remained stable throughout the impact event and did not exceed Roll or Pitch angles of 75°. The Occupant Impact Velocities and Ride Down Acceleration were within the acceptable range per MASH. There was no occupant compartment penetration and the occupant compartment deformation limits were not exceeded. The Delta met all the requirements of MASH Test 3-36.</p>	PASS

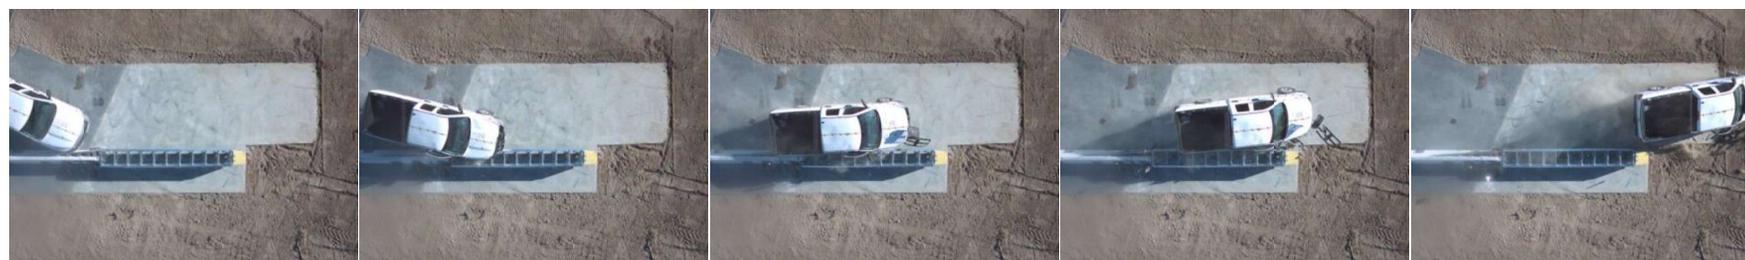
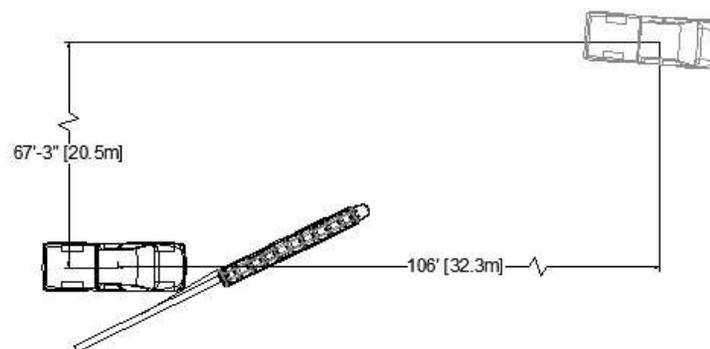
Figure 8 Summary of Test 3-37a

MASH 2016 Test 3-37a Summary

General Information	
Test Agency.....	Applus IDIADA KARCO
Test No.....	P40369-01
Test Designation.....	3-37a
Test Date.....	11/25/20
Test Article	
Name / Model.....	Delta
Type.....	Crash Cushion
Crash Cushion Length.....	21.0 ft. (6.4 m)
Road Surface.....	Smooth, clean concrete
Test Vehicle	
Type / Designation.....	2270P
Year, Make, and Model.....	2017 RAM 1500
Test Inertial Mass.....	5,023.1 lbs (2,278.5 kg)
Gross Static Mass.....	5,023.1 lbs (2,278.5 kg)

Impact Conditions	
Impact Velocity.....	63.04 mph (101.46 km/h)
Impact Angle.....	25.2°
Location / Orientation.....	4.3 ft. upstream of the rear end of the crash cushion
Impact Severity.....	121.0 kip-ft (164.0 kJ)
Minimum IS Required.....	106 kip-ft (144 kJ)
Exit Conditions	
Exit Velocity.....	41.85 mph (67.35 km/h)
Exit Angle.....	12.4°
Final Vehicle Position.....	106.0 ft. (32.3 m) downstream 67.3 ft. (20.5 m) left
Exit Box Criteria Met.....	Satisfactory
Vehicle Snagging.....	None
Vehicle Pocketing.....	None
Vehicle Stability.....	Satisfactory
Maximum Roll Angle.....	20.8°
Maximum Pitch Angle.....	-17.4°
Maximum Yaw Angle.....	31.0°

Occupant Risk	
Longitudinal OIV.....	27.6 ft/s (8.4 m/s)
Lateral OIV.....	27.2 ft/s (8.3 m/s)
Longitudinal RA.....	-6.1 g
Lateral RA.....	-6.8 g
THV.....	39.7 ft/s (12.1 m/s)
PHD.....	7.5 g
ASI.....	2.07
Test Article Deflections	
Static.....	1.1 in. (28 mm)
Dynamic.....	1.1 in. (28 mm)
Working Width.....	30.1 in. (765 mm)
Debris Field.....	N/A
Vehicle Damage	
Vehicle Damage Scale.....	1-RFQ-4 and 1-RD-3
CDC.....	01RDES2 and 01FDEK2
Maximum Intrusion.....	8.3 in. (211 mm) at toe pan

3-37 (2270P)	<p>Applus IDIADA KARCO Engineering Project# P40369-01 conducted on November 25, 2020. Test 3-37a involves a 2270P test vehicle impacting the Delta transition in the reverse direction at a nominal speed and angle of 62 mph (100 km/h) and 25°, respectively. The CIP was determined to be 4.3 ft. (1.3m) upstream from the rigid backup structure as recommended in MASH. Test 3-37a is designed to examine the snagging on the rear of the device. The primary concern is occupant compartment deformation and vehicle stability.</p> <p>The test vehicle, a 2017 RAM 1500 with a test inertial weight of 5,023.1 lbs (2,278.5 kg), impacted the Delta at a speed and angle of 63.04 mph (101.46 km/h) and 25.2°, respectively. Upon impact the vehicle was smoothly redirected and exited within the bounds of the exit box. The vehicle remained stable throughout the impact event and did not exceed Roll or Pitch angles of 75°. The Occupant Impact Velocities and Ride Down Acceleration were within the acceptable range per MASH. There was no occupant compartment penetration and the occupant compartment deformation limits were not exceeded. The Delta met all the requirements of MASH Test 3-37a.</p>	PASS

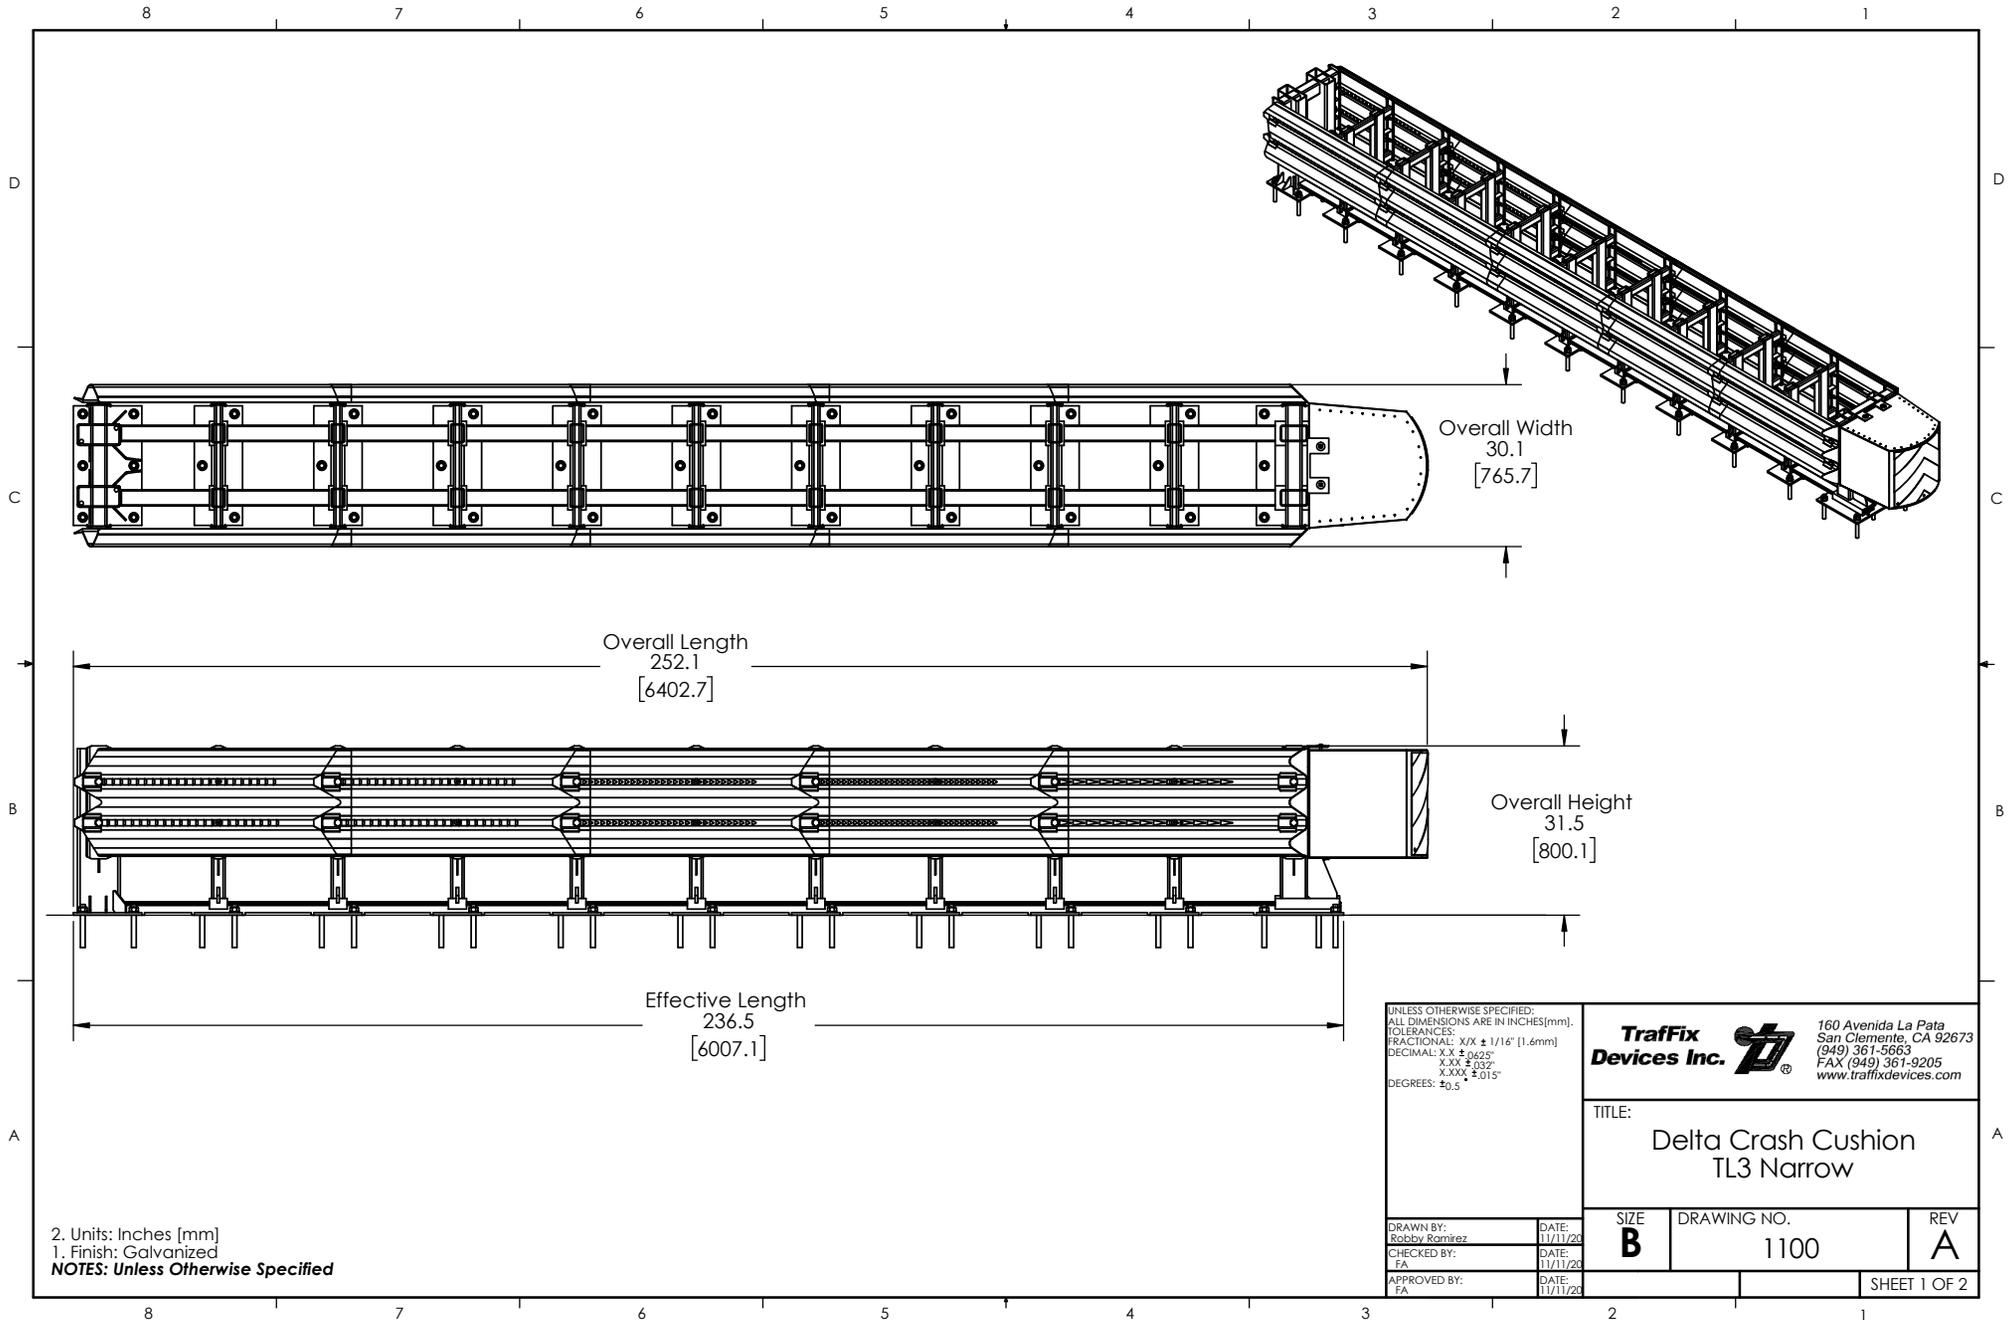
DRAWING NO.
1100

TITLE:
Delta Crash Cushion
TL3 Narrow

Item Number	Description	QTY.
1	Sheeting Panel	1
2	Energy Attenuation Module	1
3	Anchor Bolt Assembly	39
4	Impact Head	1
5	Diaphragm	9
6	Track Weldment	1
7	Bent Washer Plate Assembly	24
8	1N Fender Panel	2
9	2N Fender Panel	2
10	3N Fender Panel	2
11	4-5N Fender Panel	4

The Delta consists of 1 track weldment, 9 internal diaphragms, 10 energy attenuation fender panels, 1 front impact head, and 1 energy attenuation module. The Delta has overall dims. of 21 ft. (6.4 m) X 30.1 in. (765 mm) X 31.5 in. (800 mm). The Delta attenuates the impacting vehicles kinetic energy by tearing/shearing through a series of attenuation stages that are achieved by different shaped cutout patterns within the valleys of the Thrie beam fender panels. The attenuation is not effected by extreme cold, hot, wet, or dry conditions on the roadway. The Delta's open design reduces/minimizes debris build up in and around the device. The attenuation stages progressively increase in resistance to attenuate more kinetic energy as the impacting vehicle collapses the device. Each panel is sequentially marked from 1N to 4-5N to designate its attenuation and position order within the crash cushion with 1N front position, 2N & 3N central positions and 4-5N at the rear of the device. The Thrie beam panels utilize the AASHTO M180 profile. The panels are bolted to the front impact head, internal diaphragms, and track weldment backup structure. The fender panels splice/overlap at their leading and trailing edges. A bent washer assembly which incorporates a 3/4"-10 male thread allows the fender panels to be bolted directly to 4 of the nine internal diaphragms. The four diaphragms at these positions remain attached to the fender panel during the impact event. The remaining five internal diaphragms utilize a sacrificial fastener to restrain them to the fender panels at the mid-span location between the fender panels trailing and leading edges. The sacrificial fasteners are designed to shear upon impact and release the intermediate diaphragm from the panel. The Impact Head acts as a mounting surface for the energy attenuation module. The energy attenuation front module is 22 in. (559 mm) X 23.25 in. (591 mm) X 20 in. (508 mm) and is filled with aluminum honeycomb. The Impact Head is guided down the track by dual 12 in. (305 mm) long sliders. An object marker sheeting panel bolts to the energy attenuation module and contains 3 directional sheeting patterns gore, left, and right. The object marker panel is 19 in. (483 mm) X 19 in. (483 mm) and can accommodate different patterns and colors as requested. The track weldment consists of 2 parallel longitudinal "T" shaped tracks that are welded to ground level lateral anchoring plates. At the rear of the track weldment is a 31.0 in. (787 mm) tall backup structure that is made from 4.0 in. (203 mm) X 8.0 in. (102 mm) steel tubing and is reinforced with steel tubing and gussets.

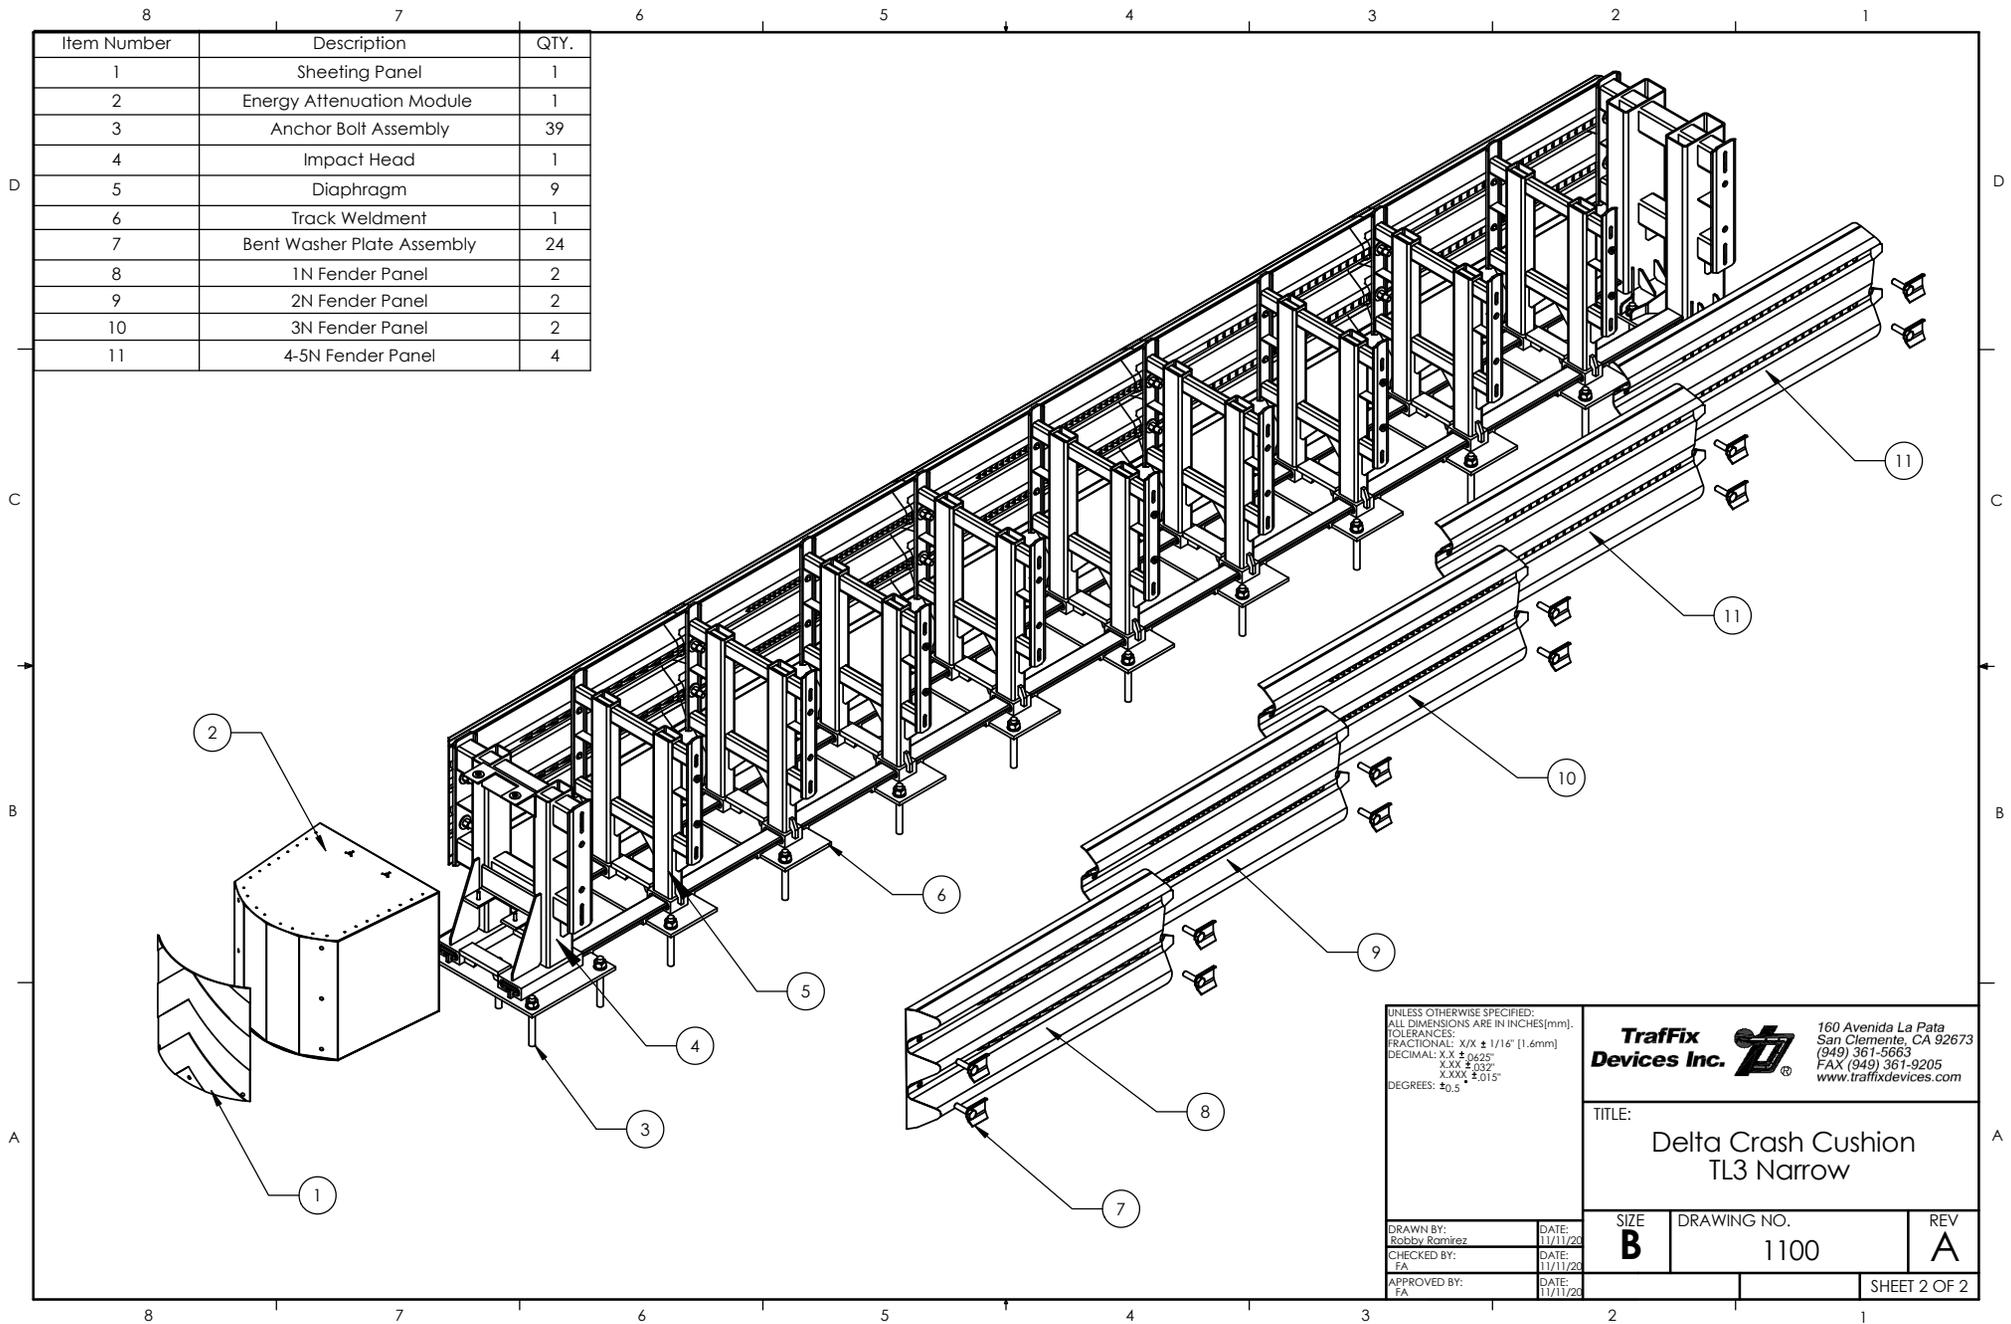
SIZE B	DRAWING NO. 1100	REV A
------------------	---------------------	-----------------

TITLE:
**Delta Crash Cushion
 TL3 Narrow**
