Improving Pavement Friction for Safety at a Florida Signalized Intersection

Summary Report

1. Report No. FHWA-SA-22-10	2. Government Accession No.	3. Recipient's Catalog No.	
4. Title and Subtitle Improving Pavement Friction for Safety at a Florida Signalized Intersection		5. Report Date November 2021

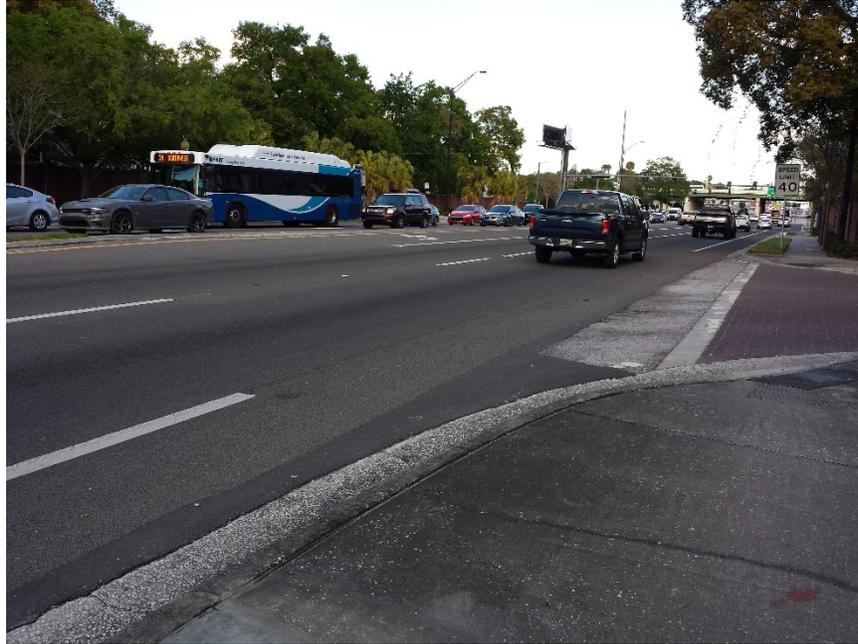
Figure 8. Photograph. HFST condition approximately 8 months after installation.

- Overall the HFST was in good condition without any cracking or other deformations (figure 8).
- There was little evidence of shedding and loose aggregate particles (note that the surface has been swept several times).
- Minor delaminations were noted near the west end of the project in the outside lane (figure 9).
- A small irregular area at the southwest corner of the Central Ave. intersection is exhibiting minor HFST loss, possibly due to manual material application required at this location (figure 10).

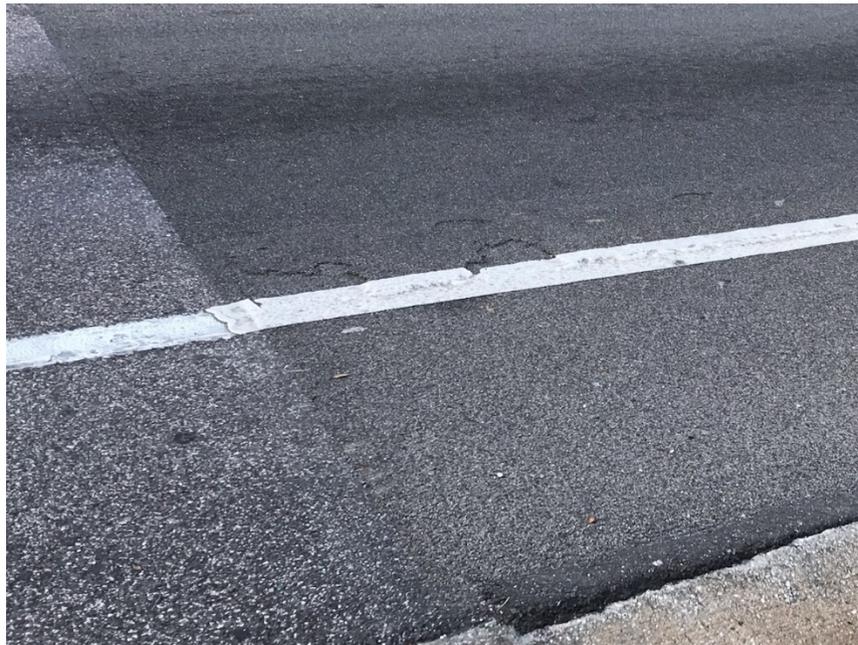
Figure 9. Photograph. Small delaminations near west end of project in outside lane.

Although the exact cause has not been determined, it is likely that the small areas of delamination near the beginning of the treatment are related to surface preparation not completely removing grease/oil deposits. The small area where HFST loss was observed at Central Ave. is likely the result of inadequate resin binder thickness at this location during manual HFST application to this area where automated application was not possible. Both areas should be monitored over time to document any additional surface loss.
