# ROAD SAFETY AUDITS: CASE STUDIES

1. Report No. FHWA-SA-06-17		2. Government Accession No.		3. Recipient's Catalog No.	
4. Title and Subtitle  <i>Road Safety Audits: Case Studies</i>				5. Report Date December 2006

The results of the RSAs have been compiled in this case studies document. Each case study includes photographs, a project description, a summary of key findings, and the lessons learned. The aim of this document is to provide state and local agencies and Tribal governments with examples and advice that can assist them in implementing RSAs in their own jurisdictions.

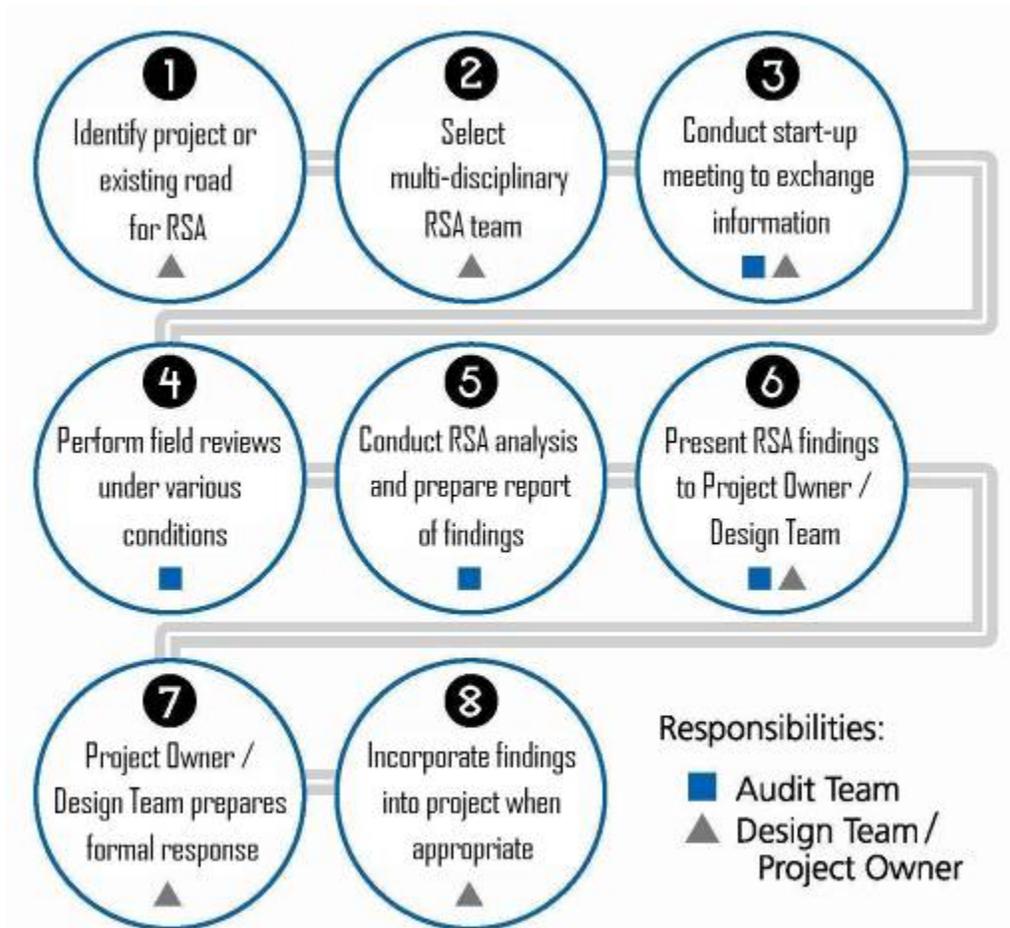
FIGURE 1 RSA PROCESS

The eight steps of an RSA are shown in Figure 1, and are discussed below with reference to the case studies.

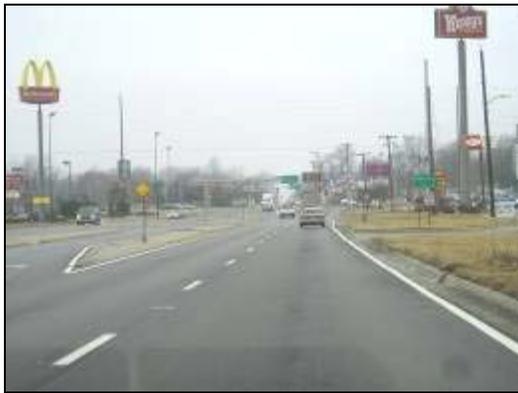
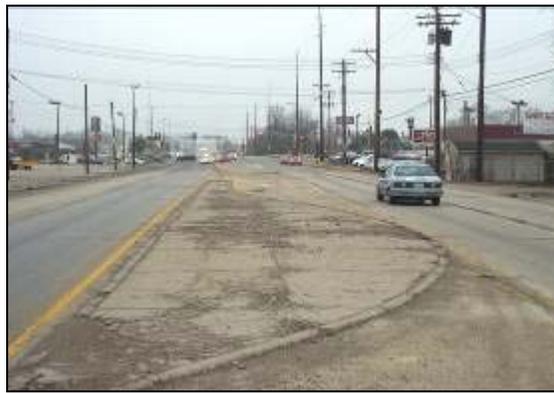
**FIGURE A.1 VIEWS OF RSA SITE (ILLINOIS DOT RSA)**

Clear Lake Avenue (looking west toward intersection with Dirksen Parkway)

Dirksen Parkway (looking south toward intersection with Clear Lake Avenue)

The intersection of Clear Lake Avenue and Dirksen Parkway was designated a high accident location for six consecutive years (1998 through 2003), and the intersection of Hill Street and Clear Lake Avenue was designated a high accident location in 2003. In response, the Illinois Department of Transportation (IDOT) developed plans to upgrade Clear Lake Avenue between Dirksen Parkway and the I-72/I-55 interchange. The scope of the planned improvements, shown in FIGURE A.2, included:

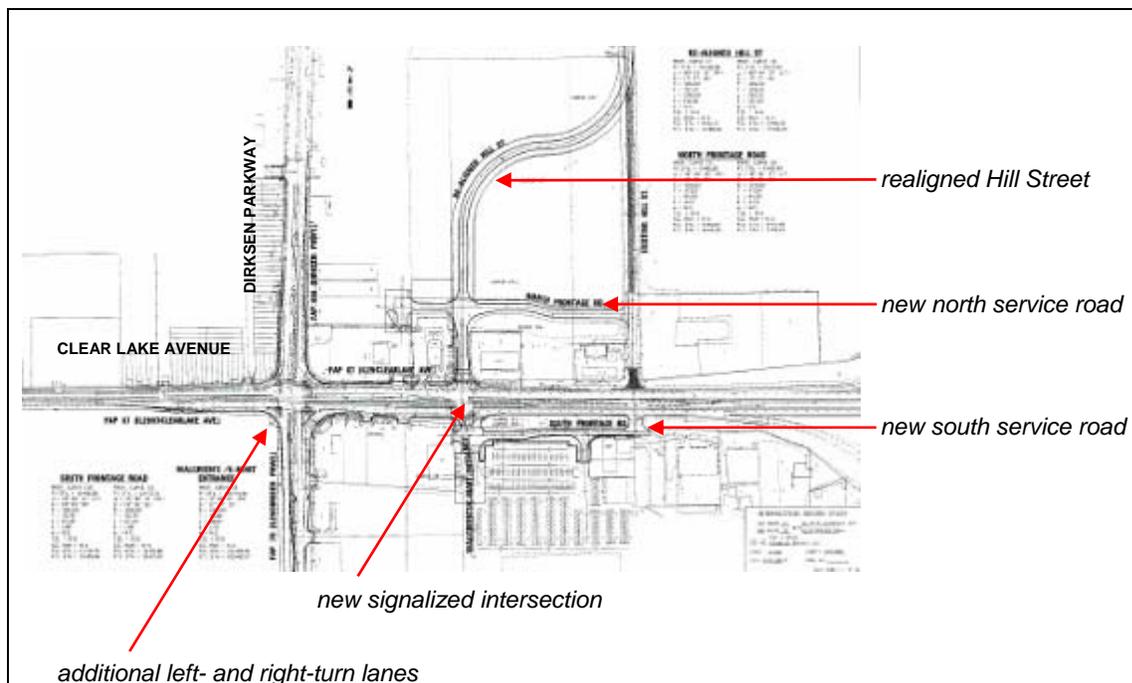
**FIGURE A.2 RSA PROJECT (ILLINOIS DOT RSA)**

- access consolidation and construction of two new service roads intersecting Clear Lake Avenue at a new signalized intersection east of Dirksen Parkway;
- realignment of Hill Street (a local road) to intersect Clear Lake Avenue at new signalized intersection;
- dual left turn lanes on all legs of the intersection of Clear Lake Avenue and Dirksen Parkway, and dual right turn lanes on the southeast corner of the intersection.

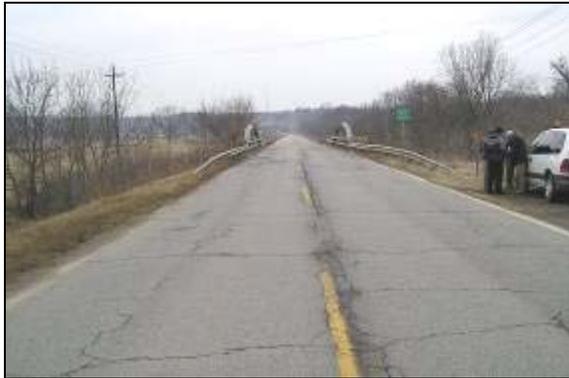
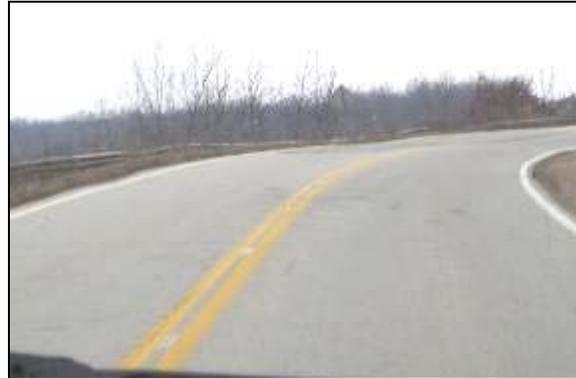
**FIGURE A.3 VIEWS OF RSA SITE (OKLAHOMA DOT RSA)**

*Buck Creek bridge  
(planned improvements include repaving, bridge improvements, and 8' paved shoulders)*

*adjacent "incidental" section  
(planned improvements include repaving and 2' paved shoulders)*

- replacing existing bridges over Buck Creek and Turkey Creek, including reconstructing the approach roadways as two 12-foot lanes with 8-foot paved shoulders;
- between the bridges, widening shoulders to provide a continuous 8-foot paved shoulder and adding one channelized right turn lane at the unsignalized intersection with Bowring Road, a section-line road;
- resurfacing a 1.2-mile "incidental section" west of Buck Creek (12-foot lanes with 2-foot paved shoulders) to connect with an adjacent segment of US 60 further west that had been recently overlaid.

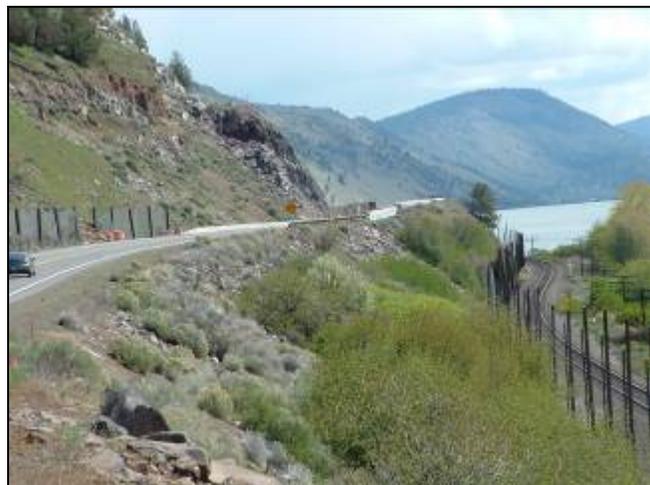
**FIGURE A.4 RSA SEGMENT OF US 97**

The project, along US Highway 97 between Modoc Point and Algoma, was located in Klamath County in South Central Oregon. In this area, the US 97 alignment passes along the east side of Upper Klamath Lake and the Union Pacific Railroad (FIGURE A.4). The Oregon Department of Transportation (ODOT) identified several safety issues along this section of US 97, including a fatality rate of 5.3 per million vehicle miles, almost double the average rate for similar Oregon highways. The DOT noted the presence of narrow substandard shoulders widths, substandard cut and fill slopes, and unprotected safety issues within clear the zone, including barriers, guardrail, and guardrail end terminals that did not meet current standards.

To address these and other concerns, a two-phase road improvement program was adopted by ODOT. Phase One work, which began in early 2005 and was in progress at the time of the RSA, included replacement/repair of four bridges as well as rockfall work and widening on the east side of the highway. Phase Two work, which was to be let in September 2007 with a projected completion date of November 2009, was expected to take place on the west side of US 97, between the highway and the adjacent railroad tracks.

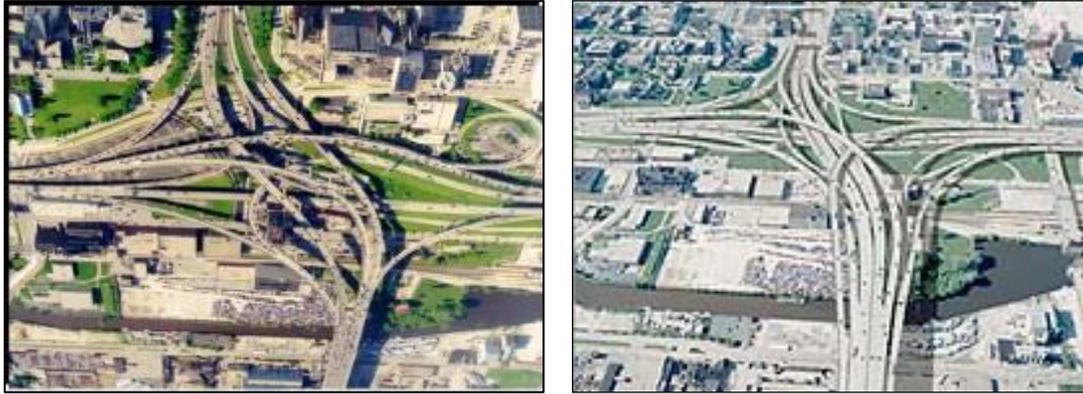
*Existing Interchange**Improved Interchange (simulation)***FIGURE A.5 EXISTING INTERCHANGE AND PROPOSED IMPROVEMENTS**

Highways I-94, I-794, and I-43 meet at the Marquette Interchange in Milwaukee. The interchange, considered the cornerstone of the southeastern Wisconsin freeway system, accommodates Milwaukee's commuter traffic, as well as interurban traffic traveling to and from Madison, Green Bay, and Chicago, and long-distance interstate traffic. Reconstruction of the existing interchange, which built in 1968, was required to address structural deterioration and operational concerns. At the time of the RSA in December 2003, planning and design for the reconstructed interchange had been ongoing for several years, and construction was to commence in about six months. The RSA examined both the proposed changes and construction-stage plans, since the interchange was required to remain operational throughout the four-year construction period. The existing and redesigned interchanges are shown in FIGURE A.5. The total cost of the interchange reconstruction was anticipated to be \$800 million.

The planned reconstruction includes upgrades and improvements include:

- replacement of left-side ramps with conventional right-side ramps,
- lengthening or elimination of existing short weaving sections,
- increased curve radii on ramps,
- lane continuity and consistency for through traffic,
- increased capacity on system ramps,
- increased barrier height.

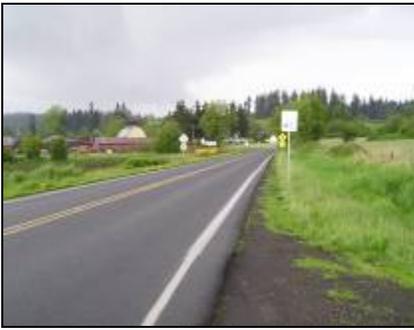
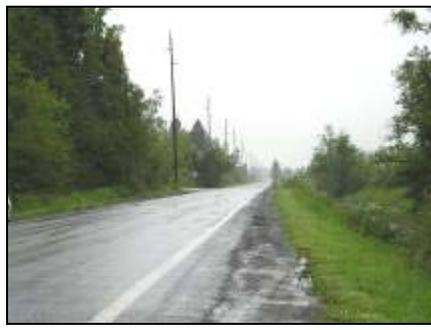
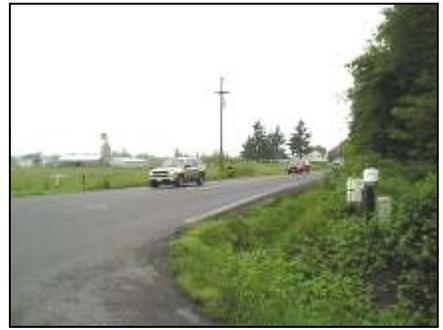
FIGURE A.6 VIEWS OF RSA SITE (CLARK COUNTY RSA)

Ward Road near Davis Road

172<sup>nd</sup> Avenue near Ward Road

182<sup>nd</sup> Avenue at 119<sup>th</sup> Street

The planned improvements affected three roads: Ward Road (also known as 182<sup>nd</sup> Avenue), 172<sup>nd</sup> Avenue, and 119<sup>th</sup> Street, shown in FIGURE A.6. In addition to functioning as major rural collectors, these roads provided access to adjacent properties (residential and farm) and a small farming town. Improvements, numbered and shown in FIGURE A.7, included:

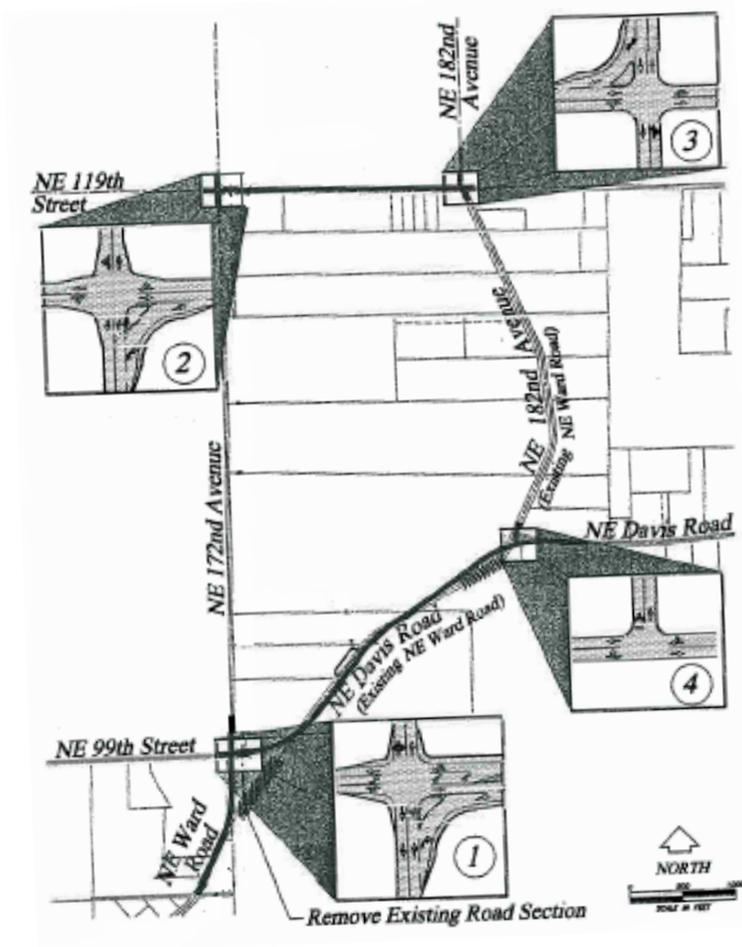
FIGURE A.7 RSA PROJECT (CLARK COUNTY RSA)

- 1) realignment of Ward Road between 172<sup>nd</sup> Avenue and Davis Road (involving abandonment of an existing road section on structure), and introduction of a new four-way signalized intersection;
- 2 and 3) intersection improvements at the STOP-controlled intersections of 119<sup>th</sup> Street / 172<sup>nd</sup> Avenue and 119<sup>th</sup> Street / 182<sup>nd</sup> Avenue, including the introduction of a free right turn lane on one approach;
- 4) reconfiguration of the existing Ward Road / Davis Road intersection, and relocating the STOP sign from Davis Road to 182<sup>nd</sup> Street.

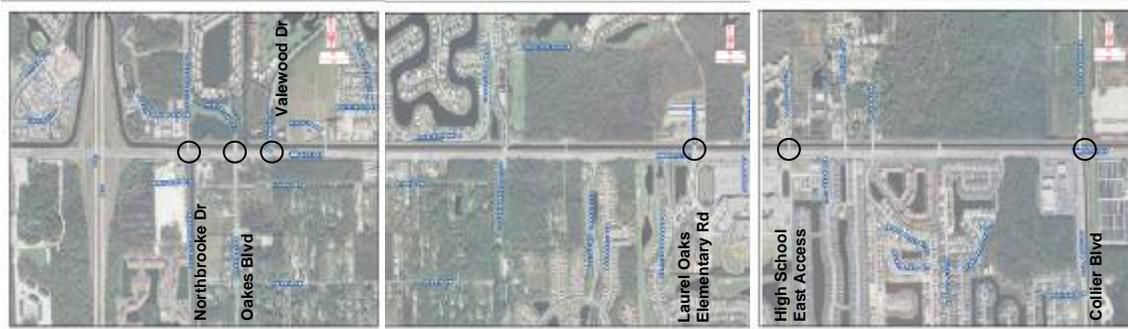
**FIGURE A.8 RSA SEGMENT (COLLIER COUNTY RSA)**

Immokalee Road, a County road, is a major east/west arterial connecting residential areas in western Collier County with I-75, US Highway 41, and the City of Naples. The RSA section of the roadway, shown in FIGURE A.8, was widened from two lanes to four lanes in 2002. The four-lane cross-section, shown in FIGURE A.9, was a divided arterial roadway with two through lanes in each direction, a grass median (up to about 40 feet wide), and turning lanes at signalized intersections. The corridor was adjacent to low-density residential, commercial, and institutional land uses, including the North Naples Fire Station No. 42, Gulf Coast High School, Laurel Oaks Elementary School, and several churches.

To accommodate current and forecast future demand, the County was considering additional widening to six lanes. The proposed upgrade would entail widening the road to a six-lane divided urban arterial standard. At the time of the RSA, the widening project was at a conceptual stage. Design documentation consisted of State design practices and the County's typical section for a six-lane divided urban arterial.

Signalized intersections shown.

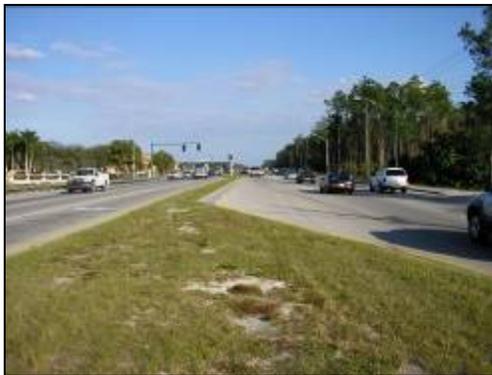
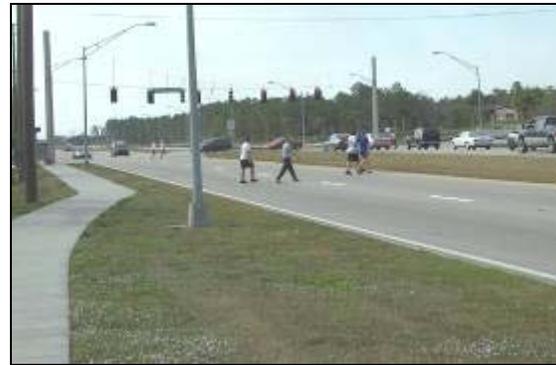
**FIGURE A.9 VIEWS OF RSA SITE (COLLIER COUNTY RSA)**

*Immokalee Road near Valewood Drive*

*Immokalee Road in front of schools*

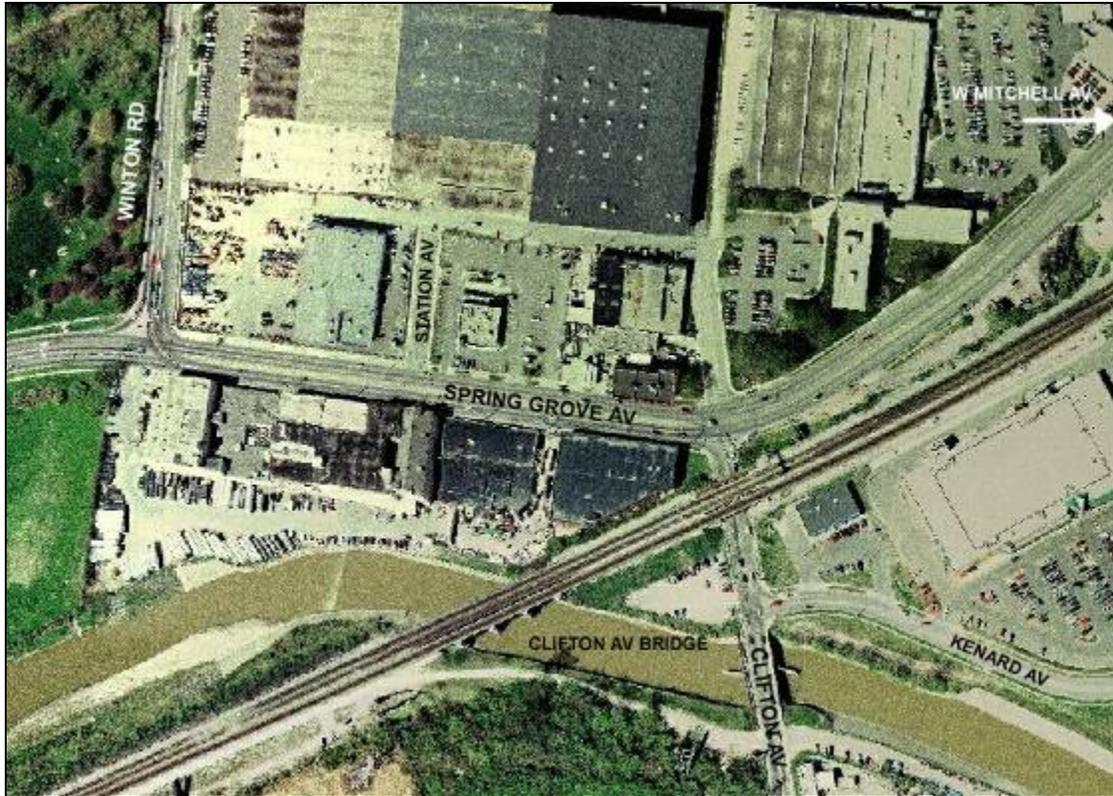
**FIGURE A.10 RSA SITE (CINCINNATI)**

- Clifton Avenue bridge widening to accommodate four 10-foot lanes and a 10-foot painted median strip,
- traffic signal improvements at the intersection of Spring Grove Avenue and West Mitchell Avenue,

- other possible improvements to Spring Grove Avenue in connection with the planned upgrade.

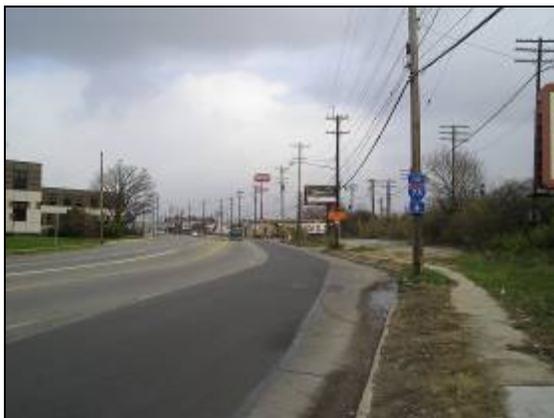
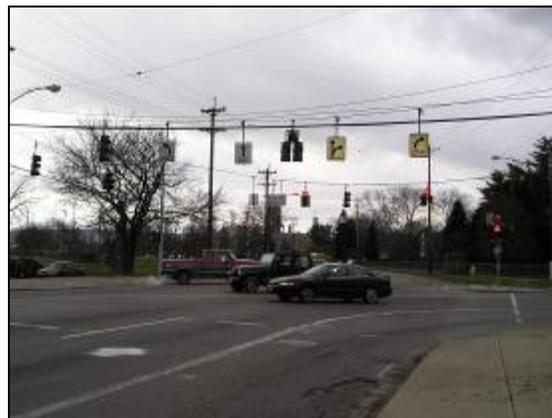
**FIGURE A.11 VIEWS OF RSA SITE (CINCINNATI RSA)**

*Spring Grove Avenue*

*intersection of Winton Road and Spring Grove Avenue*

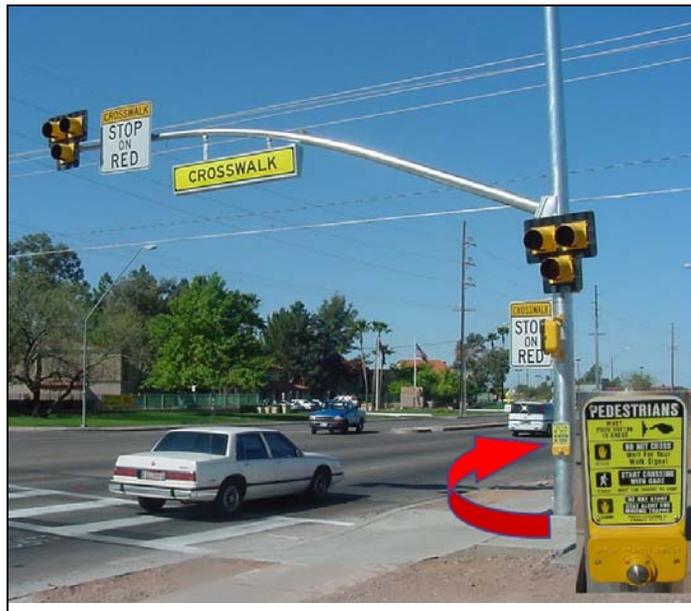
**FIGURE A.12 HAWK PEDESTRIAN SIGNAL**

HAWK (**H**igh-Intensity **A**ctivated **C**ross**W**alk) signals are a type of traffic control beacon for marked pedestrian crosswalks, developed by the City of Tucson and implemented in Tucson and elsewhere in Arizona. The City of Tucson received approval from FHWA to experiment with this device; it is not yet adopted in the *Manual of Uniform Traffic Control Devices*. The innovative HAWK signal, shown in FIGURE A.12, incorporates elements from fire station signals and school bus flashing displays, as well as from European pedestrian signal displays, to provide a familiar signal sequence for drivers and pedestrians. The HAWK signal is activated by a pedestrian

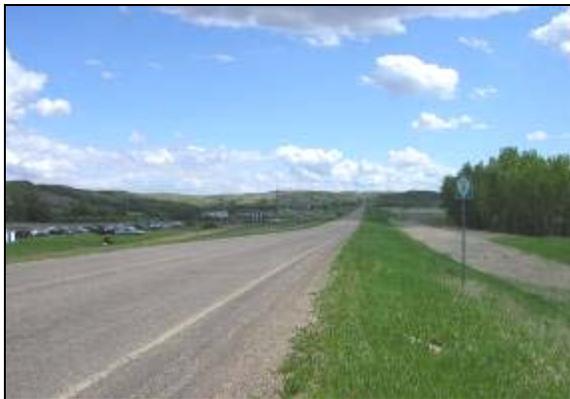
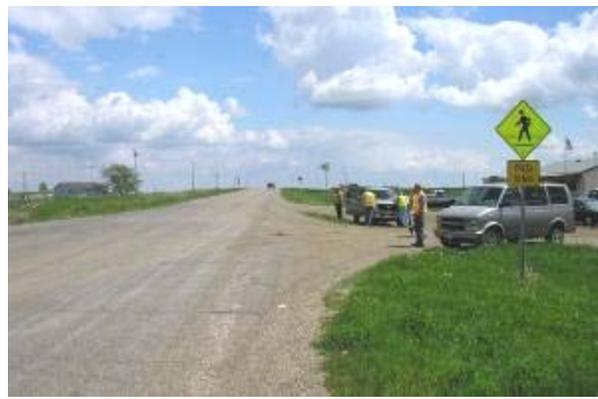
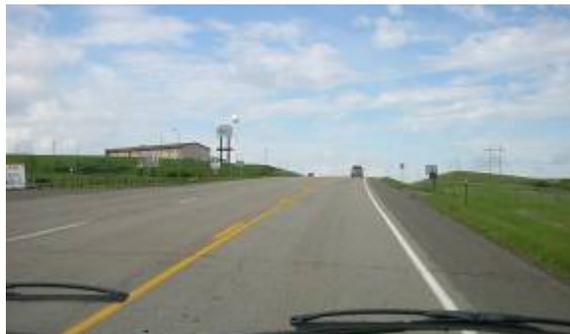
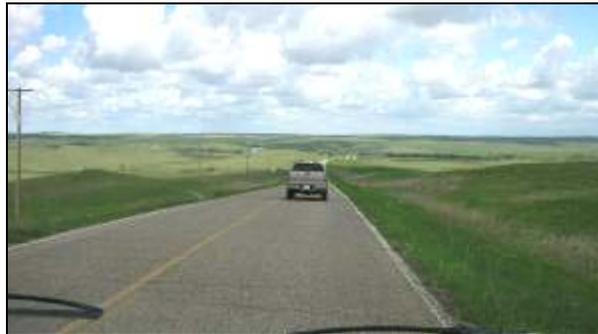
**FIGURE A.13 VIEWS OF RSA SITES (STANDING ROCK SIOUX TRIBE RSA)**

Roads studied during this RSA included ND 24 and Highway 1806 (part of BIA 3), US 12, and community access roads. Typical reservation roadways are shown in FIGURE A.13. The RSA team drove these roads to identify safety issues associated with road geometry, traffic operations, and maintenance. Although bridge inspection is not a usual part of the RSA process, the RSA team was asked to observe possible maintenance issues associated with a bridge on BIA 3 at Four-Mile Creek. RSA findings associated with the bridge were included in the RSA report.

SELECTED SAFETY ISSUE (Number and Description)		RISK RATING	SUGGESTIONS
1	<i>Road Maintenance:</i> Limited maintenance on reservation roads contributes to poor pavement conditions and concern regarding bridge stability.	B to D	<ul style="list-style-type: none"> <li>• control cracking with sawcut and fill</li> <li>• accommodate future overlays</li> <li>• bridge inspection and repair</li> </ul>
2	<i>Access to Grand River Casino:</i> Drivers turning into and out of the Grand River Casino may interfere with crossing, opposing, and following traffic on US12.	D	<ul style="list-style-type: none"> <li>• speed reduction</li> <li>• improved signing</li> <li>• westbound left turn bay</li> <li>• access relocation</li> </ul>
3	<i>BIA 31 and ND 24 (School Frontage):</i> Driver workload is potentially high near the intersection of BIA 31 and ND 24, which accommodates local, school, and through traffic.	B to D	<ul style="list-style-type: none"> <li>• no-passing zone</li> <li>• crosswalk maintenance</li> <li>• enhanced signing</li> <li>• turning lanes on ND24</li> <li>• improved lighting</li> <li>• access consolidation</li> <li>• urban cross section</li> </ul>

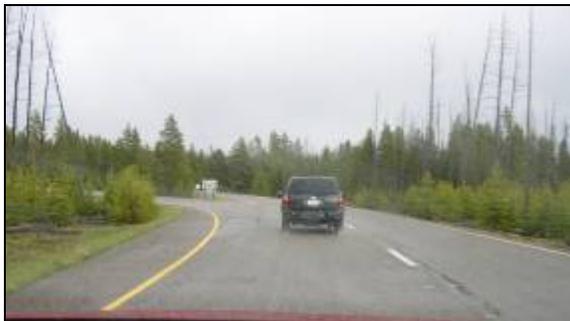
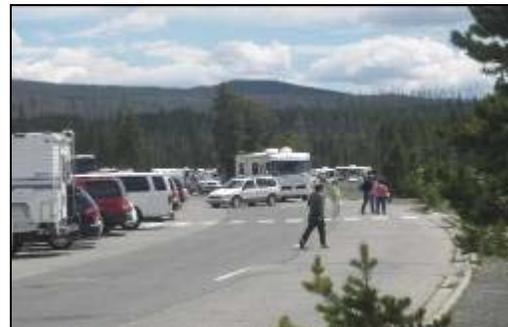
**FIGURE A.15 VIEWS OF RSA SITE (YELLOWSTONE NATIONAL PARK)**

*Old Faithful Road*

*part of main parking area near Old Faithful geyser*

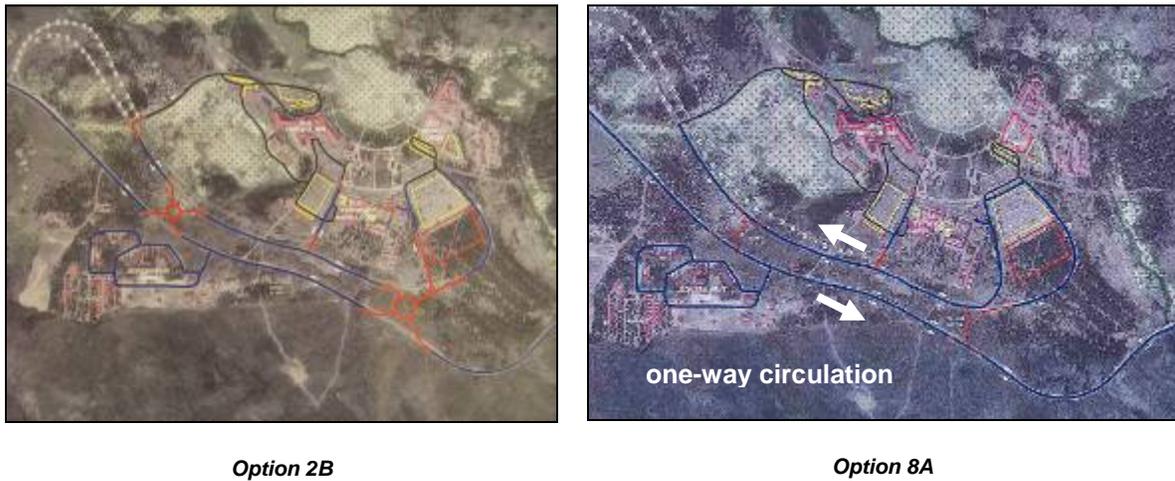
FIGURE A.16 PROPOSED IMPROVEMENTS TO OLD FAITHFUL AREA

Since construction of the interchange replacement was expected to start no sooner than 2009, about four years after the RSA, the RSA also included a review of existing roads to identify low-cost countermeasures that could be implemented on an interim basis before the start of the planned improvements. The focus of the RSA was the existing Old Faithful Road between the Old Faithful interchange and the geyser site, including the geyser parking area, as shown in FIGURES A.14 and A.15. The key findings and suggestions of the RSA are summarized in TABLE A.12. In its response, the owner undertook to consider the RSA team's observations in the final choice of design options for access to the Old Faithful area, and to incorporate the RSA team's interim suggestions for pedestrian safety into planned improvements to the Old Faithful area.

6	<p><i>Old Faithful Interchange</i></p>	<p><i>Interim measures:</i></p> <ul style="list-style-type: none"> <li>▪ roadside barriers</li> <li>▪ crash attenuators</li> <li>▪ improved signing and pavement markings</li> </ul> <p><i>Ultimate measure:</i></p> <ul style="list-style-type: none"> <li>▪ replacement of existing interchange (as planned)</li> </ul>
