# IMPROVING ACCESS TO TRANSIT USING ROAD SAFETY AUDITS: FOUR CASE STUDIES

<b>1. Report No.</b> FHWA-SA-16-120	<b>2. Government Accession No.</b>	<b>3. Recipient's Catalog No.</b>
<b>4. Title and Subtitle</b>  Improving Access to Transit Using Road Safety Audits: Four Case Studies		<b>5. Report Date</b> October 2016
		<b>6. Performing Organization Code</b>
<b>7. Author(s)</b>  Elissa Goughnour, Javier Revilla, and Corey Pitts		<b>8. Performing Organization Report No.</b>
<b>9. Performing Organization Name and Address</b>  Vanasse Hangen Brustlin, Inc. 8300 Boone Boulevard, Suite 700 Vienna, VA 22182-2626		<b>10. Work Unit No. (TRAIS)</b>
		<b>11. Contract or Grant No.</b>
<b>12. Sponsoring Agency Name and Address</b>  Federal Highway Administration Office of Safety 1200 New Jersey Ave. S.E. Washington, DC 20590		<b>13. Type of Report and Period Covered</b>  Final Report October 2016
		<b>14. Sponsoring Agency Code</b>

Road Safety Audits (RSAs) are a formal safety performance examination of an existing or future roadway or off-road facility and are conducted by an independent, experienced, multidisciplinary team. This case study document provides a review of the RSA process and fou

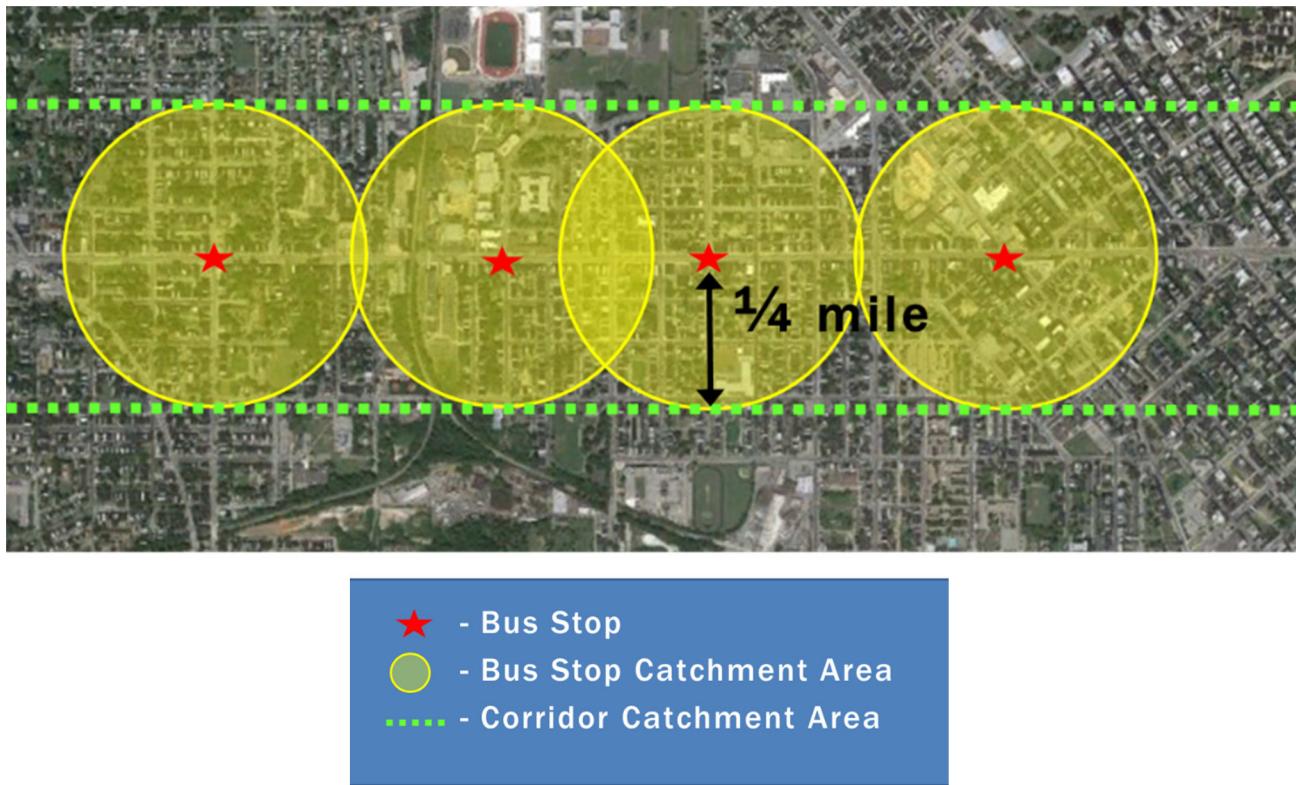
Figure 2. Example of bus stop and bus corridor catchment area (Map data: ©Google).

Figure 2 illustrates an example of a bus stop and bus corridor catchment area. Within these catchment areas, it is important to identify routes that people use to walk, bike, or drive to transit facilities and identify and address the safety risks to transit users.

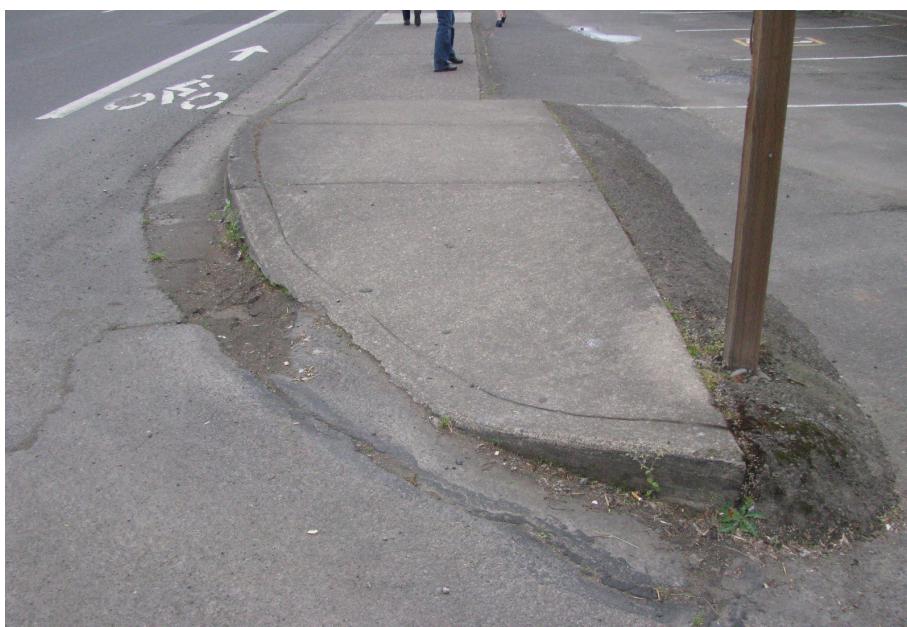
**Figure 4. Example of ramp at an unmarked crosswalk on Main Street in the City of Springfield, Oregon**  
**(Photo Credit: Elissa Goughnour).**

- *ADA compliance.* The RSA teams noted many instances where marked and unmarked crossings were not ADA compliant and were lacking ramps and/or detectible warning strips and signalized intersections lacked accessible pedestrian signals. It is important to ensure ADA compliance so that all individuals are able to access transit facilities. For example, the RSA performed in the City of Springfield, Oregon, noted that many marked and unmarked crossings did not meet ADA standards, even though there is a large population of older or disabled individuals to the east of the downtown area. Figure 4 shows an unmarked crosswalk that is not ADA compliant.

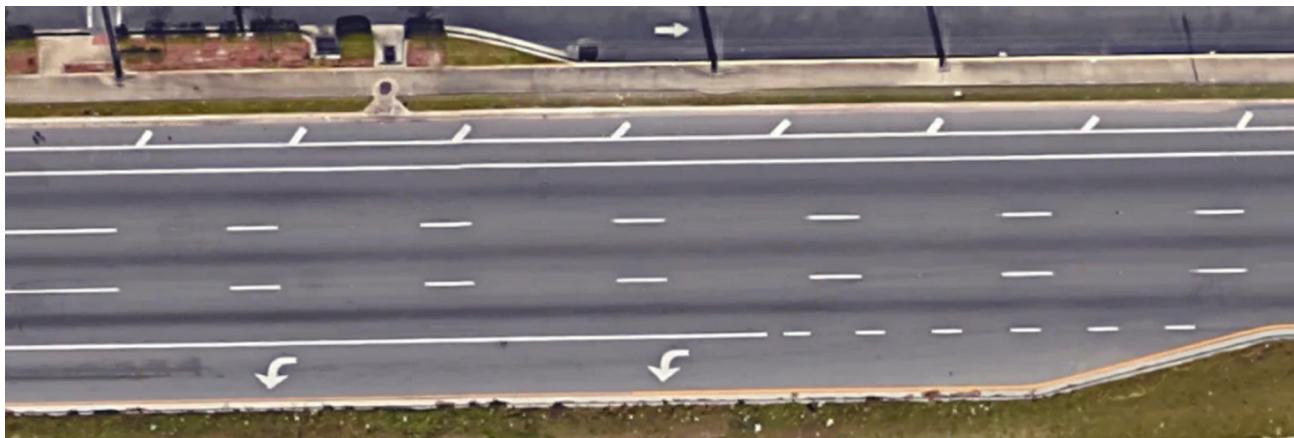
**Figure 5.** West Colonial Drive, east of the Pine Hills Road intersection, with a buffer between the bicycle lane and the curb (Map data: ©Google).

- *Pavement markings.* The use of pavement markings on roadways to alert drivers of non-motorized users plays a significant role in creating cohesive multimodal environment. During the RSAs, the team members noted many instances of faded and/or incomplete pavement markings. In some instances, the markings were present but could have been used in a more effective format. For example, in Orlando, Florida, the RSA team noted that pavement markings are present and in good conditions in all the study areas. However, in one of the focus areas, a buffer was provided between the bike lane and the curb as shown in Figure 5, rather than a buffer between the bike lane and travel lanes where it would provide the greatest benefit for cyclists. In this area, drivers were also using the bike lane and buffer as a right- turn lane possibly due to the lack of bike lane pavement markings and the available width which allows the buffer and bike lane to function as a full travel lane.

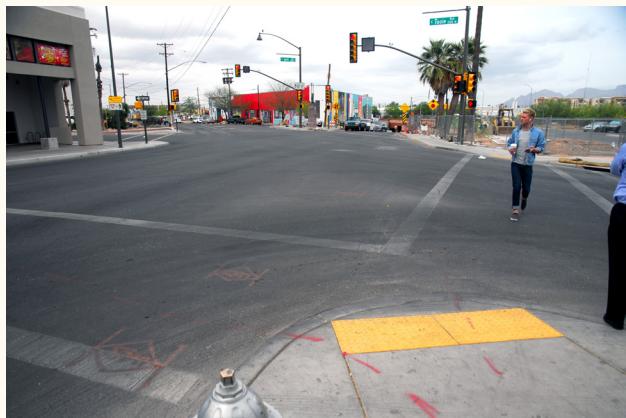
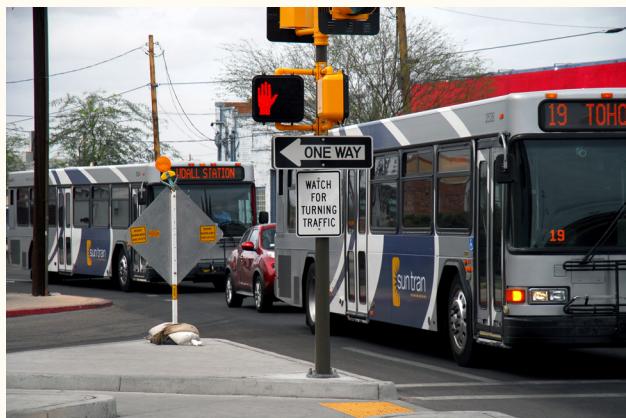
**Restricted Sight Distance.** Intersection geometry and building placement combine to create challenging sight lines for vehicles attempting to turn left from North 6th Avenue to East Alameda Street and drivers turning left from northbound North Toole Avenue to southbound North 6th Avenue. It is particularly difficult for drivers turning left to see pedestrians waiting on the corner to cross East Alameda Street and North 6th Avenue.

**Top Photo:** Sight lines of turning traffic from westbound East Toole Avenue to North 6th Avenue. **Bottom Photo:** Signage designed to alert pedestrian to watch for turning vehicles (Photo credit: Dan Nabors).

**Modify Pedestrian Warning.** Replace existing black and white "WATCH FOR TURNING TRAFFIC" signage with yellow warning sign and consider alternative warning methods such as adding pavement marking warnings for pedestrians to watch for turning vehicles.

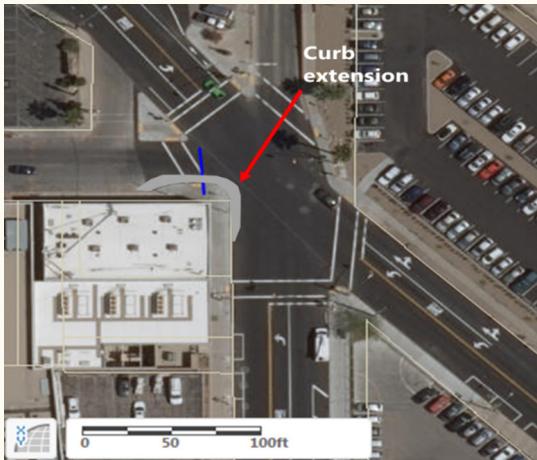
**Above:** diagram showing the curb extensions on East Alameda Street and North 6th Avenue (Map data: Microsoft® Bing™).

**Curb Extension.** Reduce the pedestrian crossing distance and improve visibility of pedestrians at the intersection by extending the existing curb extension on East Alameda Street and adding a curb extension on the southwest corner of the intersection along North 6th Avenue. Any reconfiguration of the curb line should consider future bicycle infrastructure designs that may be installed along East Alameda Street.

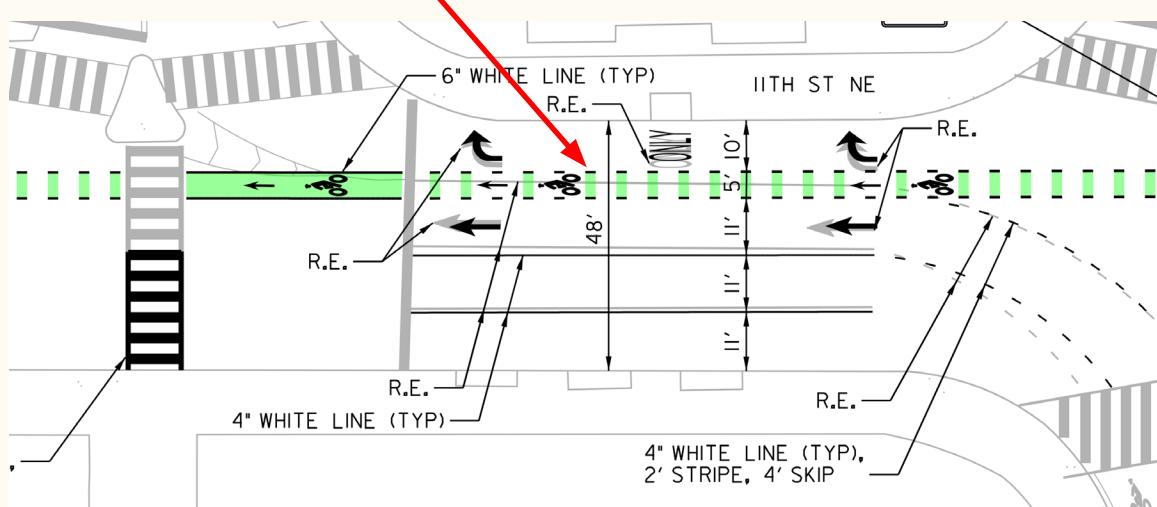
*Above: An example of the dashed bicycle lane and green pavement markings that could be considered in transition areas (Source: VHB).*

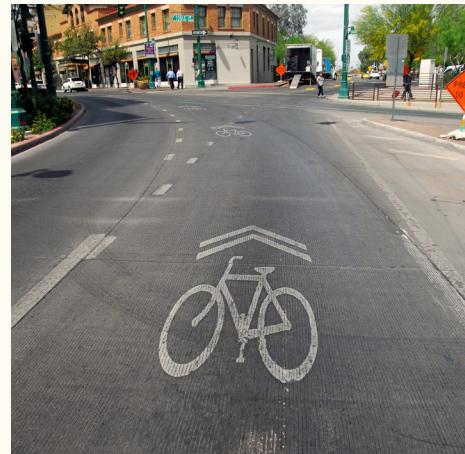
*Example of a shared-lane marking placed in the center of the lane (Photo credit: Dan Nabors).*

**Pavement Markings.** Consider shifting the shared lane markings along North 6th Avenue from the right edge to the center of the lane.

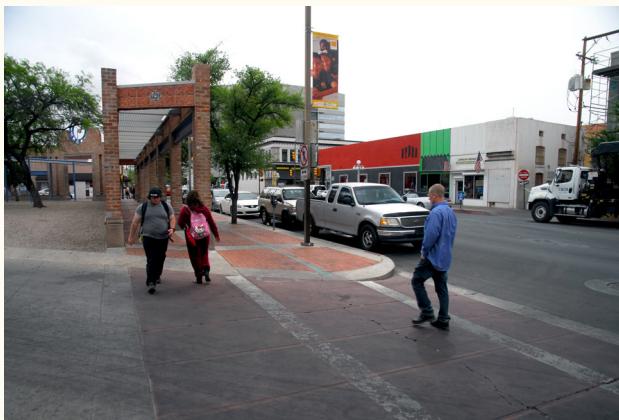
**Mid-block Pedestrian Crossings.** Pedestrians were observed crossing North 6th Avenue mid-block between East Congress Street and East Pennington Street. This area is planned for redevelopment, likely increasing pedestrian activity. There is currently no mid-block crossing here.

*Above: View looking south along North 6th Avenue from behind the stop bar at the bus exit (Photo credit: Dan Nabors).*

**Mid-block Pedestrian Crossing Improvements.** Consider adding a mid-block crossing on North 6th Avenue as part of the redevelopment of the transit center.

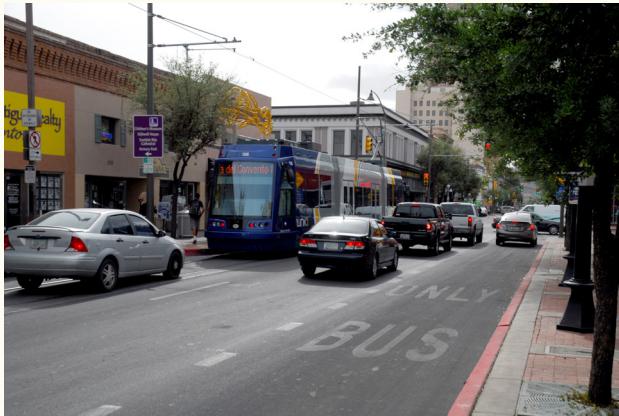
**Unmarked Lanes.** The lane striping used along East Congress Street approaching North 6th Avenue does not clearly indicate that the curb lane is a bus only lane. This was noted as part of the general observations for the study.

*Above: Bus only lane along East Congress Street uses broken lane markings with "Bus Only" and red curbpaint as opposed to the hatched pavement markings found along North 6th Avenue (Photo credit: Dan Nabors).*

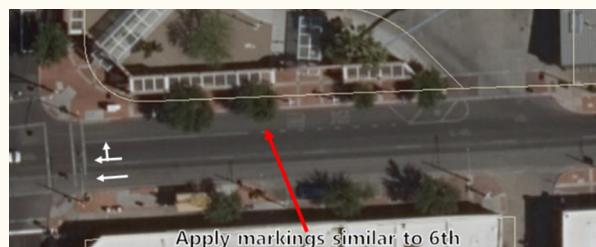
*Above: Suggested pavement marking changes along Congress Street (Map data: Microsoft® Bing™).*

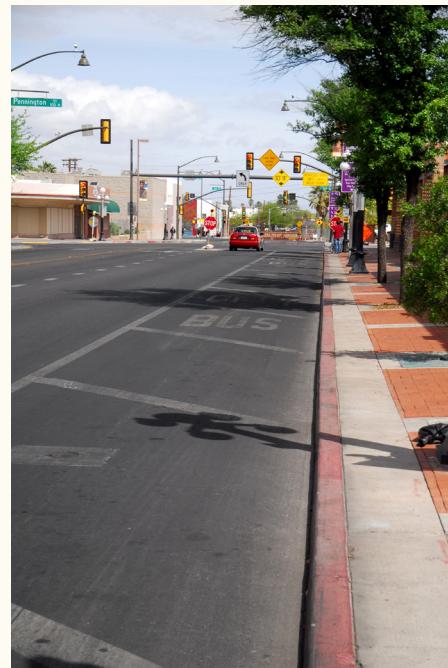
*Above: Example of hatched pavement markings in bus only lane along North 6th Avenue (Photo credit: Dan Nabors).*

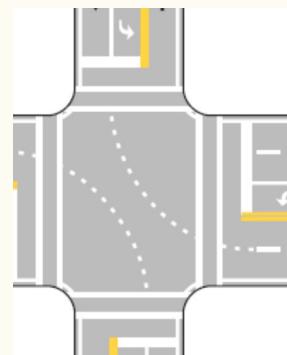
*Example of dotted line markings to extend the left-turn lane line markings into the intersection (Source: MUTCD).*

**Skip Lines.** Consider adding dotted line markings to extend the South 5th Avenue southbound left turn lane line markings through the intersection.

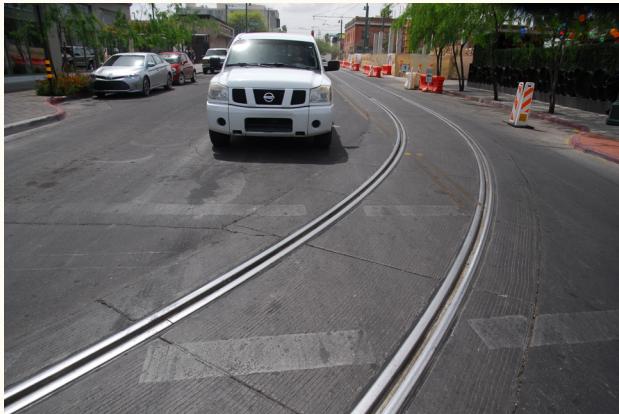
*Left turn lane stop bar currently crosses the streetcar tracks, blocking the streetcar if vehicles are pulled forward (Photo credit: Dan Nabors).*

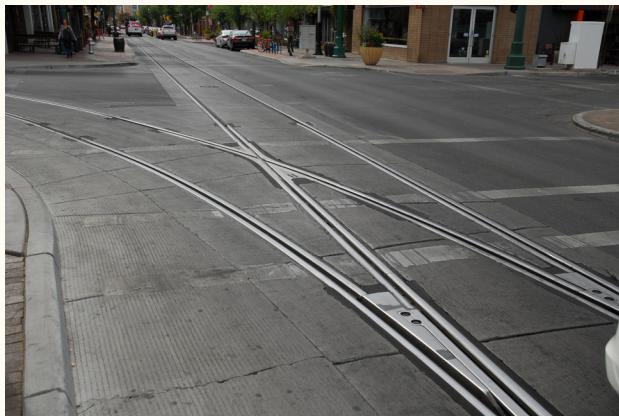
**Gaps in Streetcar Tracks.** There were incidents involving cyclists whose bike wheels became trapped in the tracks at the split in the streetcar tracks. Due to their smaller wheel size, it is more difficult for cyclists to traverse roadway elements that may not pose a hazard to other roadway users with larger wheels.

*Streetcar track split can present challenges for bicycles attempting to turn left and cross over the multiple tracks (Photo credit: Dan Nabors).*

**Bicycle Safety Measures.** Consider adding a two-stage left turn queue block for bikes turning left from East Congress Street onto South 5th Avenue so that cyclists can completely avoid crossing the tracks or cross them at a 90 degree angle, allowing them to cross without trapping their wheels in the tracks.

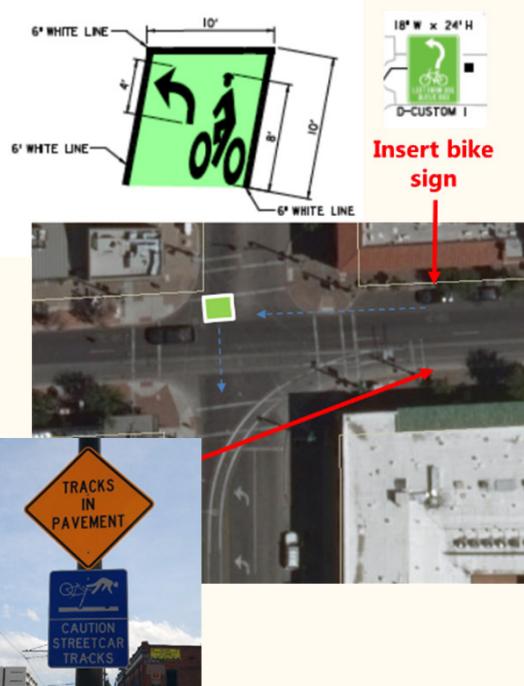
*Example of relocating the stop bar and providing a two-stage left turn queue box for cyclists (Photo credit: Dan Nabors; Map data: ©Google).*

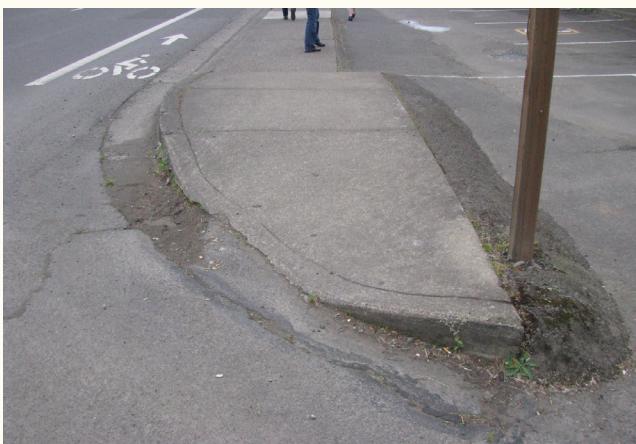
Concerns / Issues	Examples of Suggested Actions
<p><b>ADA compliance and accommodations for older pedestrians.</b> The RSA team noted many instances where marked and unmarked crossings were not ADA compliant and were lacking ramps or detectable warning strips. It was also discussed that to the east of the downtown area, there is a large population of older and/or disabled individuals. It is important to ensure ADA compliance so that all individuals are able to access transit facilities.</p>	<p><b>Ensure that pedestrian routes and crossings are ADA compliant.</b> This is particularly important in areas with an aging population or populations with mobility challenges. The city should review pedestrian routes and develop or update a Transition Plan for addressing the necessary changes to bring the routes up to current ADA standards.</p>

<p><b>Example of ramp at an unmarked crosswalk on Main Street (Photo credit: Elissa Goughnour).</b></p>	<p><b>Continue and enhance education efforts.</b> Many people may be unaware that unmarked crossings are legal crossings. However, according to the same FHWA study referenced above, “On multilane roads with traffic volumes greater than 12,000 vehicles per day, having a marked crosswalk was associated with a higher pedestrian crash rate (after controlling for other site factors) compared to an unmarked crosswalk.”<sup>2</sup> Education efforts can help education both drivers and pedestrians on pedestrian-related laws but also safe crossing techniques. Similarly, education efforts are needed to educate cyclists about wrong-way riding, sidewalk riding, and mid-block crossings.</p>
<p><b>Unmarked crossings and mid-block crossings.</b> The RSA team witnessed many pedestrians crossing at unmarked crossings or mid-block crossings. While unmarked crossings are legal crossing locations, drivers may not expect pedestrians to cross Main Street outside of the marked crosswalk locations due to the high speeds and wide crossing distance.</p>	<p><b>Bike lane maintenance.</b> Ensure that the bike lane is swept regularly and is free of debris. Also, during the next paving cycle, inspect to make sure there is a smooth transition between the pavement and gutter pan, so that cyclists can use the full width of the bike lane, and also to help ensure that the road drains properly and does not pool in the bike lane.</p>

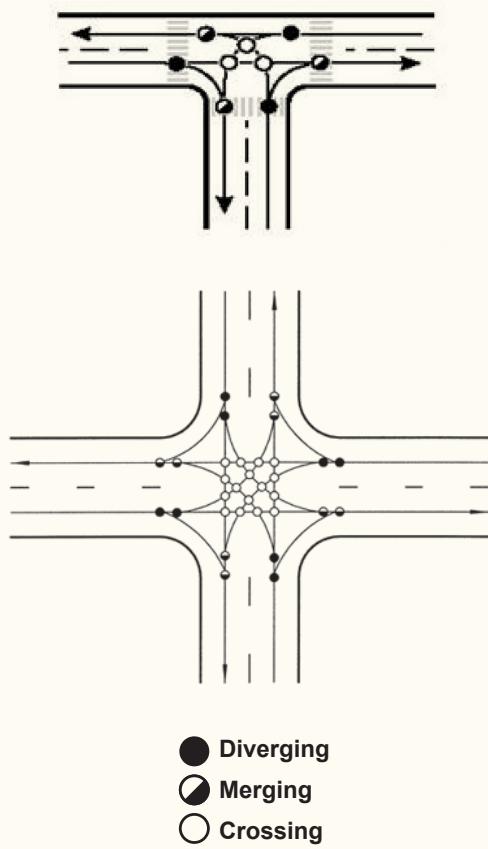
**Corridor access.** There are many roadway access points, particularly on the eastern end of Main Street. A four-leg intersection has 32 conflict points and a three-leg intersection has nine conflict points. Each roadway access point (i.e. driveway, commercial entrance, etc.) has many potential conflict points which increase the crash risk for all roadway users. Additionally, with so many entrances into the roadway there are many opportunities for slower moving vehicles to enter or exit the roadway, leading to a speed differential with faster moving vehicles continuing straight along the road.

**Conflict points for three and four-leg intersections**  
(source: FHWA).

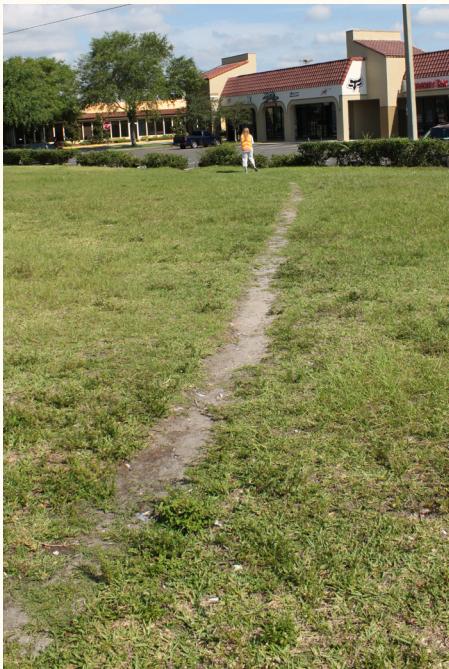
**Lack of accessible paths from bus stop to neighboring destinations.** There were pathways worn into the grass, indicating the path that pedestrians travel from the transit stop to neighboring destinations.

**Pathway leading to the shopping center on the northwest corner of West Sand Lake Drive and Summer Day Lane intersection (Photo credit: Elissa Goughnour).**

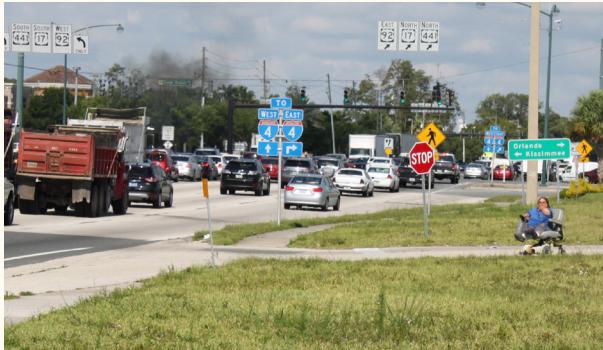
**A wheelchair user accessing the same shopping center by using the driveway (Photo credit: Elissa Goughnour).**

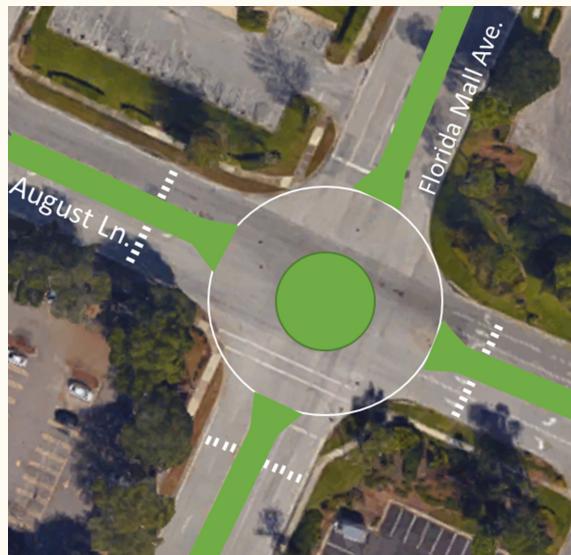
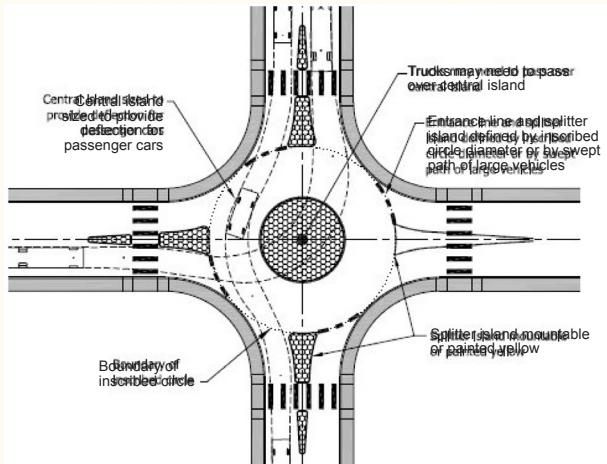
**Alternative intersection design option. Mini-roundabout intersection conceptual diagram (Map data: ©Google).**

**Mini-roundabout diagram (Source: FHWA).**

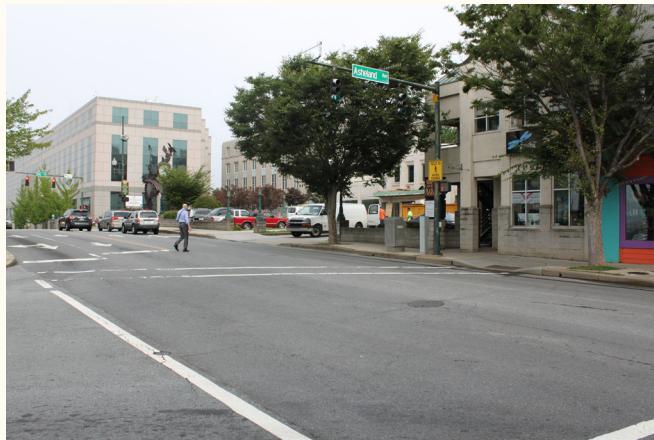
<p><b>Driver speed and yield behavior.</b> The RSA team noted driver behavior when approaching an intersection with a pedestrian present, that little or no attempt was made to yield to pedestrians. In addition, driver speeds were higher than the posted speed limit of 20 mph.</p>	<p><b>Speed reduction through road diet.</b> Road diets are a FHWA proven safety countermeasure that reallocate space from travel lanes to provide safety improvements such as two-way left-turn lanes, medians, or dedicated space for bicycles and pedestrians.<sup>25</sup> The primary goals of a road diet are, “Enhanced safety, mobility and access for all road users and a “complete streets” environment to accommodate a variety of transportation modes.”<sup>26</sup> Currently, the wide four-lane undivided roadway on Patton Avenue encourages higher speeds. Reallocating space through a road diet could provide a variety of safety benefits along the corridor.</p>

*Image shows an example of pedestrians crossing outside of the crosswalk (Photo credit: Elissa Goughnour).*

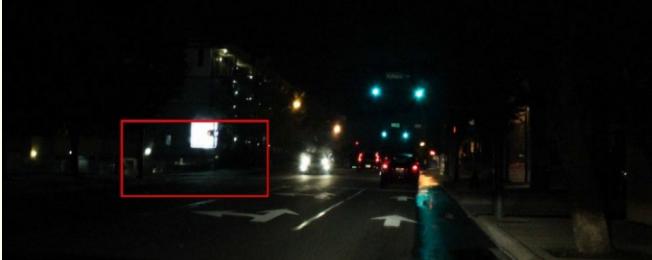
<p><i>Image shows reduced lighting at the intersection of Patton and Asheland Avenues. The intersecting road (Asheland Avenue) is highlighted within the red box, and is not visible to drivers due to reduced intersection street lighting (Photo credit: Elissa Goughnour).</i></p>	<p><b>Ensure ADA compliance.</b> Continue evaluating transit stops locations and pedestrian access to transit facilities. Ensure compliance with ADA access requirements for bus boarding and alighting areas.<sup>27</sup> Work with business owners to develop a plan for implementing measures, such as installing ramps, if features prohibit installation by the city and state (such as underground vaults in the downtown area of Asheville).</p> <p><b>Lighting.</b> Review/add lighting at intersections, transit stops, and certain pedestrian crossings. During the nighttime review, the RSA team noted that LED lighting on Asheland Avenue is obscured by an overgrown tree, which should be trimmed to maximize lighting. The downtown corridor of Patton Avenue utilizes older yellow street lighting that is not as effective as LED lighting. The city should consider replacing or retrofitting the existing lighting with LED lights, in addition to replacing bulbs that are burnt out to ensure proper lighting on the corridor.</p>
