# Planning for Safe Routes to School Pedestrian Road Safety Audit

Bass River Elementary School  
New Gretna, New Jersey

**Delaware Valley  
Regional Planning  
Commission**

March 2008

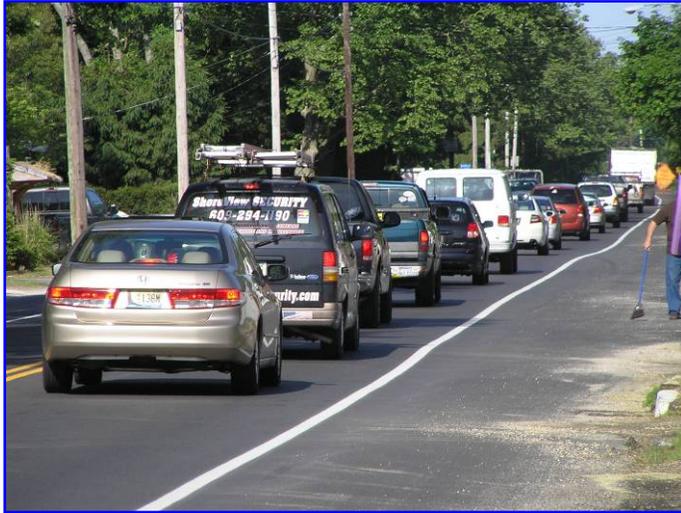
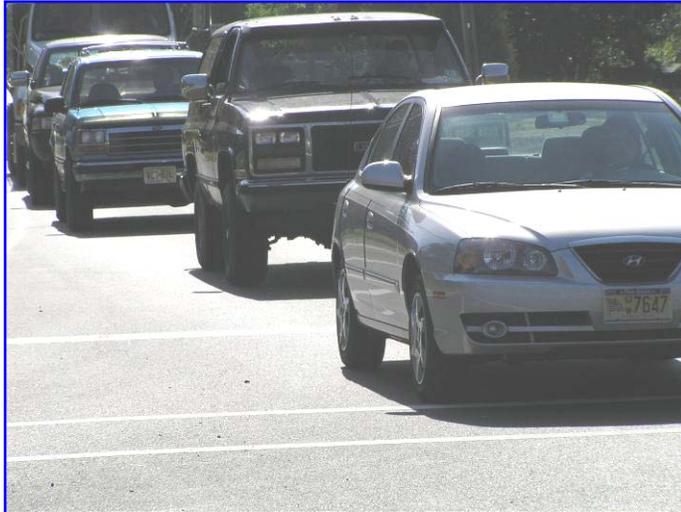
### New York Road (US 9)

**Top and Middle:** Morning traffic near North Maple Avenue.

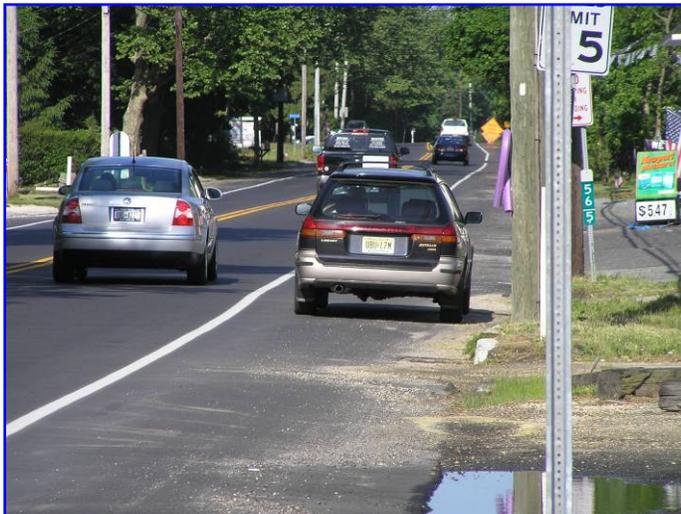
While Route 9 has wide shoulders, the audit team observed drivers drifting into the shoulder inattentively, using the shoulder to overtake left-turning vehicles on the right, and parking in the shoulder. The audit team agreed that an existing shoulder taper at the intersection with Maple Avenue encourages improper passing behavior.

**Bottom:** Vehicle overtaking on the right in the shoulder.

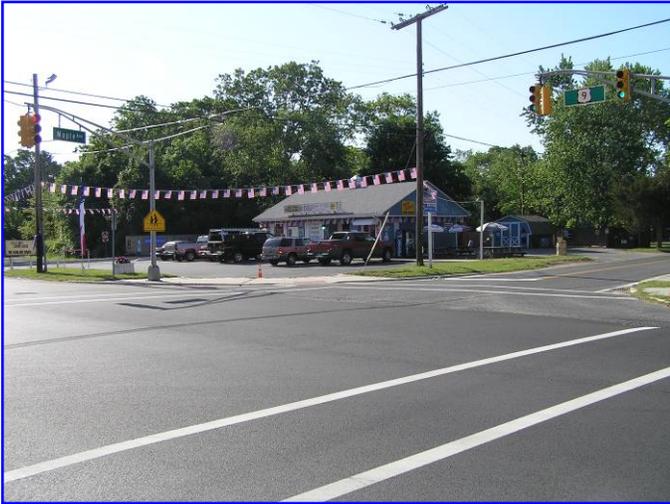
### Maple Avenue/US 9 Intersection

**Top left:** View looking southeast across the intersection. A convenience store occupies the southeastern corner. The crosswalk in the foreground crosses US 9.

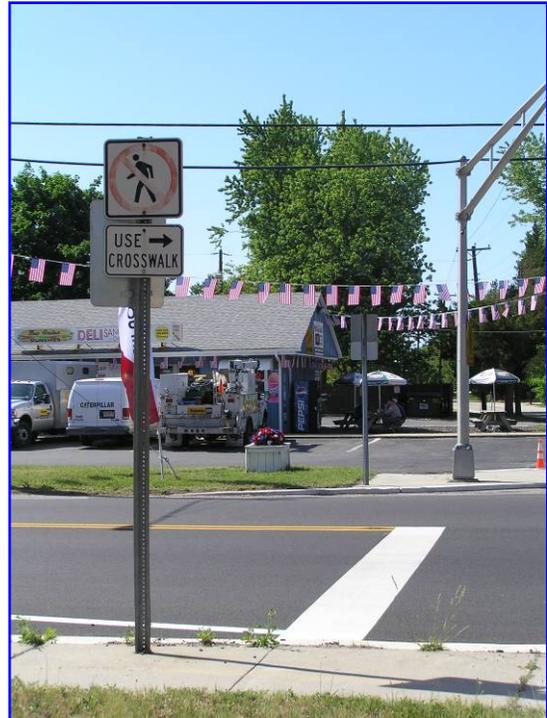
**Above:** Crosswalk warning sign is placed beyond the crosswalk.

- Installation, relocation, or replacement of various worn, mislocated, or needed regulatory warning and route signs (detailed in Table 1);
- Moving the start of the North Maple Avenue 25 mph school zone northward; and
- Installation of tactile warning devices for the visually impaired on sidewalks at the school driveway and at a nearby church driveway.

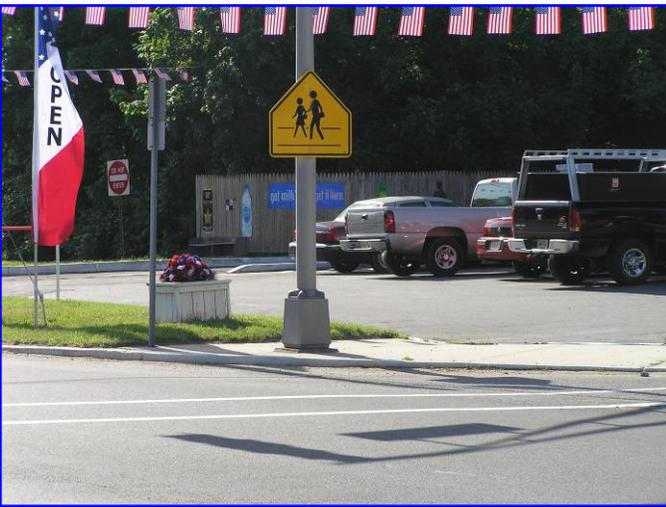
**Top right:** A faded “pedestrians prohibited” sign directs pedestrians to use the crosswalk a few feet away to the right (just out of the picture frame).

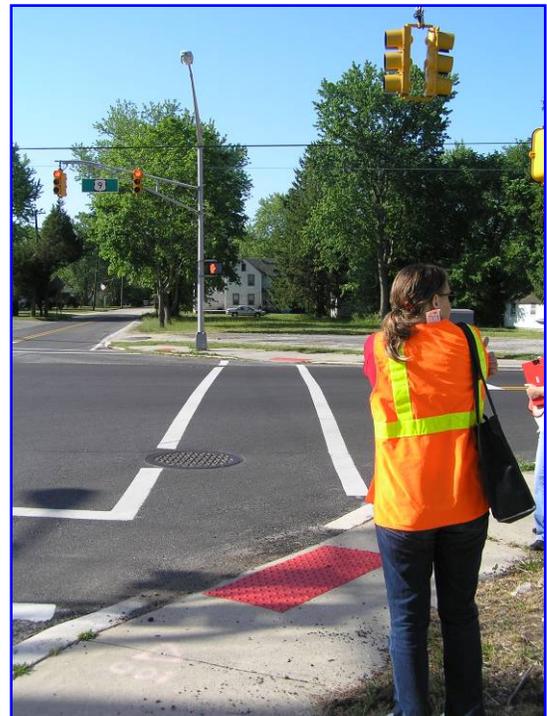
**Right:** The intersection has clearly marked transverse crosswalks, pedestrian signal heads, and wheelchair ramps with tactile warning devices.

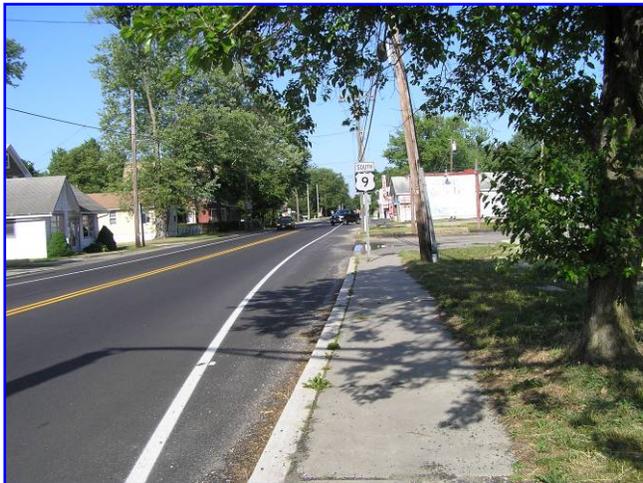
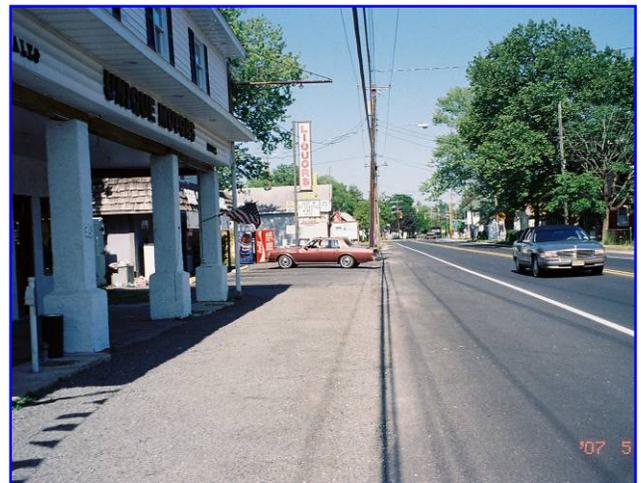
**New York Road (US 9)**

- discontinuous sidewalks;
- highway guide signs mounted too low, obstructing the pedestrian way;
- unchannelized motor access to commercial properties; and
- excessive motor vehicle speeds.

**Top and middle left:** Discontinuous sidewalk.

- Installation of sidewalks on Route 9 and North Maple Avenue, with highest priority being the extension of the sidewalk on the west side of North Maple Avenue to West Road;
- Extension of the school driveway toward the old schoolhouse to increase vehicle holding capacity and moving the entrance northward;
- Construction of a new walkway to the school building entrance from the sidewalk;
- Installation of additional pedestrian push-button signal actuators at the Route 9/Maple Avenue intersection;
- Installation of curb extensions (“bulb-outs”) at the Route 9/Maple Avenue intersection to calm traffic and decrease crossing distance;
- Management of access to commercial properties on Route 9, including definition of driveways with sidewalks and curbs; and
- Eradication of centerline and relocation of fog lines to create wide shoulders on South Maple Avenue.

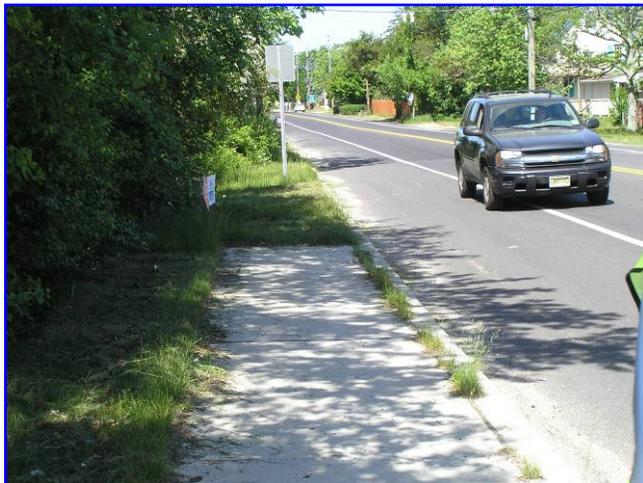
**Bottom left:** Audit team walking along shoulder where sidewalks are absent.

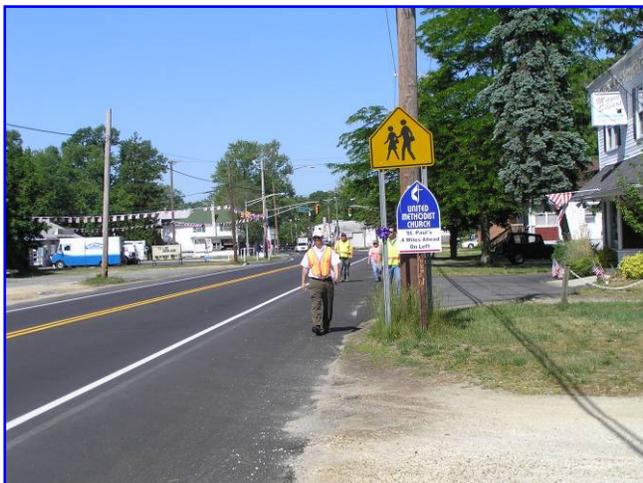
**Above:** Unchanneled vehicular access to roadside businesses creates a hazardous condition for pedestrians.

NJDOT and the Township should jointly prepare an access management plan for Route 9 through New Gretna and explore funding of the plan and its implementation through NJDOT’s local aid programs.

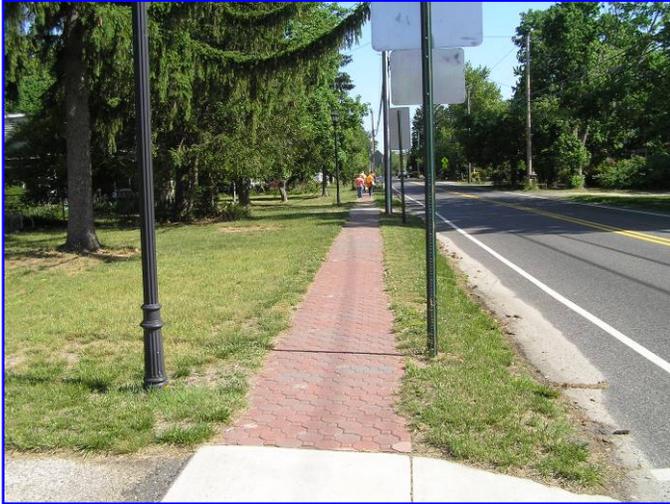
**North Maple Avenue**

**Top left:** Brick paver sidewalk recently installed by the Township along the west side of the road.

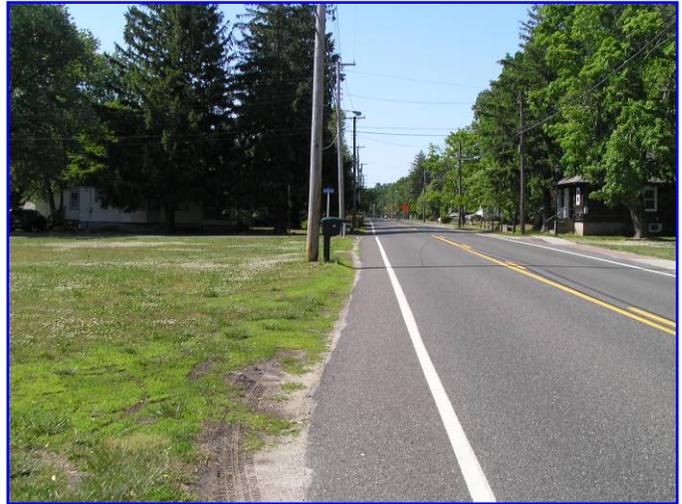
**Left:** Where the sidewalk ends.

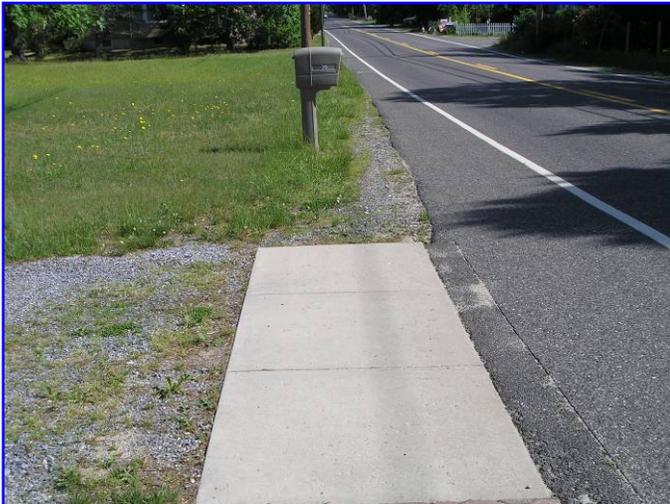
**Bottom left:** Narrow and deteriorated sidewalk in front of residential property.

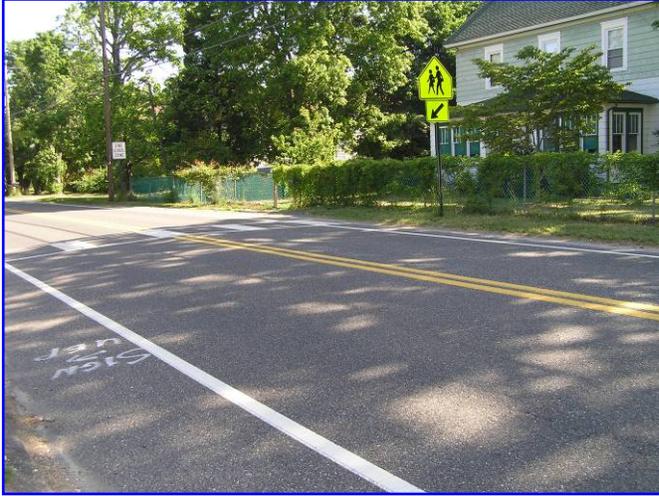
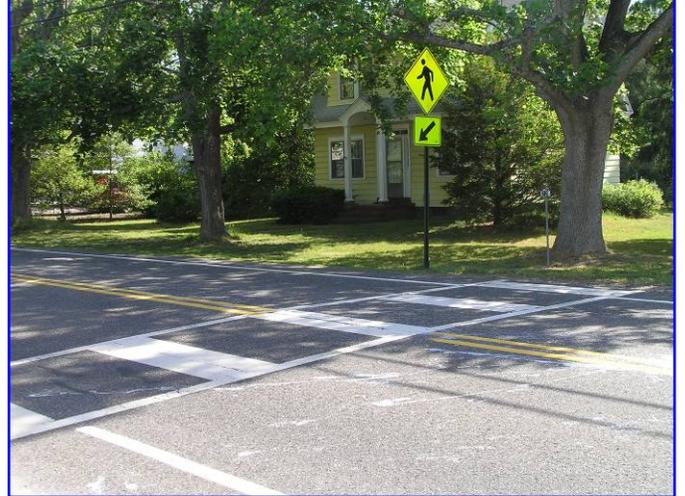
### North Maple Avenue

**Top left and right:** Clearly marked ladder-type midblock crosswalks.

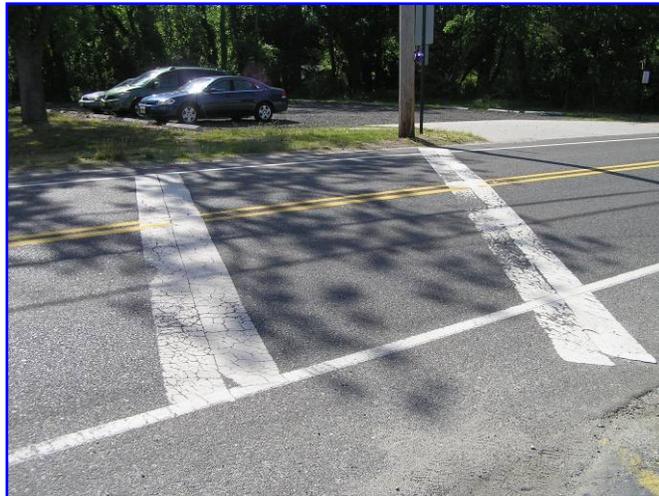
**Left:** Pavement markings of unknown type, possibly intended as a crosswalk between the school and employee parking.

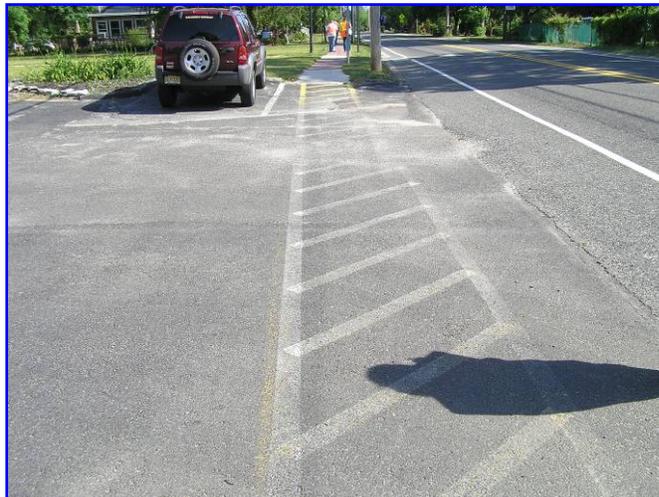
**Bottom left:** Faded crosswalk at school driveway.

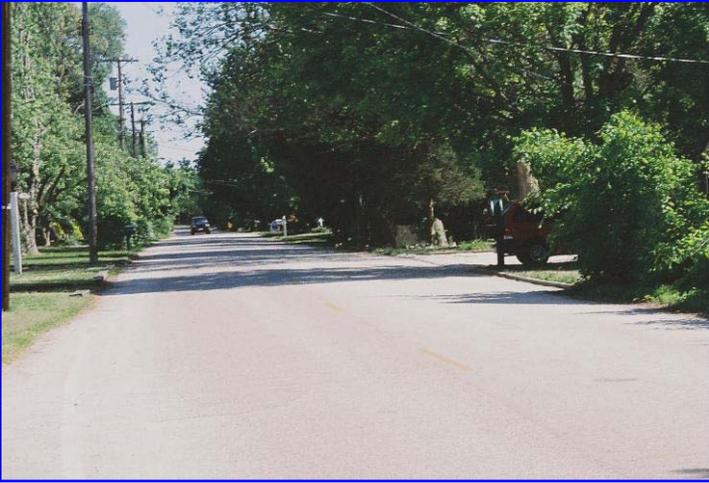
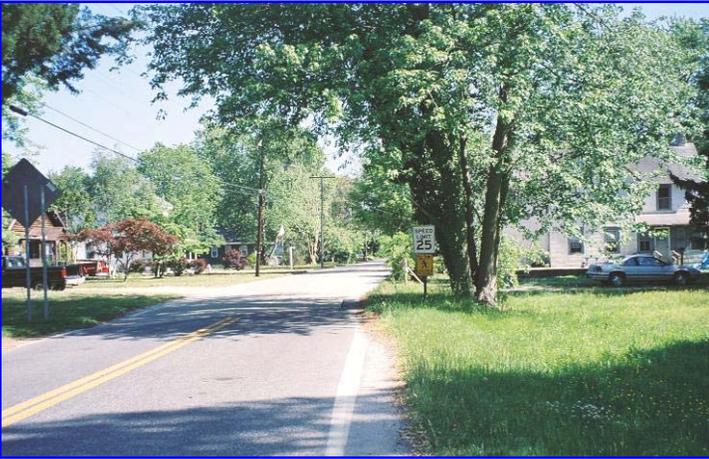
## South Maple Avenue

The audit team found traffic to be virtually absent during the early weekday afternoon of the audit. Despite its light traffic load and local service characteristics, this residential street is designed like a highway, with a minimum 24-foot width, a centerline, and fog lines. Sidewalks are nonexistent. In the Southbound direction, this straight road takes a sharp right curve as it reaches the Garden State Parkway right-of-way. The team was also concerned about excessive vehicle speeds.

The photos at left illustrate the highway-like feel of this local street.

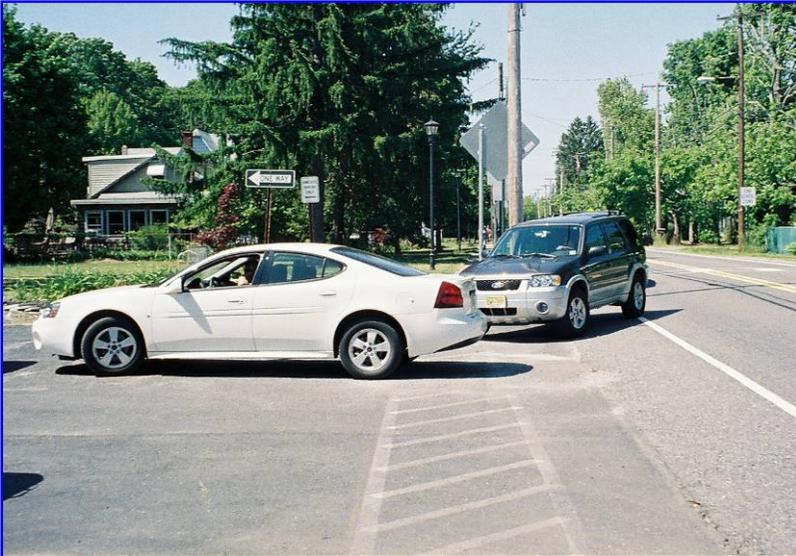
## School dismissal

During school dismissal, vehicles stacked briefly on southbound North Maple Avenue while waiting to enter the school driveway, blocking the driveway crosswalk.

**Below:** Vehicles stacking at school driveway block the crosswalk.
