Route 70 (Marlton Pike) Cuthbert Boulevard to Penn Avenue

Pedestrian Road Safety Audit/Assessment

Cherry Hill, New Jersey

September 15-16, 2008

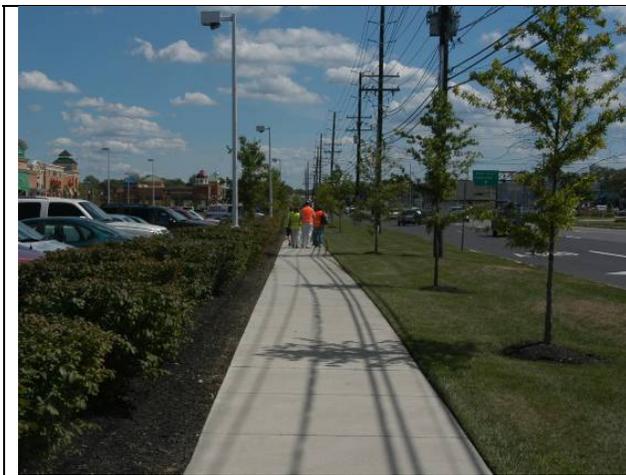
View along Route 70 between Haddonfield Rd and Garden Park Blvd. Photo illustrates the benefits of streetscaping to reduce visual clutter and provide a buffer that separates pedestrians and vehicles.

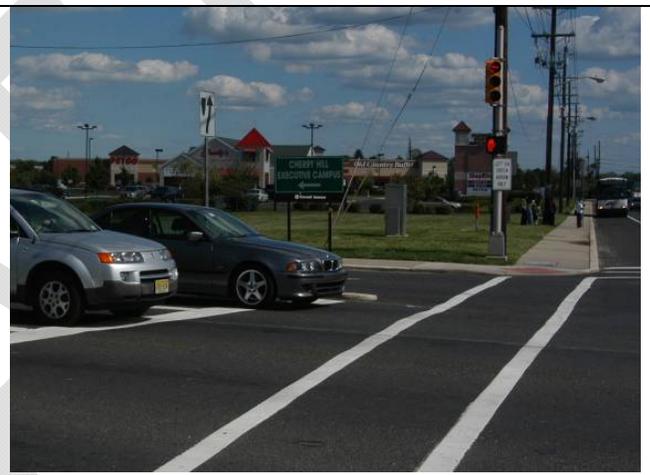
Intersection at Cornell Avenue. Photo illustrates a proper use of crosswalks, curb ramps, and pedestrian signals to enhance safety for pedestrians. The stop bar is also placed before the crosswalk to separate vehicles from pedestrian traffic.

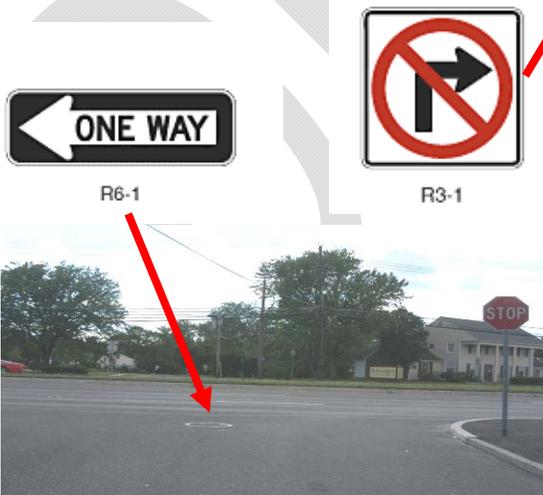
A view of the median from Union Avenue.

- Replace faded signs (e.g., ‘USE CROSSWALK’ sign on northwest quadrant at Cornell Avenue).
- Remove redundant and outdated signs (e.g., ‘RIGHT LANE MUST TURN RIGHT’ signs on northeast quadrant at Garden Park Boulevard).
- Install signage where currently insufficient (e.g., prior to jug handle at Cornell Avenue and install one way sign (R6-1) in median facing Union Avenue).
