# **Cerrillos Road/Alta Vista Street/Luisa Street/Cordova Road**

**Pedestrian Road Safety Assessment**

**Santa Fe, New Mexico**

**May 11 – 12, 2009**

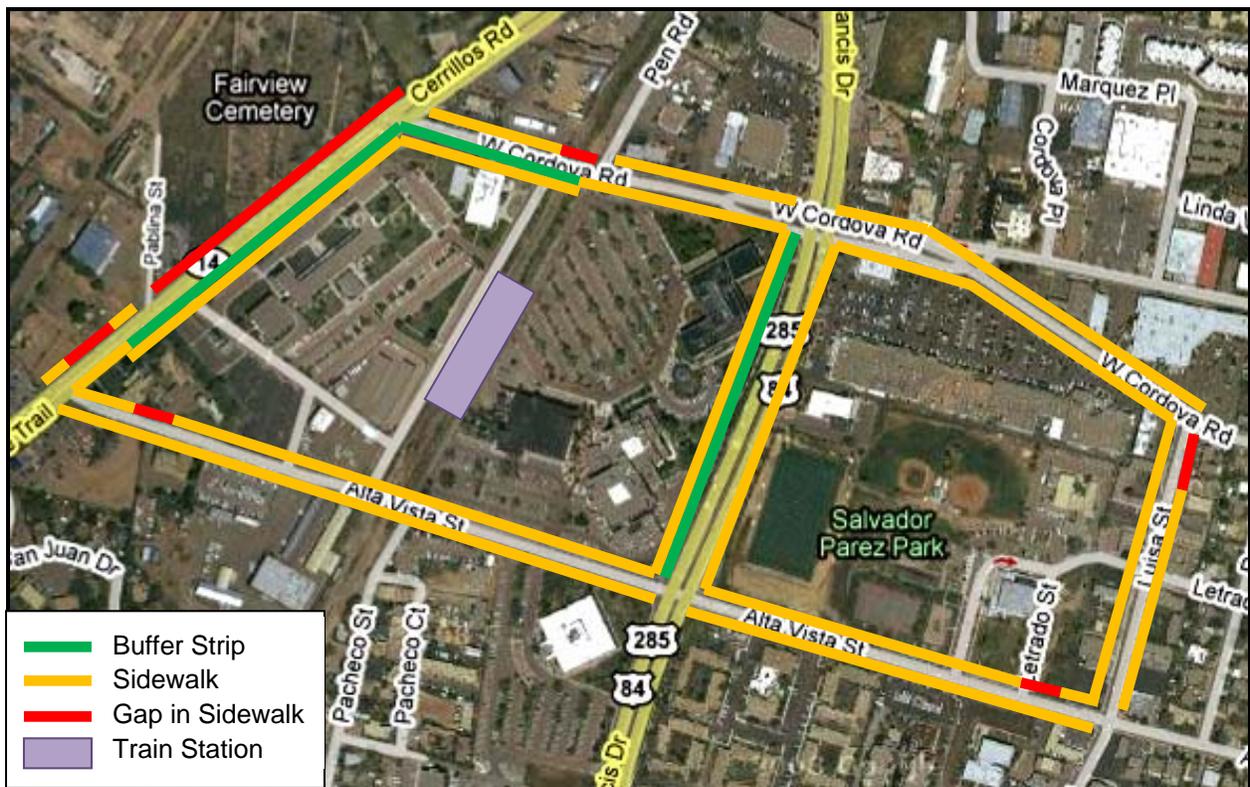
Figure 2. Pedestrian Facilities within the Study Area

Cerrillos Road is a four-lane, divided, urban arterial with a posted speed limit of 35 mph through the study area. There is a raised center median; on the east and west side of the roadway are shoulders (approximately 5 ft wide) and curb-and-gutter through the study area. There is a sidewalk along the east side, but not along the west side of Cerrillos Road (see Figure 2).

Cordova Road is a four-lane, divided, urban arterial with a posted speed limit of 30 mph. There is a two-way left-turn lane with curb-and-gutter along the north and south side of the road through the study area. There is a sidewalk along both sides of the road (see Figure 2). Alta Vista Street and Luisa Street are two-lane urban local roads with a posted speed limit of 25 mph. Both roads have sidewalk along both sides (see Figure 2).

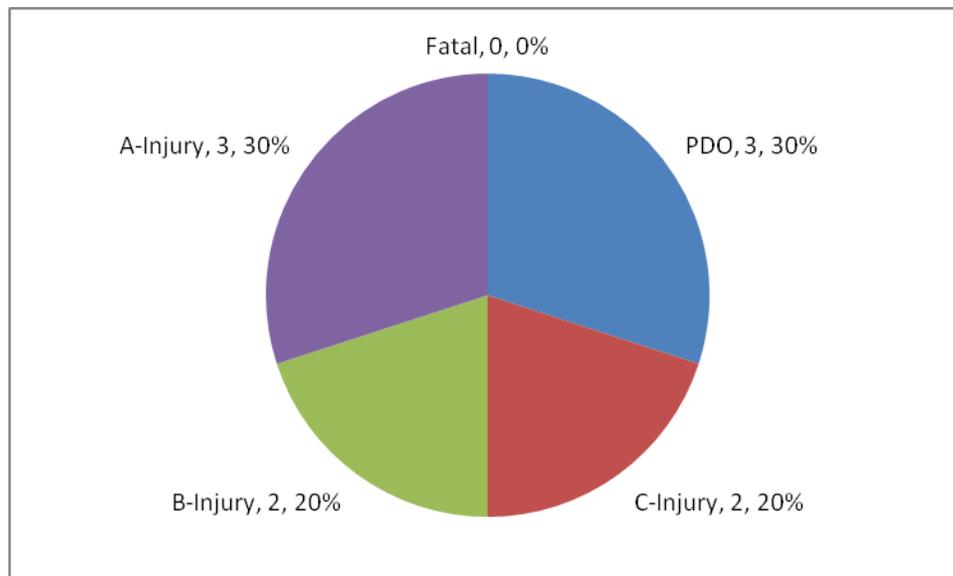
**Figure 3. Pedestrian/Bicycle Crashes by Severity**

The majority of the pedestrian/bicycle crashes (70 percent) were injury-related, including all six of the pedestrian-vehicle crashes. The remaining three crashes (30 percent) were property damage only (PDO), all involving a bicycle, as shown in Figure 3. There were no fatalities reported within the study area from 2004 to 2008.

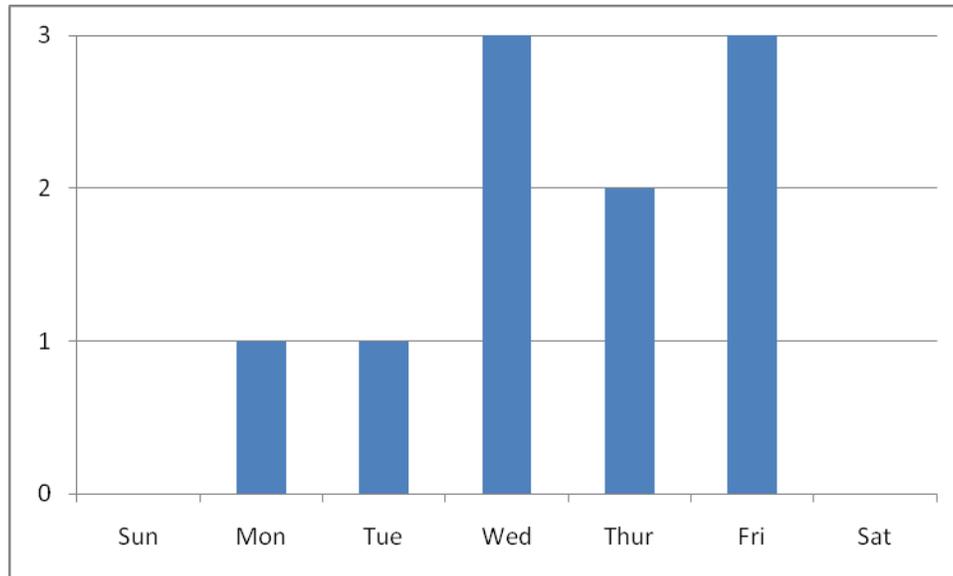
**Figure 4. Crashes by Day of Week**

All of the crashes from 2004 to 2008 occurred during the week and there were no crashes on the weekend as shown in Figure 4. During the weekdays, the majority of crashes are occurring between Wednesday and Friday.

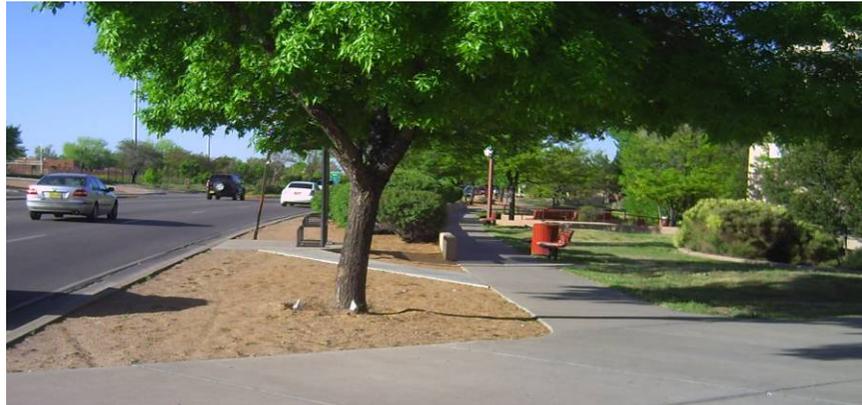
between vehicles and pedestrians, reducing the opportunity for conflict and providing a more comfortable walking environment for pedestrians.

View of southwest quadrant of the intersection of St Francis Drive and Cordova Road. Photo shows where trees and bushes have been planted to provide a buffer strip between the sidewalk and roadway.

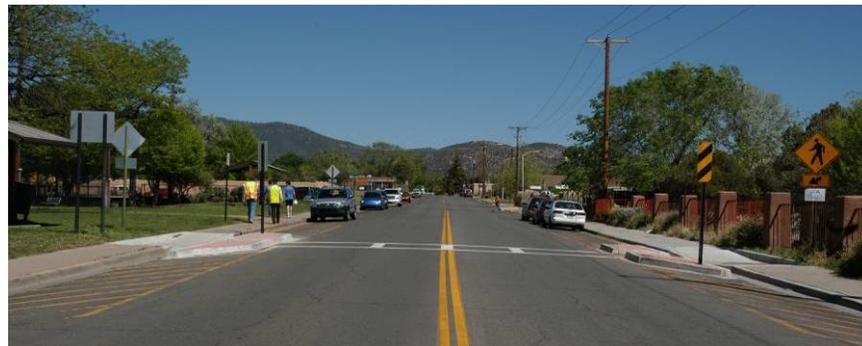
- **Traffic Calming** – There is neck-down installed along Alta Vista Street near the senior center. The neck-down reduces the crossing distance for pedestrians and also helps to reduce vehicle speeds by narrowing the roadway width.

View of Alta Vista Road looking eastbound between St Francis Drive and Luisa Street. Photo shows a neck-down strategy where the pedestrian crossing distance has been reduced by providing raised islands near the edge of the travel lanes.

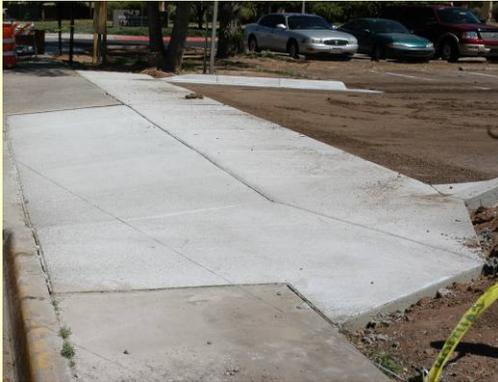
<p>Photo shows a recent sidewalk upgrade on Alta Vista Street. Pedestrians are provided a level area around the sloped driveway apron. Such designs provide improved accessibility for pedestrians.</p>
