## Retroreflective Borders on Traffic Signal Backplates Increase Visibility

This article summarizes safety benefits the SCDOT achieved by applying of retroreflective borders on existing signal backplates that reduced crashes at three urban signalized intersections in Columbia, South Carolina.

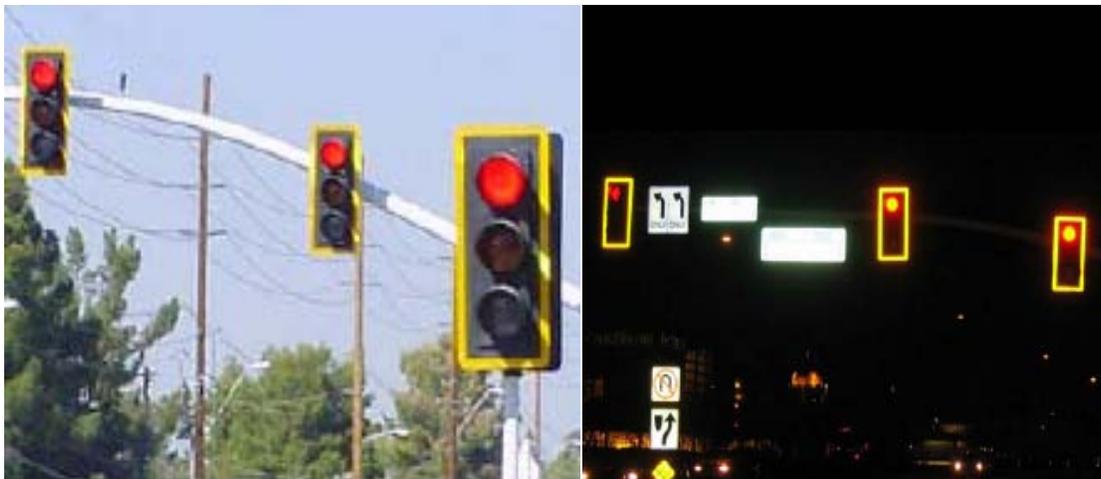
**Figure 1: Retroreflective Borders Installed on Signal Backplates**

The treatment involved adding a 3-inch yellow retroreflective border to the face of the existing signal backplates (see Figure 1) in June, 2005. The retroreflective border helps to increase the intersection's visibility during the day for drivers, and even more so at night or under limited visibility conditions.

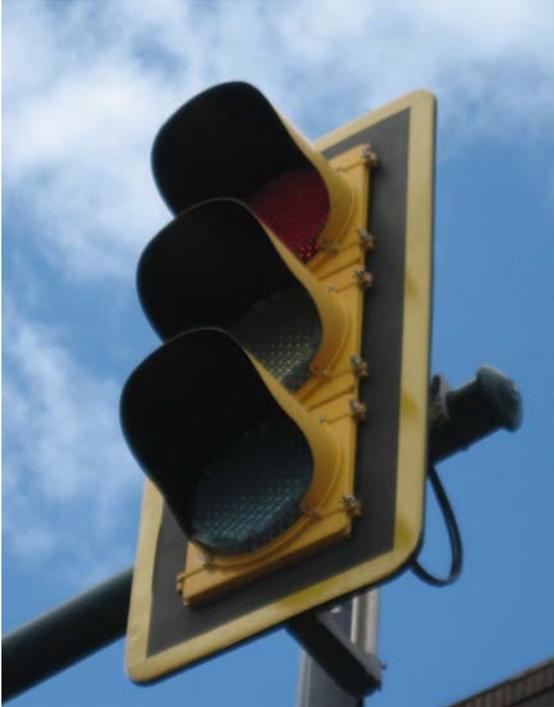
**Figure 2: Retroreflective Backplate Border**

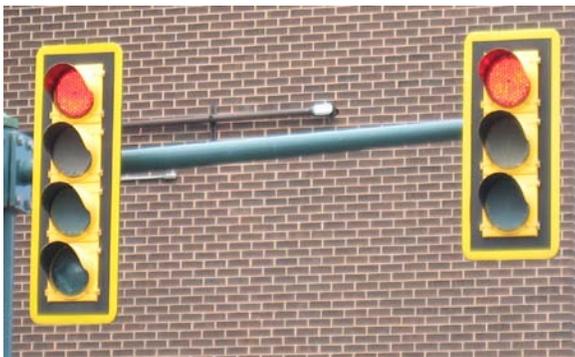
**Figure 3: Retroreflective Borders  
Installed on Signal Backplates**
