U.S. Department
of Transportation
**Federal Highway
Administration**

In Reply Refer To: HSSD/CC-88B

Name of devices: Sequential Kinking Terminal (SKT), and
Flared Energy Absorbing Terminal (FLEAT) with 2 Breakaway Posts
Type of devices: W-Beam Guardrail Terminals
Test Level: NCHRP Report 350 Test Level 3
Testing conducted by: Midwest Roadside Safety Facility
Date of request: April 22, 2008

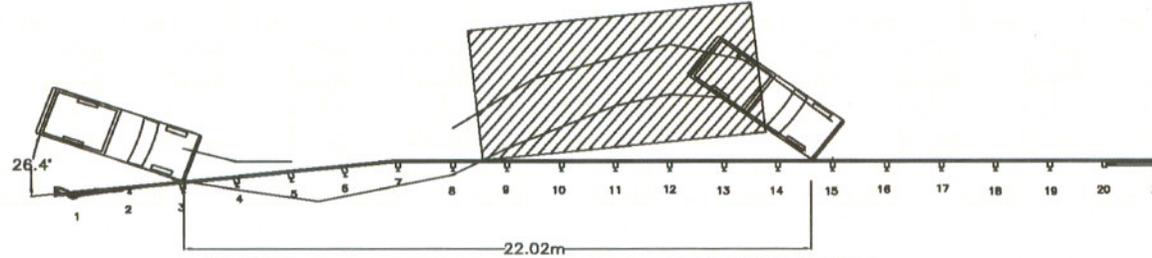
Summary of Test Results and Sequential Photographs, Test No. FLT2P-1

- Test Agency MwRSF
- Test Number FLT2P-1
- Date 11/29/2007
- NCHRP 350 Test Designation 3-35
- Appurtenance Two Post FLEAT End Terminal
- Total Length 38.1 m
- Key Element FLEAT impact head
- Key Element - Steel W-beam
 - Thickness 2.67 mm
 - Top Mounting Height 706 mm
- Key Element - Breakaway Steel Posts
 - Post No. 1 HP-1
 - Post No. 2 HP2A top and HP3B bottom
 - Spacing 1,905 mm
- Key Element - Steel Posts
 - Post Nos. 3-19 W152x13.4 by 1,829 mm long
 - Spacing 1,905 mm
- Key Element - Wood Spacer Blocks
 - Post Nos. 3-19 152 mm x 203 mm x 362 mm long routed
- Type of Soil Grading B-AASHTO M 147-65 (1990)
- Test Vehicle
 - Type/Designation 2000P
 - Make and Model 1991 Chevrolet C2500 pickup truck
 - Curb 2,005 kg
 - Test Inertial 2,012 kg
 - Gross Static 2,012 kg

- Impact Conditions
 - Speed 97.2 km/h
 - Angle 26.4 degrees
 - Impact Location Centerline of post no. 3
- Exit Conditions
 - Speed 43 km/h
 - Angle 28.1 degrees
 - Exit Box Criterion Pass
- Post-Impact Trajectory
 - Vehicle Stability Satisfactory
 - Stopping Distance 22.0 m downstream
- Occupant Impact Velocity
 - Longitudinal -5.33 m/s < 12 m/s
 - Lateral (not required) -3.63 m/s
- Occupant Ride Down Deceleration
 - Longitudinal -7.48 g's < 20 g's
 - Lateral (not required) -4.92 g's
- Test Article Damage Moderate
- Test Article Deflections
 - Permanent Set 1,400 mm
 - Dynamic 1,464 mm
 - Working Width 1,723 mm
- Vehicle Damage Moderate
 - VDS 01-RFQ-3
 - CDC 01-RFEW4
 - Maximum Deformation 13 mm

The test data summary sheets for the three recommended crash tests, FLT2P-1 (Test 3-35), FLT2P-2 (Test 3-34), and FLT2P-3 (Test 3-30) are enclosed for reference. In test FLT2P-3 there was a small hole in the floor pan caused when the nearly-stopped vehicle came to rest on the end of a guardrail post that was under the vehicle. We concur that this does not pose a significant risk to vehicle occupants. Otherwise, all occupant risk parameters of NCHRP Report 350 were within recommended guidelines. We concur that this testing shows acceptable performance for both FLEAT and SKT terminals when modified as described.

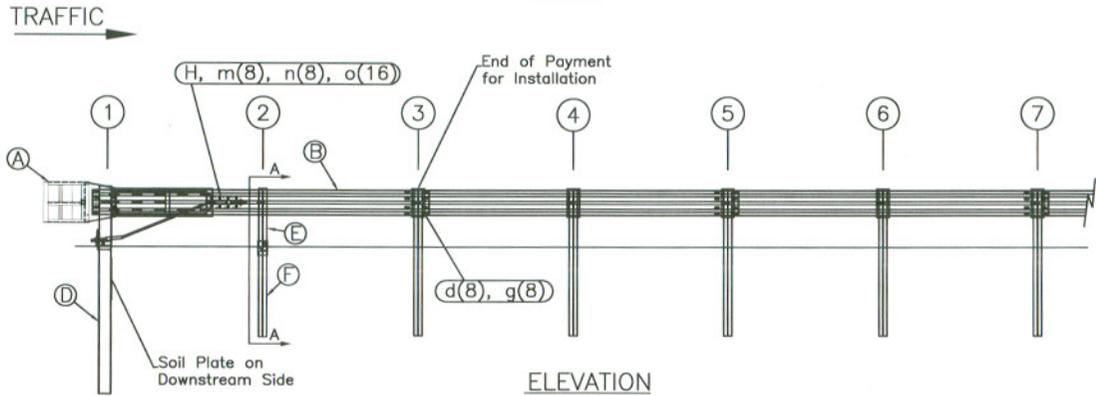
SKT Terminal Metric Height		Sheet: 1
2 Post System		Date: 04/17/08
Drawing Name: SKT2P-S		By: JRR
Scale: None		Rev: 0

PLAN

ELEVATION

OPTIONAL FLARED INSTALLATION
25:1 maximum flare rate

The modified FLEAT and SKT terminals described above and detailed in the enclosed drawings are acceptable for use on the NHS under the range of conditions tested, when acceptable to a highway agency.

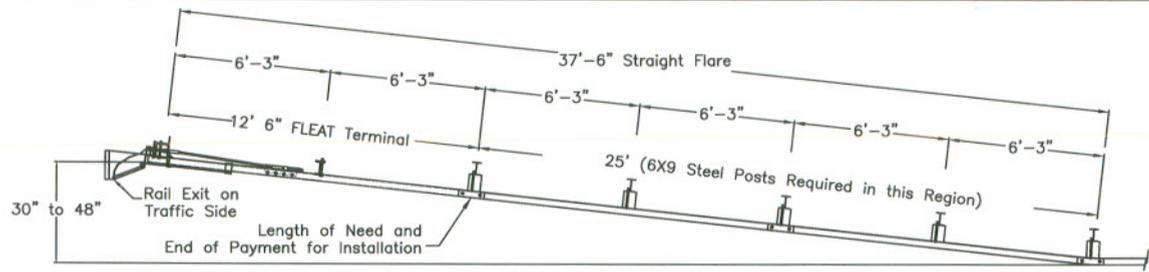
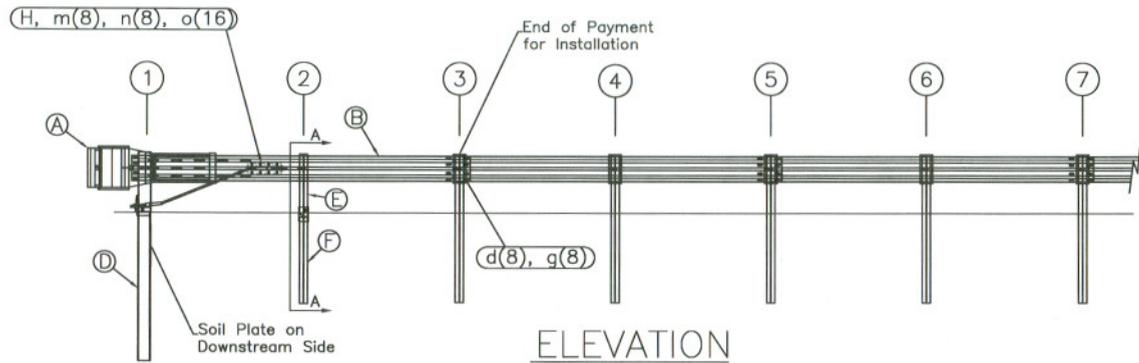
FLEAT Terminal
Metric Height
2 Post System

PLAN

ELEVATION

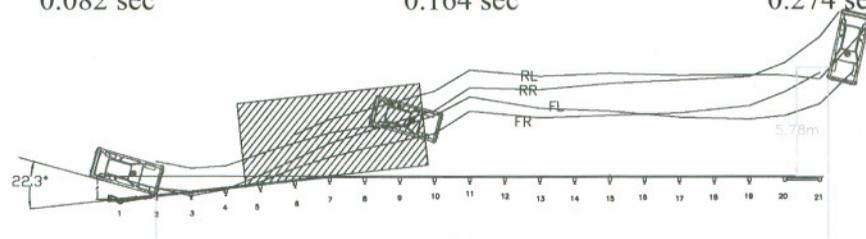
Summary of Test Results and Sequential Photographs, Test No. FLT2P-2

- Test Agency MwRSF
- Test Number FLT2P-2
- Date 2/13/2008
- NCHRP 350 Test Designation 3-34
- Appurtenance Two Post FLEAT End Terminal
- Total Length 38.1 m
- Key Element - Steel W-beam
 - Thickness 2.67 mm
 - Top Mounting Height 706 mm
- Key Element - Breakaway Steel Posts
 - Post No. 1 HP-1
 - Post No. 2 HP2A top and HP3B bottom
 - Spacing 1,905 mm
- Key Element - Steel Posts
 - Post Nos. 3-19 W152x13.4 by 1,829 mm long
 - Spacing 1,905 mm
- Key Element - Wood Spacer Blocks
 - Post Nos. 3-19 152 mm x 203 mm x 362 mm long routed
- Type of Soil Grading B-AASHTO M 147-65 (1990)
- Test Vehicle
 - Type/Designation 820C
 - Make and Model 2000 Chevrolet Metro
 - Curb 844 kg
 - Test Inertial 841 kg
 - Gross Static 914 kg
- Impact Conditions
 - Speed 100.0 km/h
 - Angle 22.3 degrees
 - Impact Location Centerline of post no. 2

- Exit Conditions
 - Speed 64.1 km/h
 - Angle 13.5 degrees
 - Exit Box Criterion Pass
- Post-Impact Trajectory
 - Vehicle Stability Satisfactory
 - Stopping Distance 36.6 m downstream
5.8 m traffic-side
- Occupant Impact Velocity (EDR-3)
 - Longitudinal -5.89 m/s < 12 m/s
 - Lateral -5.58 m/s < 12 m/s
- Occupant Ride Down Deceleration (EDR-3)
 - Longitudinal -7.59 g's < 20 g's
 - Lateral -8.65 g's < 20 g's
- Occupant Impact Velocity (DTS)
 - Longitudinal -5.61 m/s < 12 m/s
 - Lateral -5.90 m/s < 12 m/s
- Occupant Ride Down Deceleration (DTS)
 - Longitudinal -8.60 g's < 20 g's
 - Lateral -11.00 g's < 20 g's
- Test Article Damage Moderate
- Test Article Deflections
 - Permanent Set 464 mm
 - Dynamic 592 mm
 - Working Width 804 mm
- Vehicle Damage Moderate
 - VDS 1-RFQ-4
 - CDC 01-RDEW9
 - Maximum Deformation 102 mm
