## MINNESOTA ROUNDABOUT REDUCES CRASHES, IMPROVES SAFETY

### INTRODUCTION

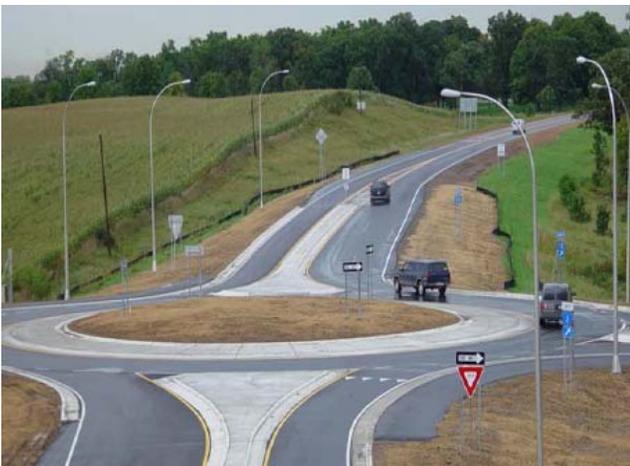
### **Intersection of Highway 13 and County Rd 2**

The Scott County roundabout was constructed in 2005 with a central island 110 feet in diameter. Approach lanes to the roundabout were 16 feet wide, and departure lanes from the roundabout were 14 feet wide. A 200-foot long median island was provided on County Road 2, and a 300-foot long median island was provided on State Highway 13. Splitter islands were 25 feet wide, and the truck apron width was 10 feet, with transverse rumble strips spaced apart on the truck apron at approximately 20 feet, center to center.

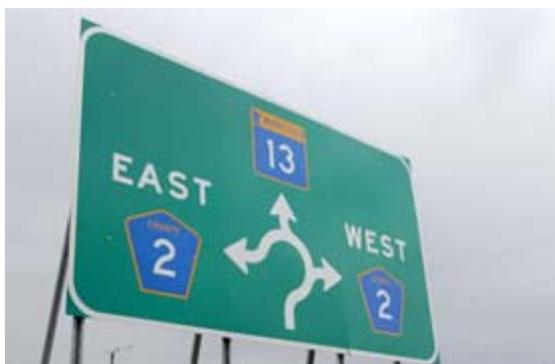
**Sign on the approach to the Roundabout**

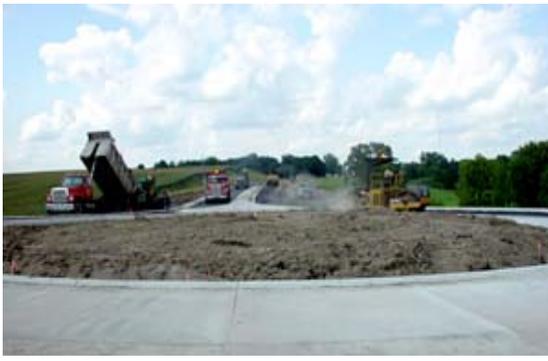
**Construction of the Roundabout**

Mn/DOT had no implementation issues with the installation of the roundabout. The construction of the roundabout took place in 2005 and lasted 90 days. During this time, both State Highway 13 and Scott County Road 2 were closed at the intersection, and motorists were advised to follow the posted detour routes during the closure. The cost to construct the roundabout was \$725,000 (no additional right-of-way acquisition was required).
