• 2019 MASH 2-Tube Bridge Rail Transition

Name of system: 2019 MASH 2-Tube Bridge Rail Transition Type of system: Longitudinal Barrier Transition Test Level: Test Level 3 (TL3) Testing conducted by: Texas A&M Transportation Institute (TTI) Date of request: April 17, 2020

Request for Federal Aid Reimbursement Eligibility of Highway Safety Hardware

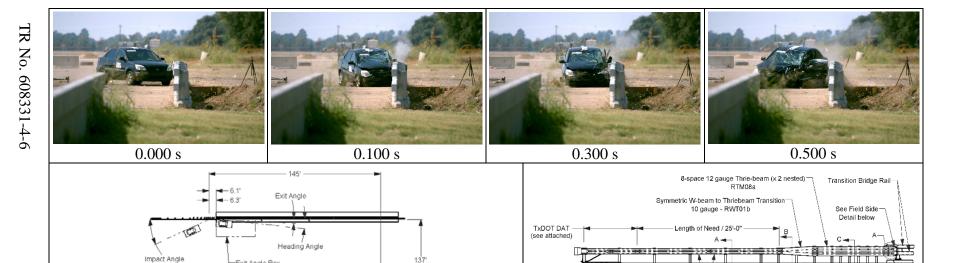
Figure 5.6. Summary of Results for MASH Test 3-20 on 2019 MASH 2-Tube Bridge Rail Thrie Beam Transition.

18				
∞	General Information		Impact Conditions	Post-Im
	Test Agency	Texas A&M Transportation Institute (TTI)	Speed 60.9 mi/h	Stopp
	Test Standard Test No	MASH Test 3-20	Angle	
	TTI Test No	608331-01-4	Location/Orientation 6.06 ft upstream of	Vehicle
	Test Date	2019-09-02	end of curb/deck	Maxim
	Test Article		Impact Severity 61 kip-ft	Maxim
	Туре	Transition		Maxim
	Name	2019 MASH 2-Tube Bridge Rail Thrie	Exit Conditions	Vehic
		Beam Transition	Speed 39.5 mi/h	Vehic
	Installation Length	207 ft 3 ¹ / ₂ inches (incl 154 ft of deck)	Trajectory/Heading Angle 7.1° / 14.0°	Test Ar
	Material or Key Elements	Thrie beam guardrail terminal to 38-inch	Occupant Risk Values	Dynar
		tall 2-tube bridge rail, 34¾ inch tall thrie	Longitudinal OIV 22.6 ft/s	Perma
		beam guardrail section, symmetrical	Lateral OIV 30.5 ft/s	Worki
		W-beam to thrie beam terminal, 25 ft of	Longitudinal Ridedown 14.5 g	Heigh
		W-beam guardrail	Lateral Ridedown 9.2 g	Vehicle

Stopping Distance	145 ft downstream
	137 ft twd traffic
Vehicle Stability	
Maximum Yaw Angle	63°
5	
Maximum Pitch Angle	
Maximum Roll Angle	12°
Vehicle Snagging	No
Vehicle Pocketing	No
Test Article Deflections	
Dynamic	3.5 inches
Permanent	1.25 inches
Working Width	26.1 inches
Height of Working Width	34.75 inches
Vehicle Damage	
VDS	11LFQ6
CDC	11FLEW5
Max. Exterior Deformation	14.0 inches
OCDI	FL0010000
Max. Occupant Compartment	
	0 5 inches
Deformation	3.5 Inches

Page 3 of 8
Required Test Number	Narrative Description	Evaluation Results
	Test 3-20 involves an 1100C vehicle impacting the test article at a target impact speed of 62 mi/h and target angle of 25°. The target CIP for the left corner of the front bumper was 5.1 ft upstream of the end of the concrete curb/deck.	
	The results of the test conducted on September 2, 2019, are found in TTI Test Report No. 608331-4-6 as Test #4. The test vehicle was traveling at aspeed of 60.9 mi/h as it made contact with the 2019 MASH 2- Tube Bridge Rail Transition 6.06 ft upstream of the end of the concrete curb/deck at impact angle of 26.5°. After loss of contact with the transition, the vehicle came to rest 145 ft downstream of the impact point and 137 ft toward the traffic side.	
	The 2019 MASH 2-Tube Bridge Rail Transition contained and redirected the 1100C vehicle. The vehicle did not penetrate, underride, or override the installation. The vehicle exited within the exit box criteria defined in MASH. Maximum dynamic deflection of the rail during the test was 3.5 inches. Maximum	5400

3-20 (1100C)	permanent deformation was 1.25 inches. Working width was 26.1 inches. No detached elements, fragments, or other debris were present to penetrate, or to show potential for penetrating, the occupant compartment, or to present undue hazard for others in the area. The 1100C vehicle remained upright during and after the collision event. Maximum roll	PASS
	and pitch angles were 12° and 3°, respectively. Longitudinal OIV was 22.6 ft/s and lateral OIV was 30.5 ft/s. Maximum longitudinal occupant ridedown acceleration was 14.5 g, and maximum lateral occupant ridedown acceleration was 9.2 g. Occupant risk factors were within the maximum limitsspecified in MASH.	
	Maximum exterior crush to the vehicle was 14.0 inches in the side plane in the front plane at the left front corner at bumper height. Maximum occupant compartment deformation was 3.5 inches in the left kick panel area. No damage to the fuel tank was observed. The 2019 MASH 2-Tube Bridge Rail

Transition performed acceptably for MASH test 3-20.
