VISION ZERO SUCCESS STORY – INFRASTRUCTURE

Rainier Avenue South Redesign — Seattle, Washington

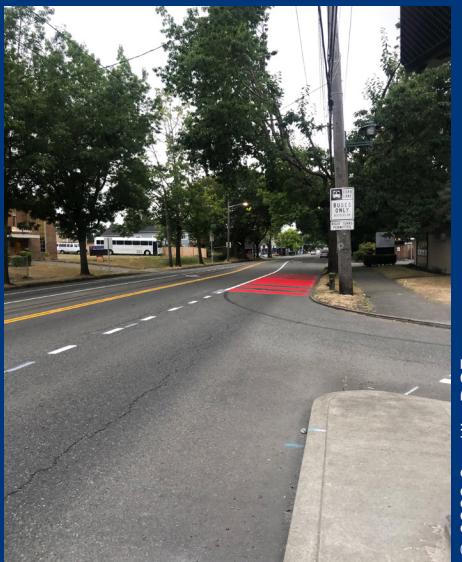
Figure 1. Photograph. Newly installed bus lane on Rainier Avenue South at South Cloverdale Street.

The redesign of the Rainier Avenue South corridor including geometric changes, signal timing and speed limit modifications, and transit efficiency measures such as new bus lanes (figure 1) resulted in the following traffic safety successes:

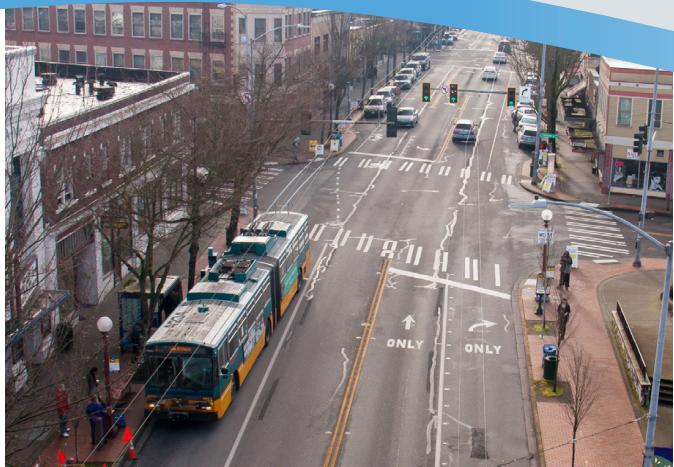
Figure 2. Graphic. Aerial photograph of Rainier Avenue South intersection showing transit and lane improvements.

- **Reconfigured Roadway** – Removed one travel lane from each direction (shown in both figures 2 and 3) to accommodate a center two-way left-turn lane.
- **Prioritized Transit** – Added a transit priority signal² and added dedicated bus (and right-turn) lanes to both directions.
- **Retimed Signals** – Retimed signals for the new flow of traffic, including longer cycle lengths, leading pedestrian intervals³, and left-turn signals.
- **Lowered Posted Speed Limit** – Reduced the posted speed limit from 30 to 25 mph.
- **Enhanced Sight Lines** – Added pavement paint and flexible delineator posts at crossings to improve sight lines for traffic entering the corridor and reduce distance for pedestrians crossing the street. Additionally, new reflectors, curb bulbs, and raised and/or repainted crosswalks increased visibility for pedestrian crossing.

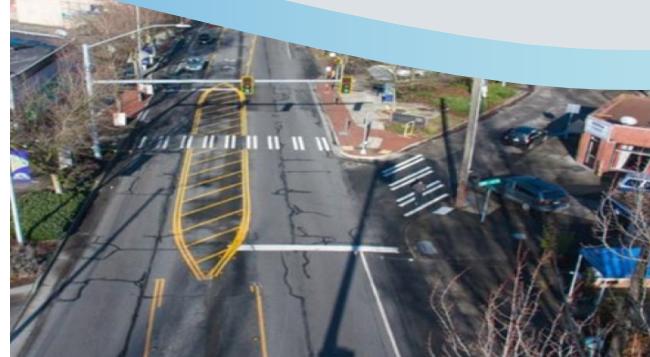
Figure 3. Graphic. Aerial photograph of Rainier Avenue South intersection showing rechannelization improvements.
